### Incident description: gas leak 2017

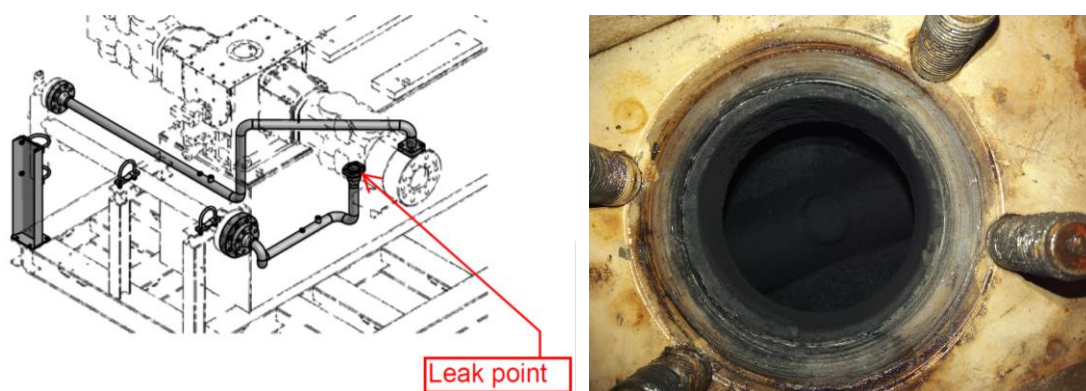
A gas leak occurred due to a blown gasket on a spool connected to a gas lift compressor. The way the connection was designed, alignment was more critical than on other more typical flanged connections on hydrocarbon systems. The recommended practice specified by the gas lift compressor manufacturer was to remove the complete spool (both flange pairs) during maintenance, and replace/install the connection where the leak occurred first. Thereafter, the other flange pair should be installed. The above was not known by the involved personnel, and the maintenance was carried out by only disconnecting and replacing the connection where the leak occurred (see right picture below).

- Lost containment in a flanged connection due to loss of bolt tensioning.

- The design of the bolted connection was not sufficiently robust to cope with loads imposed by vibration, temperature variations and frequent restarts.

- Reinstallation of the pipe spool was not performed according to recommended practice as only one flange pair was released when the gasket was replaced. Recommended practice was not known by the involved personnel, and was not described in any procedure.

- Implement a revised bolted solution as recommended by the gas lift compressor manufacturer.
- Update work instruction to check bolted connections prior to restart of the gas lift compressor. Revise current manual to include specific installation sequence for critical spools.
- Evaluate if the gas lift compressor manufacturer should be more involved in future repair work.
- Revise the barrier system to include more thorough evaluation of Synergi reports to discover similar incidents at an early stage.
