## 2018-G: Gas leak when replacing manifold valve

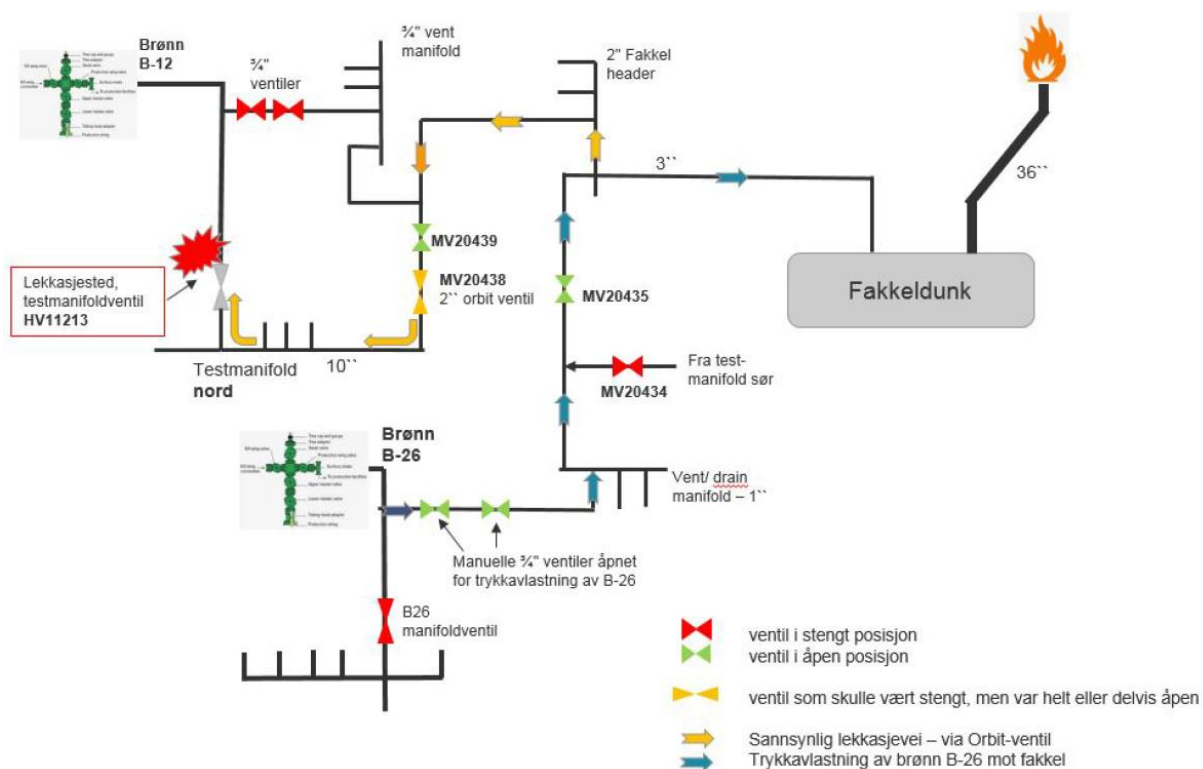
The leak originated from the flare system via the flare header, through a two-inch orbit valve to the test manifold and on to a manifold valve which was being remounted following a maintenance job. See Figure 1. The maintenance job was done with the orbit valve as a single barrier against the flare system. Following the incident, it was discovered that this valve was not in the closed position as indicated in the valve and blind list.

Figure 1 Diagram of the incident.

The immediate cause of the gas leak was that the orbit valve, which functioned as a single barrier against the flare system, was not properly closed during remounting of the manifold valve. The leak

1. Hold a working meeting to discuss and raise awareness of the vulnerability to human factors when implementing isolation plans. The discussion should address:
  - where requirements involve varying practice and unclear points
  - identifying possible requirements for clarification, both locally and in the work process.
2. Clarify work processes/requirements for strengthening the organisational barrier elements which could prevent hydrocarbon leaks. This covers:
  - clarifying the method for verifying the isolation plan
  - clarifying when marking should be done in the field
  - clarifying requirements for change of status in an established isolation plan.
3. Assess measures for enhancing process operator expertise through courses in process safety.
4. Verify whether infra-red point gas detectors function during deluge.

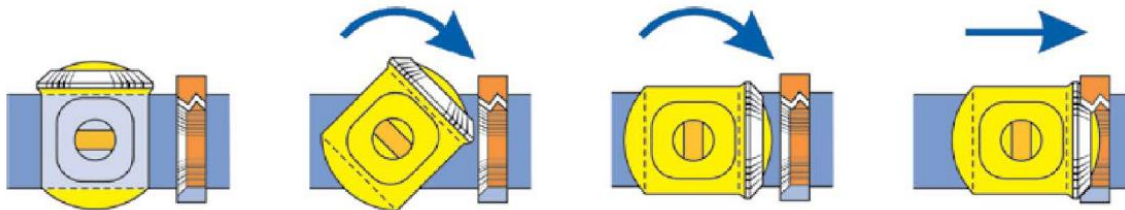
1. An attempt was made to close the valve, but it had remained open by three-five millimetres.
2. Closing the valve had been overlooked when establishing the isolation plan or when opening after the plan had been established.

Figure 2 Illustration of an orbit valve in a pipeline – status from fully open (left) to fully closed (right)

- The orbit valve could have been standing open after an **attempt to close it** because of inadequate expertise and experience with a valve type which is seldom operated and which is operated rather differently from other ball valves.
- The orbit valve could have been **forgotten in the open position** because the work process for setting, verifying and approving isolation has an inherent vulnerability to human factors such as memory lapses, faulty operation, unintentional opening and so forth.
