2018-H: Gas leak via stuffing box

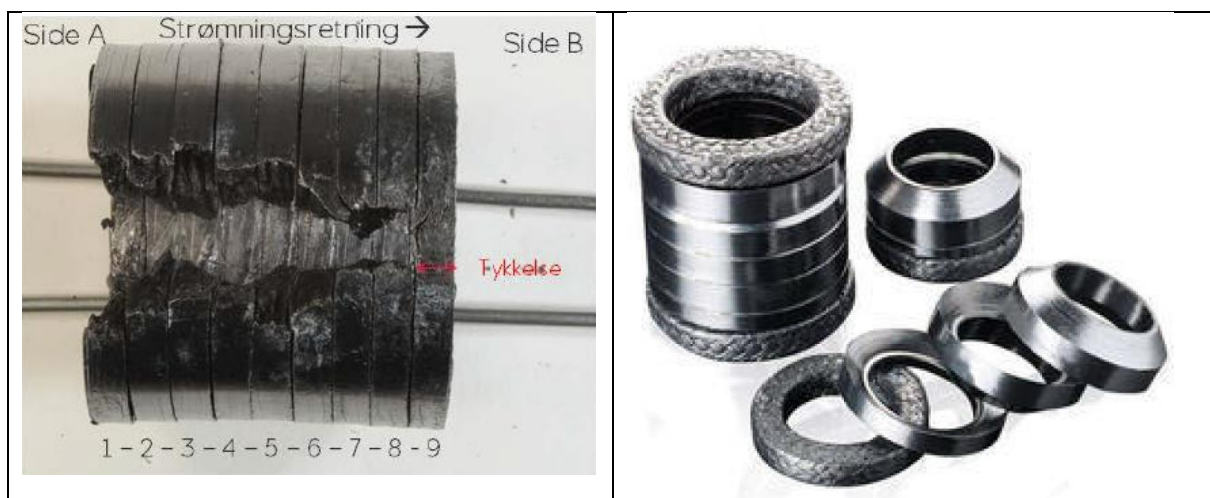
One of the causes was that the stuffing box did not conform with requirements. It contained only moulded packing rings instead of a combination of moulded and braided rings. In addition, the direction of rotation was inaccurately marked on the valve – the symbols showed (incorrectly) that the handwheel should be rotated clockwise when both opening and shutting the valve. Moreover, the correct direction of rotation was the opposite of normal practice. About a month before the incident in question, the valve was closed instead of being opened. In that connection, both valve and gearbox were subject to excessive torque. This probably caused the valve stem to get bent.

Figure 1 Damaged stuffing box rings. The first and last of these should actually have been braided, like those shown on the right.

3. Leak in the stuffing box
- the graphite rings were partially washed out of the stuffing box
 - gas and oil against the stuffing box with a pressure of 310 barg

- braiding graphite packing rings were not inserted at top and bottom of the stuffing box
 - updated requirements from 2013 specified that a mix of braided and moulded packing rings should be inserted. This was not done.

- create common guidelines on how the equaliser system is to be operated
- Replace stuffing boxes which only contain moulded rings (applies to valves which experience high pressure and are often operated, such as manual valves against the equaliser and gas injection manifold)
