### Incident description: oil leak 2015

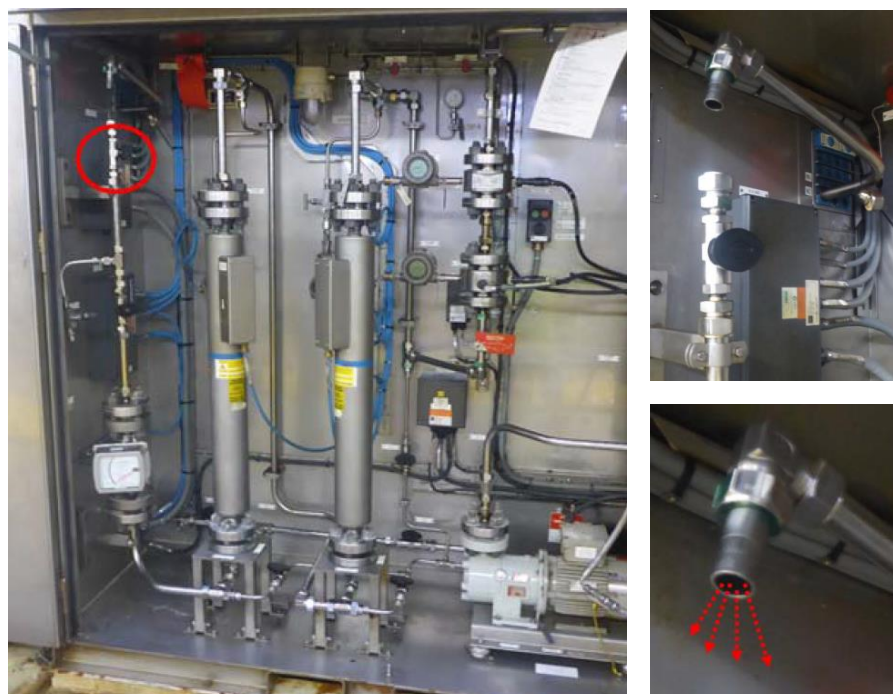
The latter tried to tighten the fittings, and the 25mm tubing came loose. Unstabilised oil at 55 barg and 53°C flowed out and hit the operator's hard hat. A total of 538kg was spilt, comprising 91kg of gas and 447kg of oil. Gas flashing off formed a flammable gas cloud. The initial discharge rate was 6.9kg/s. No oil was registered on the sea, and it was probably all collected in the closed drain system.

**Figure: The red circle shows the site of diffuse leakage from the fittings on the analysis cabinet's final outlet valve. The 25mm tubing came loose when the operator tried to tighten the fittings. Oil and gas flowed out.**

The work was carried out without a WP. Work was done on a connection outside the closed pipe segment.

- Inadequate preparations before repair work. Lack of an isolation plan and marking.
- Lack of confirmatory communication between the operator performing the work and the person in charge of the area led to differing perceptions of what had been isolated and blown down.
- Insufficient attention paid – the safety talk was carried out the day before. Experience from previous jobs in the cabinet was not adequately reviewed.
- Work outside the content of the WP.

- Better quality of conversations in the field between people doing work and the person in charge of the area. Training on safety talks, with attention concentrated on the risk posed by altered assumptions.
- Greater management control over compliance with requirements for WPs.
- Review processes for work on systems which are normally pressurised, with particular attention paid to responsibilities and roles in connection with shutdown.
- Introduce an isolation plan and marking as standard practice for this type of job.
- When work is being done on a pressurised system, the technician responsible for the area must show the work team where the barriers are located. Those doing the work must confirm their understanding of this by showing where the barriers are located.
