Incident description: gas leak 2015

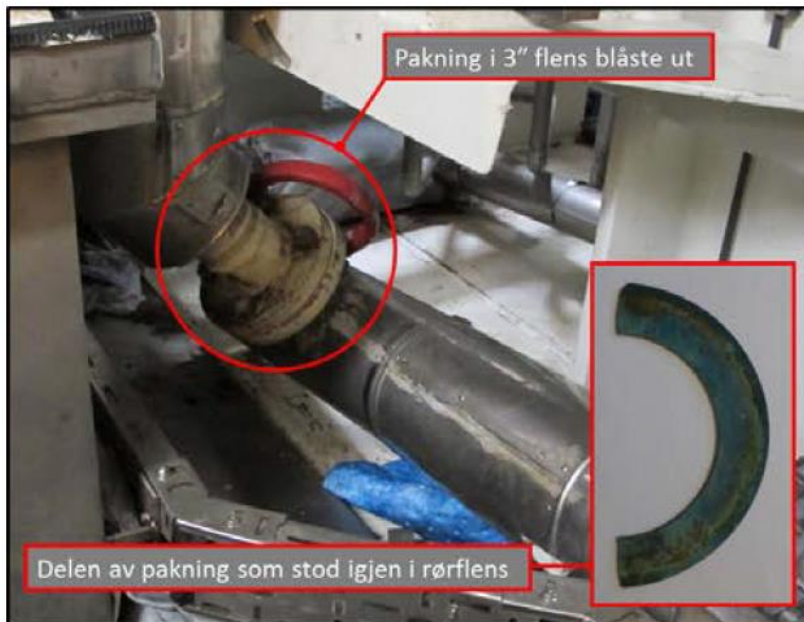
Figure: Red ring indicates where the gasket in the three-inch flange blew out.

A gasket in a three-inch flange downstream from the primary gaskets on the second-stage reinjection compressor failed as a result of overpressure.

- The flare valve intended to prevent overpressure in the pipe segment, and normally locked in the open position, was closed because of troubleshooting.
- The decision to close the flare valve was not in accordance with the relevant work process, and compensatory measures were not implemented.
- A number of procedures relating to work permits and securing valves were not complied with.
- No routine for handover/change of jobs within the same shift.
- Change in pipe specification (spec break) was not entered on the P&ID for the second-stage reinjection compressor. Operator knowledge of the actual spec break was limited ahead of the incident.
- Level of activity on the platform was high because of activities ahead of the maintenance shutdown as well as ongoing operational disruptions. This created conditions where personnel felt they were under pressure of time.

- Kick-off and time-out meetings must be used to secure the barrier status with regard to unforeseen circumstances related to troubleshooting and maintenance.

- Review the safety strategy on the basis of the incident. Assess whether further measures are required.
- Assess whether solutions which involve securing valve positions included in safety barriers should be addressed in standardisation work.

- Introduce handover procedures for transfer of safety-critical information between work teams on the same shift. The dashboard showing safety-critical equipment which has been disabled should be updated continuously and a shift log should be kept.

- The P&ID for the compressor package should be reviewed and updated to accord with governing documentation.
- Pursue experience transfer with the supplier of compressor packages/project contractor (where the reasons why the spec break was not entered in the P&ID are clarified and where the requirements in governing documentation for marking spec breaks in the P&ID are emphasised).
