Incident description: gas leak 2015

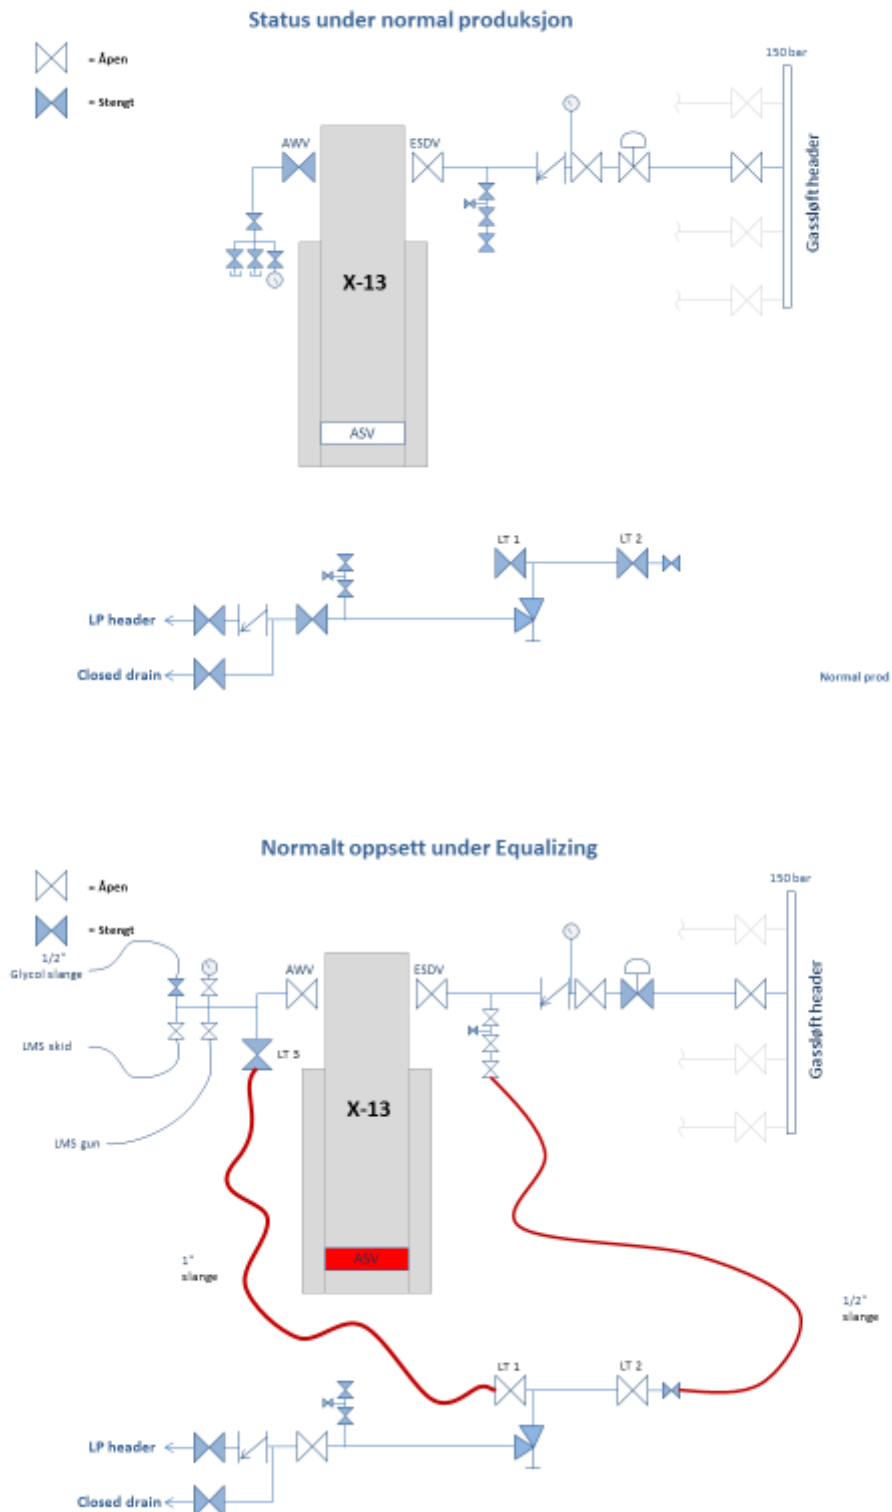
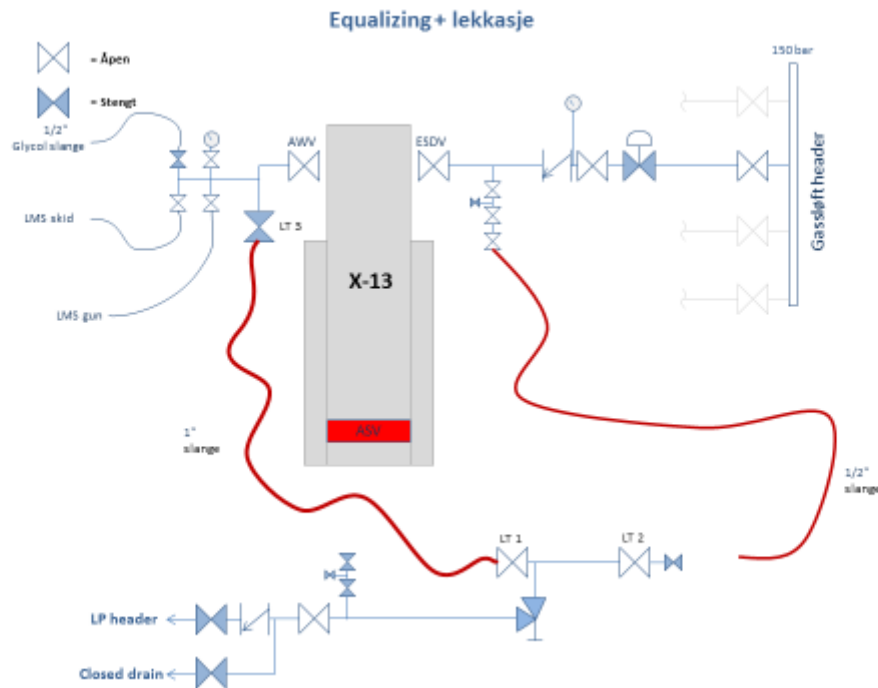
Gas escaped to the well area through the half-inch hose. The automatic shutdown and deluge initiation system was activated. The quantity of gas was minimised through automatic shutdown, and further reduced by closing the flow control valve. Since this valve was designed to reopen, some more gas was released before it was permanently closed.

A total of just under 40kg of gas was released, with a maximum rate of 0.11kg/s. No ignition or personal injuries occurred. The process technician scheduled to carry out the test was not in the immediate vicinity of the hose and was not directly exposed to the incident.

The half-inch hose used for bleed-off was incorrectly connected.

- Procedures and work descriptions failed adequately to cover all critical elements in the job.
- Preparatory activities were not all covered in the isolation plan.
- The hose was unnecessarily subject to gas under pressure.
- Inadequate verification before the system was pressurised.

- Revise test procedures to ensure that the bleed-off segment is isolated.
- Ensure that all exposed parts of the plant are adequately covered by leak testing.
- Strengthen the use of management verification.
- Limit or avoid exposure of hoses to pressure when they are not part of the test.

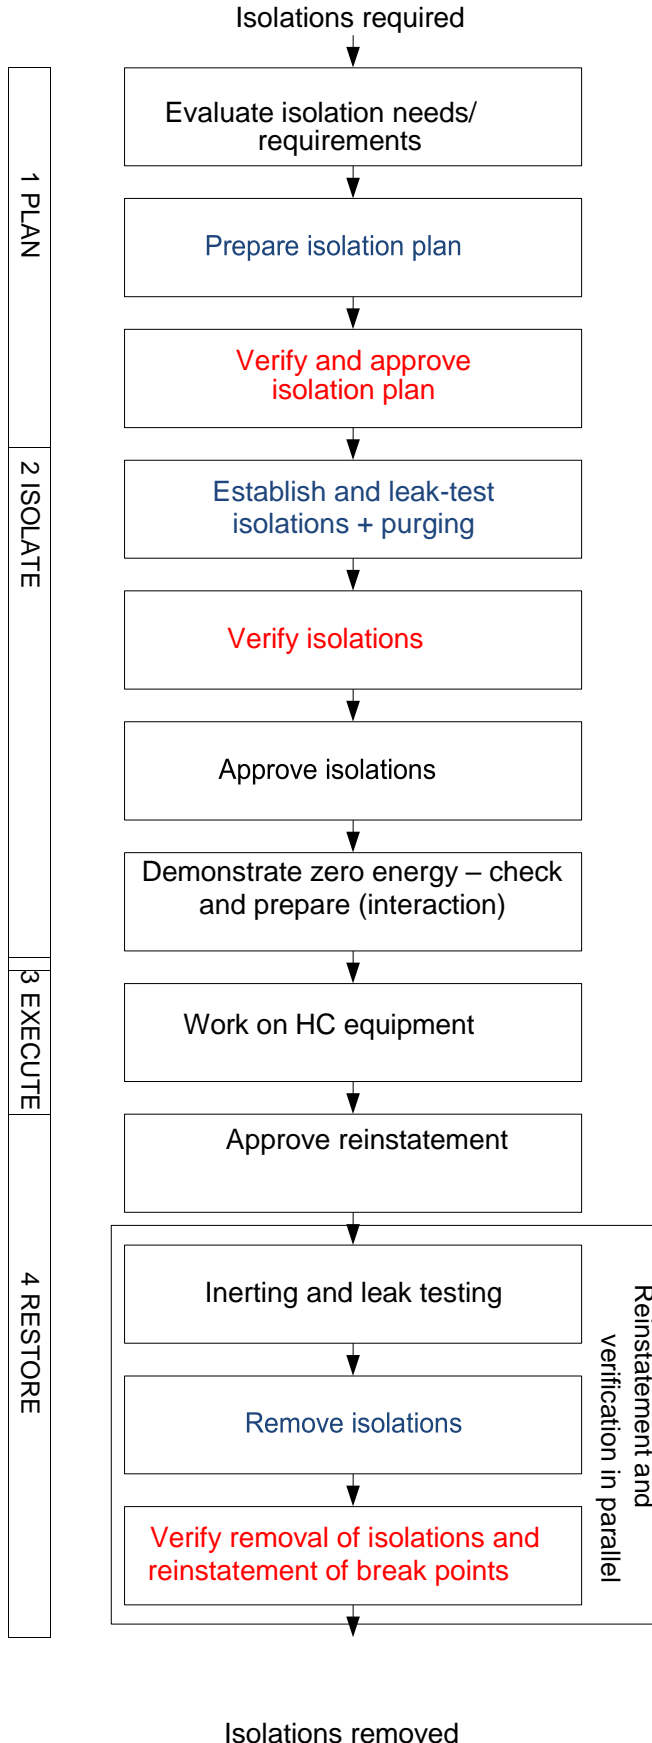
Status for stages in best practice document

- 1 Carried out, with approved non-conformity from isolation requirements.
- 2 Carried out, general isolation plan for all wells. Lacked details for leak testing and reinstatement.
- 2 Carried out, general isolation plan for all wells. Lacked details for leak testing and reinstatement.
- 1 Carried out as planned.
- 1 Carried out.
- 3 Not carried out, no requirement for approval before reinstating break points.
- 1 Carried out.
- 1 Carried out.
- 3 Not carried out, no requirement for approval before reinstatement.
- 2 No overview of valve status when leak-testing, not described in isolation plan or purging with air before testing.
- 2 Forgot to close bleed-off to a safe area.
- 3 Not carried out.

Gas leak when repressurising annulus – 0.11kg/s, eight minutes.
