Incident description: gas leak 2015

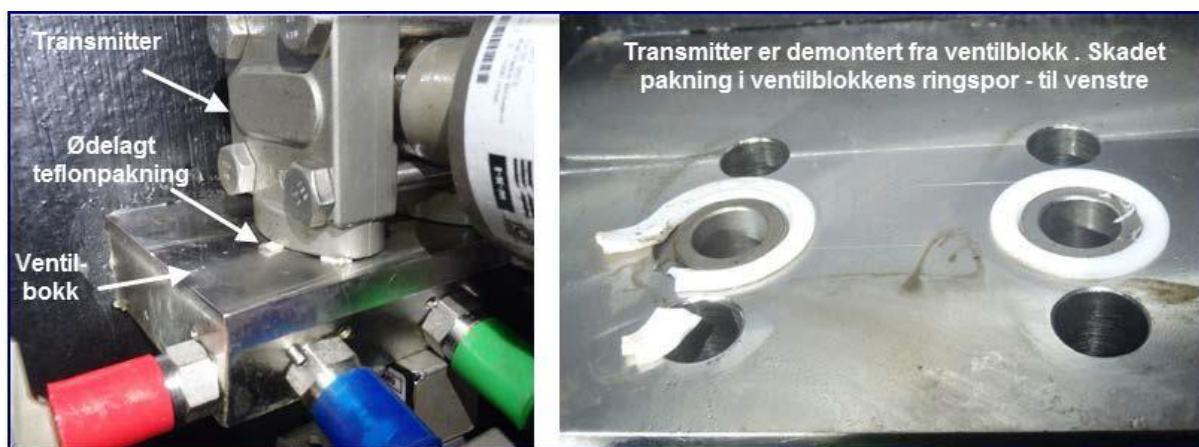
Figure: Destroyed teflon gasket between transmitter and valve block.

The investigation showed that the gasket failed because bolts between transmitter and block lost their pretensioning as a result of creep in the teflon gasket. Given the shape of the gasket, this creep probably reflects faulty tightening when installing the instrument on the valve block.

- The teflon gasket between transmitter and valve block failed.

- Bolts between transmitter and block lost their pretensioning because of creep (cold flow) in the teflon gasket.
- Wrong torque used when tightening bolts between transmitter and valve block.

- A risk exists that teflon gaskets will creep over time – this can give rise to leaks. On that basis, it is therefore recommended that an assessment be made of whether IEC 61508 should be implemented by the companies. The importance of using torque wrenches when tightening bolts must also be highlighted on a general basis.
- Include the user manual with specific torque in the management system and make this known to everyone on board.
- The calibration contractor should mark calibrated instruments with a reminder to use a torque wrench when the instrument is returned.
- Training in tightening methods and bolt tightening could help to boost risk understanding. Requirements for relevant training on tightening methods, bolt tightening and the use of torque wrenches should be established for automation technicians, with verification of the level of competence attained.

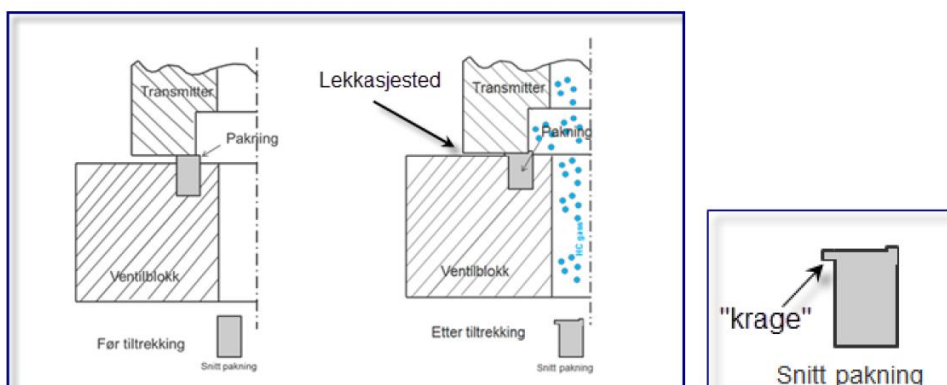
Figure: Tightening method

- The description of the tightening method was imprecise – no torque was specified in the user manual.
- No expertise requirements were specified in the management system related to bolt tightening and gaskets when replacing the relevant transmitter.
