Incident description: gas leak 2015

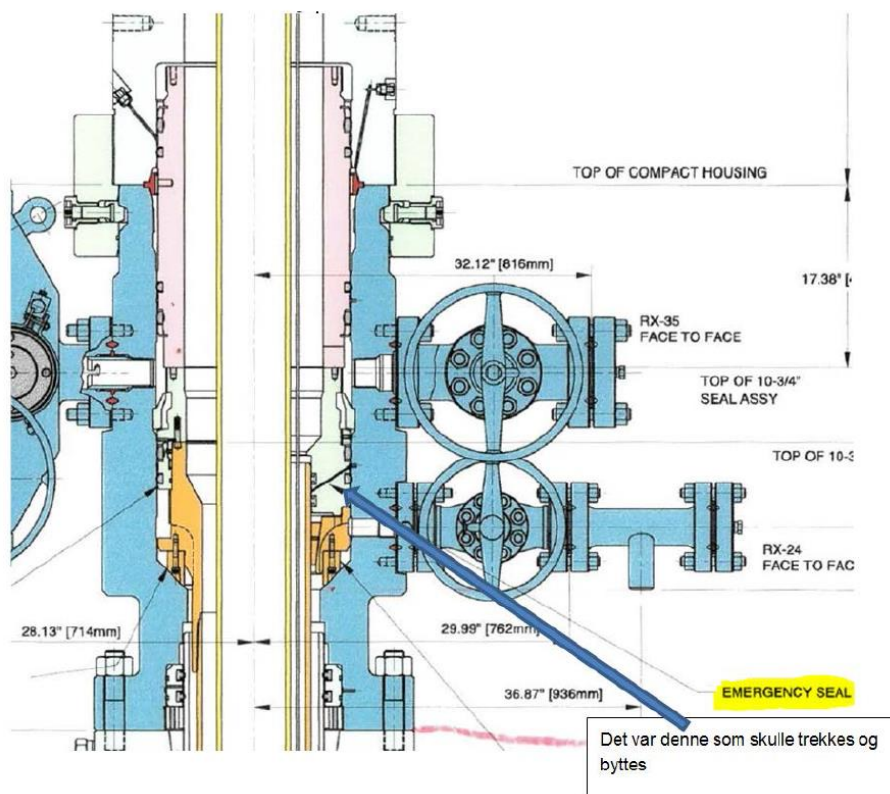
Figure 1 Seal assembly to be pulled and replaced.

According to the operational procedure, pressure in annulus B must be monitored and annulus A closed when pulling the seal. Depressurisation of the B annulus had not been verified when the seal assembly was pulled. Gas at low pressure was released and leaked through the two-inch valve on annulus A and up the riser to the drill floor. This triggered gas detection on the wellhead deck and in the drilling module, with consequent shutdown of the platform.

- The seal assembly was pulled without checking that annulus B was gas-free/depressurised or blown down between the barriers in annulus B.

- The well was categorised as green, which means in barrier terms that no ruptures or leaks are present in the well barriers. Little attention was paid to possibility of gas pressure between the primary and secondary barriers in annulus B.
- Handover documentation did not include remarks concerning the history of pressure build-up in the annulus.
- The scale on the pressure manometer was inappropriate for reading off low pressures.
- Imprecise operational procedures and documentation.
- Mismatch between procedures from operations and the supplier.
- Inadequate compliance with procedures.
- Inadequate planning and control.
- Inadequate pre-job conversation, inadequate communication during execution. Gas under the seal assembly was identified as a possible risk in the operational procedure, but not taken sufficiently into account when carrying out the work.

- Replace the manometer to secure a more appropriate scale for reading off low pressures.
- Improve pre-job conversations, including a review of identified risks.
- Ensure procedures are mutually consistent between the supplier and operations.
- Improve the quality of the operational procedure. Ensure that it clearly specifies what is to be done and in what sequence.
- Strengthen the attention paid by management in order to ensure risk understanding and compliance with procedures.
- When working on barrier elements, depressurisation of the system must always be verified immediately before starting work even when the pressure has been bled off on an earlier occasion – during handover of the well from another department, for example.
