Incident description

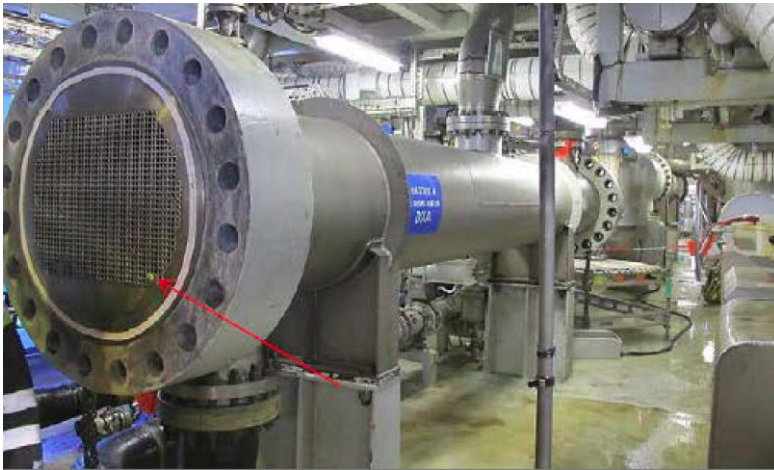
Hydrocarbon gas was detected on the main deck. A loose gas tube inside a shell and tube heat exchanger had rubbed against adjacent tubes until its wall thickness had become so thin that it began to leak. This leak developed into a ductile final fracture which opened the tube to a 131mm flange.

Figure 1: Gas cooler. The leaking tube is identified with an arrow.

- The gas tube in the heat exchanger had rubbed against adjacent tubes until its wall thickness had become so thin that the tube began to leak and subsequently fractured.
- The aspirator system with detection functioned poorly and gave a low alarm (clogged by moisture and salts in the conductor).
- The gas detector was circumvented (disconnected) and failed to activate ESD.
- The rupture disc did not burst.

- Weakened integrity of the heat exchanger owing to rubbing between baffle plate and gas tube.
- The heat exchanger could have been exposed to seawater rates above its design level over a long period since start-up.

- Flow-induced vibration (high seawater rate through the heat exchanger).
- Unfortunate optimisation of the gas train at maximum gas export.
- Method selected for repair had caused damage to the heat exchanger

- A suitable method must be developed for repairing titanium tubes in heat exchangers.
- The design of aspiration and detection of HC gas in the seawater system must be improved.
- HC gas must be prevented from passing via vent lines to the bypass line.
- A good overview of safety systems which have been rendered non-functional must be ensured.

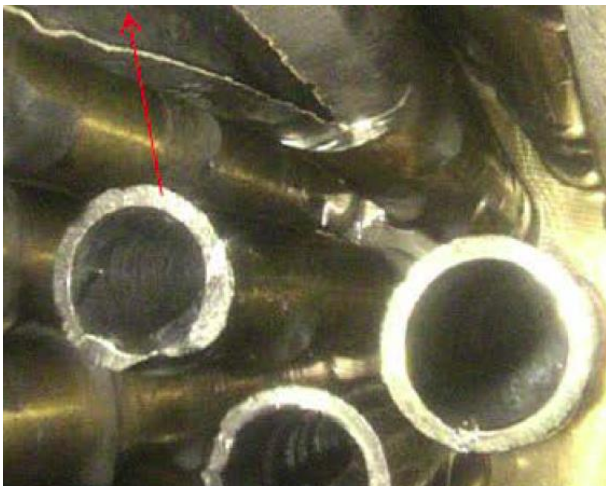
Figure 2: Video inspection after the incident. The leak site is marked with an arrow. Seen towards the cylinder plate.
