### Incident description: Gas leak 2016

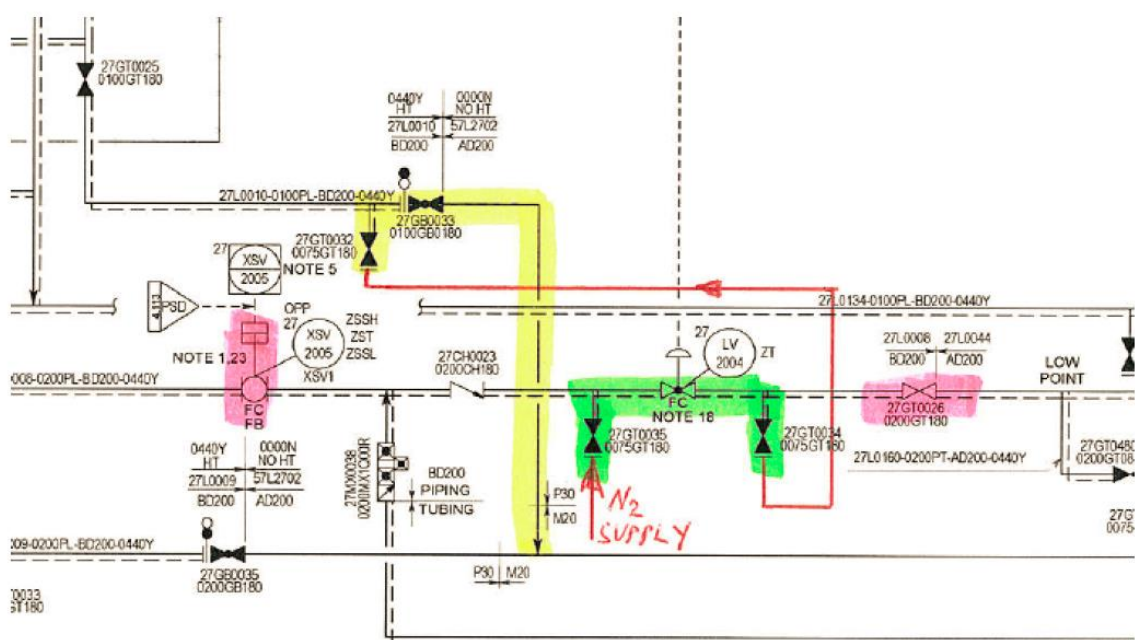
The leak came from a level control valve (LV) where the cage was taken out for cleaning. This valve controls the liquid out of the 1st stage suction scrubber on a high pressure compressor. The upstream process shutdown valve (XSV) was being used as a barrier against the pressure from the scrubber. However, the air supply to the actuator on the XSV was not blocked. With the air supply not being de-energized, the valve acted on signals from SAS/CCR. The XSV was programmed to open at 50% level in the scrubber, resulting in a gas/condensate/water leak from the level control valve.

When the XSV opened, process fluids (gas, condensate and water) were released through the top of the LV. The leak was calculated to 330 kg in total with an initial leak rate of 8.7 kg/s. It lasted for 38 seconds.

Figure 1 Reproduction of barriers and drain connection mark-up (The line from the scrubber is the one on the left hand side of the XSV).

- The air supply on the actuator on the XSV was not blocked.

- It is recommended to implement work instructions for typical/routine operations on all systems.
- Revise procedure: need to specify that for valves to be isolated – the actuator supply; hydraulic, pneumatic and electric shall be isolated in order to approve the valve as a barrier.
- Make a list of typical valves how to de-energize and prevent unwanted action.
- It is recommended to do the following immediate implementation of a checklist for hazardous systems based on the figure on the next page.

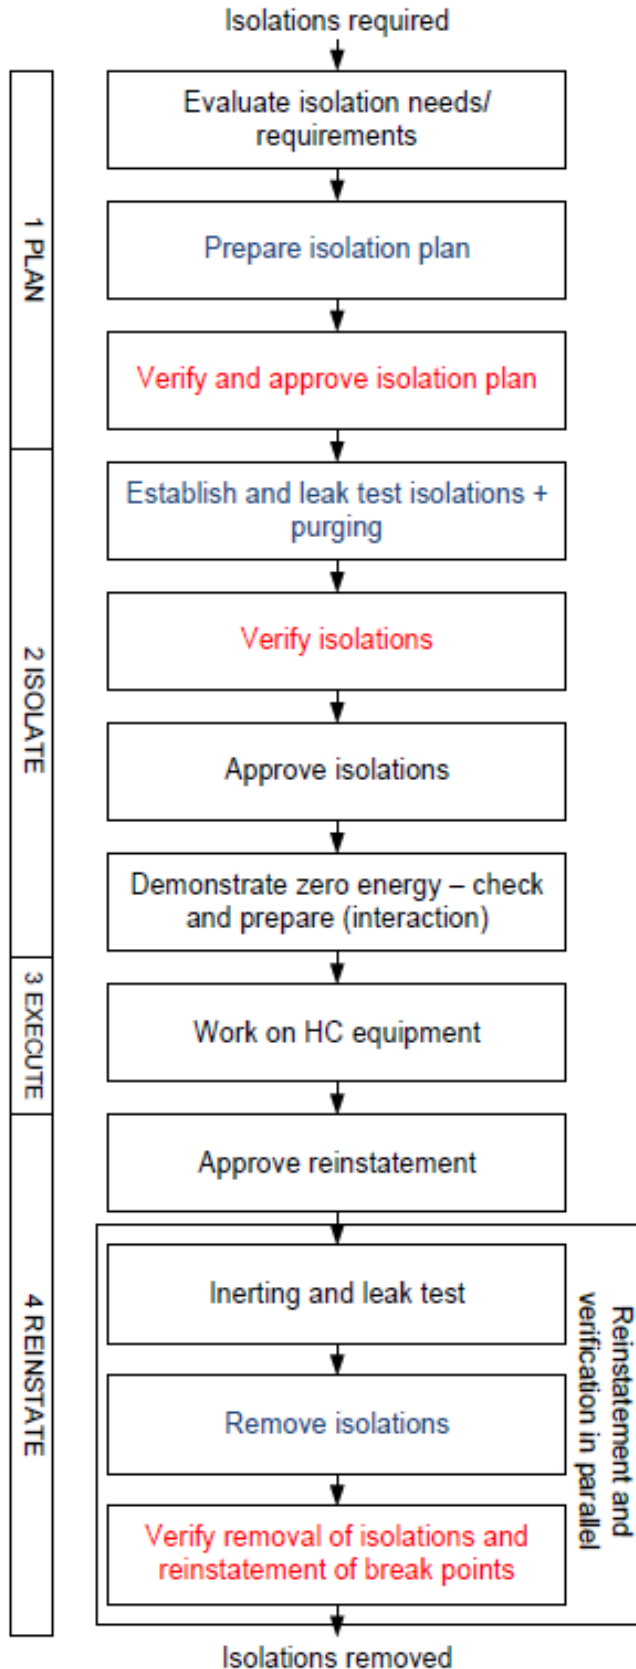
**Status for the steps in best practice document**

2: No job instructions with checklists available or used

3: V&B list was not used (only P&ID markup)

3: Not executed

2 Energy supply to actuator not blocked, uncertain whether leak test was executed, purging was carried out

Hydrocarbon leak 8.7 kg/s, 38 seconds, 330 kg
