Incident description: gas leak 2016

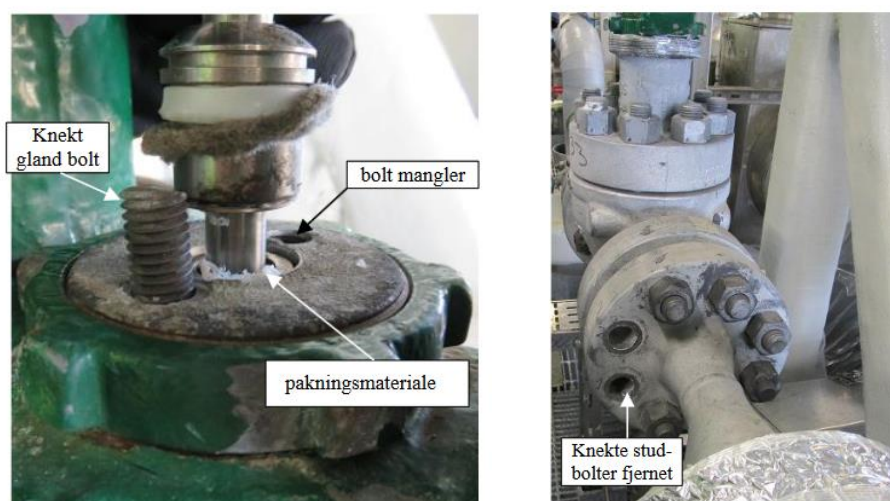
After the incident, the packing box for the anti-surge valve on the injection compressor was found to have failed because both gland bolts had fractured. After isolation, three additional stud bolts in the flange faces between valve and pipe system on the inlet and outlet sides were also found to be fractured. The initial leak rate has subsequently been calculated at 4kg/s, with the total quantity leaked put at 560 kg.

Figure 1 Left: damaged gland bolt on the packing box for the anti-surge valve. Right: outlet flange on the anti-surge valve.

- Failure of the packing box in the anti-surge valve because of fatigue in bolts.

- Acoustically induced high-frequency vibrations.
- Liquid precipitation from the anti-surge valve.
- Faulty design (dimensioning of the anti-surge valve), possibly because of a failure in communication between operator, contractor, compressor supplier and valve supplier.

- Reduce the flow coefficient (C_v) on existing two-inch anti-surge valve.
- Upgrade to three-inch anti-surge valve, but with the original C_v .
- Change operational conditions to avoid liquid precipitation.
- Vibration monitoring which covers the whole operational window.
