Incident description: gas leak 2016

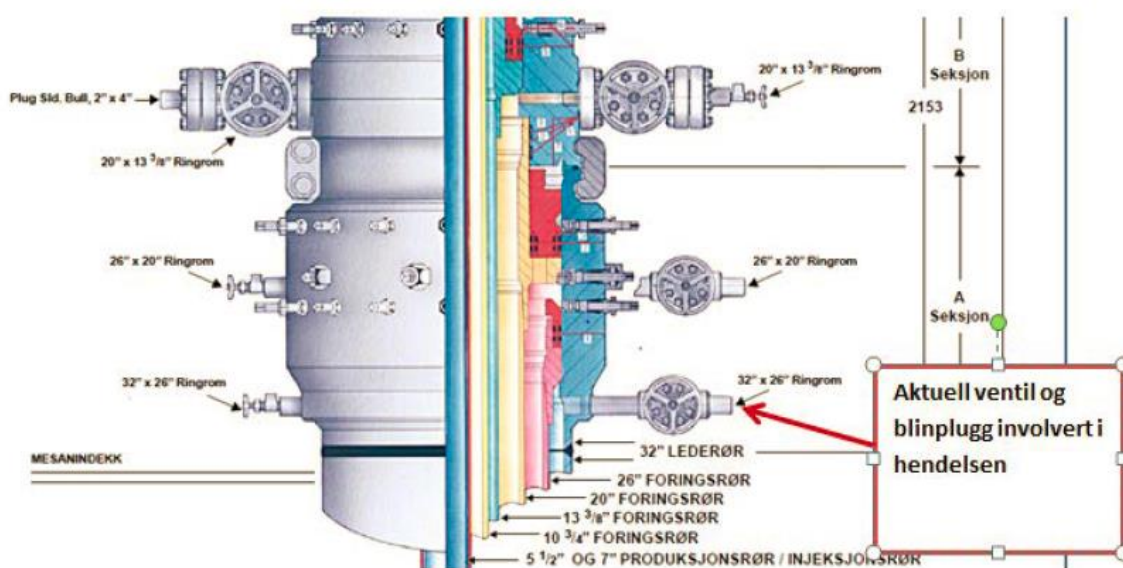
A blind plug was removed during the installation of wireless pressure transmitters for annulus monitoring, which led to a leak. The annulus valve upstream from the blind plug was in the open position when the plug was removed (see illustration). This valve should have been closed. It was re-labelled as closed, but this proved to be incorrect. Hydrocarbon gas was present in the annulus. This is not normal, and was not known to those doing the work. The incident led to a hydrocarbon leak of 1.9kg/s for 20 seconds, with a total gas volume of about 3.87kg.

An isolation plan had been prepared and verified. However, the verification had failed to pick up that the annulus valve lacked an isolation plan. The person in charge of the area established the isolation single-handedly, without verification by a third party. This person was not present when the blind plug was removed.

- A blind plug was removed on a pressurised system.

- The annulus valve was in the fully open position.
- The annulus contained hydrocarbon gas, probably as a result of seepage from the formation.
- The annulus valve was not tested and depressurised downstream from the valve before the blind plug was removed.

- Prepare a local job description to ensure uniform understanding of its content, how pressure in the annulus is bled down and how barriers are tested and secured in accordance with the requirements.
- Improve communication on personnel changes in offshore projects so that decisions taken on land which could be negative for the level of activity expected of offshore personnel are picked up by the offshore management.
- Changes related to the level of activity in projects and a high level of parallel activities in the same area must be covered by the operation plan and picked up in operation meetings.
- Ensure compliance with procedures for approved physical barriers, preparation of the isolation plan and establishing, verifying and approving isolations.
- Change the design – blind plugs without bleed-off provision must be avoided on the wellhead.

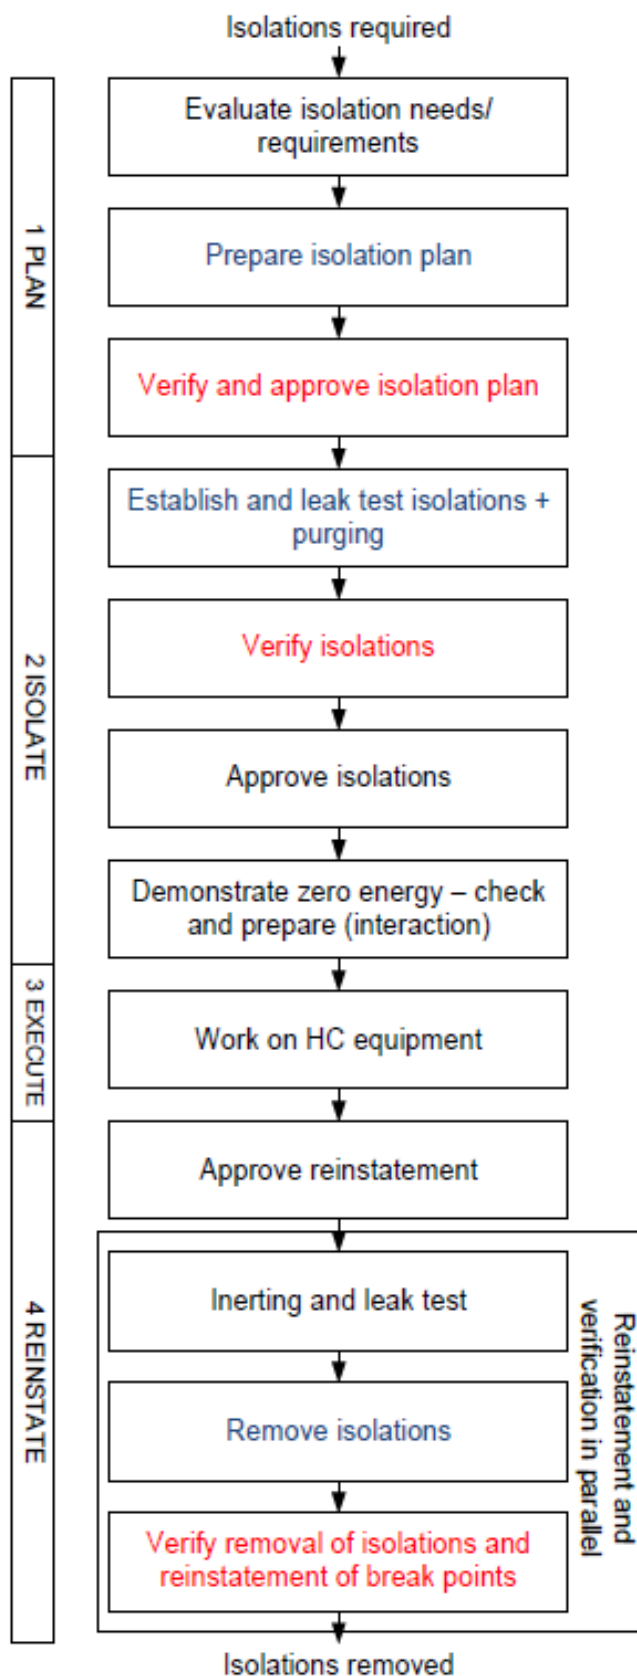
Status for stages in best practice document

Status during the incident:

- 1 Carried out.
 - 2 Carried out, but annulus valve not included in isolation plan.
 - 2 Carried out, but failure to include the annulus valve in the isolation plan not noticed.
 - 3 Annulus valve not tested or depressurised downstream from the valve before removing the blind plug.
 - 3 Not carried out.
 - Not known whether carried out.
 - 3 Not carried out. HC system split without the person in charge of the area being present.
- ☁ Gas leak 1.9kg/s. 3.87kg.
