Incident description: gas leak 2016

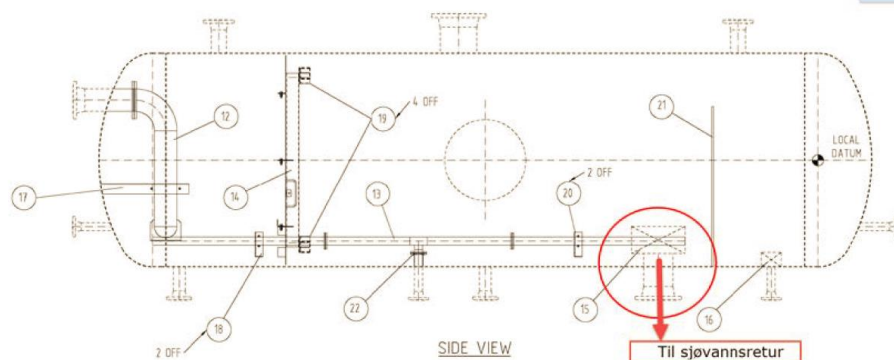
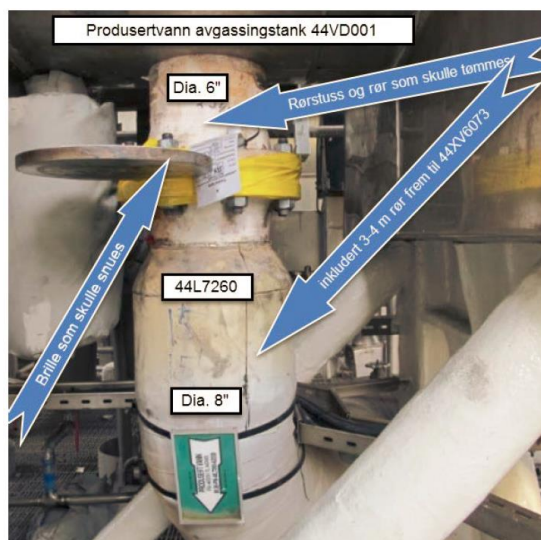
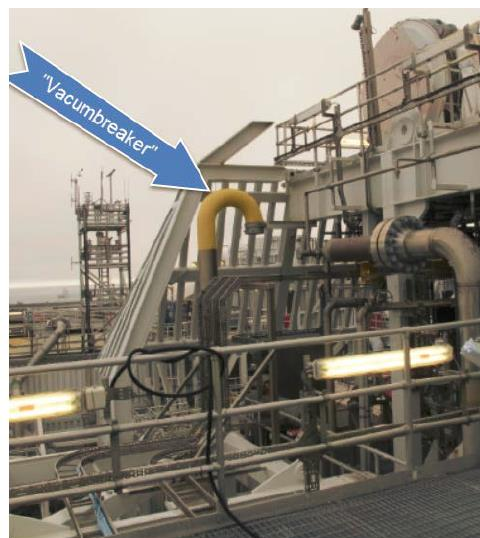
In connection with preparing for a maintenance shutdown, a number of tanks and separators were to be drained for entry and inspection. These included a degassing tank for produced water. A general plan based on gas blowby was drawn up for fluid drainage and readying. This involves using process gas to blow fluid out of a tank, either to the next tank or to a closed drain. The degassing tank for produced water was the last tank in this process, and the bulk of the fluid had already drained to the closed drain pursuant to the drainage plan. This plan called for the degassing tank to be drained to a closed drain in the same way as the preceding tanks. When the area technician reached the site, however, a short length of pipe was discovered which had to be drained in order to open a spectacle blind. An opportunity was available for draining the relevant segment to a closed drain, but this had not been included in the drainage plan prepared in advance. As a result, the blind had not been turned to the open position ahead of the drainage routine. The minimum required to turn the blind on the seawater return line was to drain the pipe spool between blind and tank, including three-four metres of piping. This had not been noticed in the planning.

On the basis of the above, it was decided that the simplest approach would be to use an alternative procedure – draining the connector via the seawater return line rather than the closed drain. The central control room (CCR) was instructed by walkie-talkie to open two valves in order to drain the remaining produced water to the seawater return line with the aid of gas from the process plant. The area technician positioned himself by the valve to listen for gas blowby. This is a method used with all separators and tanks in order to ensure that fluid has been fully drained. However, the difference in this case was that the outlet went directly to the seawater return line rather than the closed drain. The CCR increased the pressure in the tank to about two bar, and then opened the control valve by roughly 40 per cent. The CCR technician observed almost immediately that the pressure fell and understood the pipe spool was empty of fluid. He then shut the valve at once. However, the valve took a long time to close, so that gas continued to flow to the seawater return line for about 40 seconds after the closure signal had been given. This resulted in the seawater return line containing so much gas that an overpressure developed and the gas was blown out through the vacuum breaker. This line normally contains large fluid flows/underpressure, but two of the three seawater pumps had been stopped because of the shutdown preparations. This meant that underpressure in the line was lower than in normal operation.

The initial leak rate is put at 0.5kg/s. The leak lasted for two minutes and totalled 60kg.

- The control valve stayed open for too long in relation to the fluid level and pressure in the tank.

- Insufficient ongoing risk assessment in relation to changes in the general procedure.
- Inadequate communication between personnel doing the work.
- No detailed procedure for the drainage job.
- Insufficient risk assessment in relation to draining the pipe spool to the seawater return line.
- Drainage of the pipe spool to the seawater return line was not in the detailed planning.
- Inadequate experience transfer/updating of governing documentation.

- Gas blowby is not an appropriate method for draining liquid to the seawater return line.
- Assess the location of the vacuum breaker, since HC gas can escape from it in certain conditions.
- Ensure experience transfer to other units.
