## 2017- J: Gas leak during valve testing

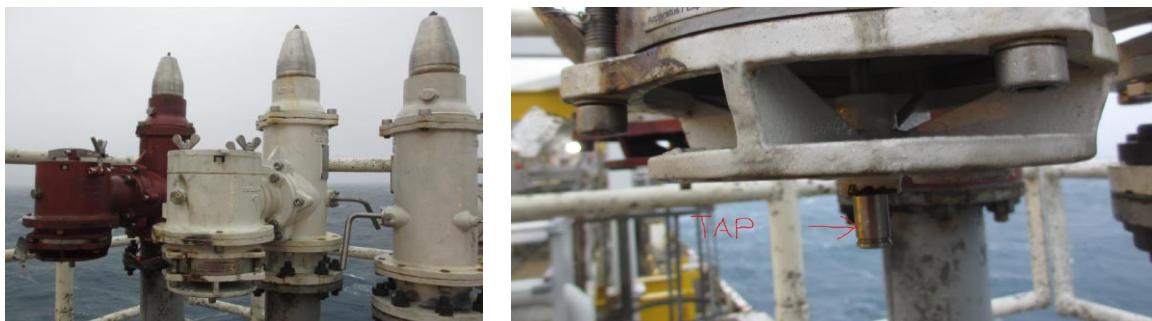
Figure 1 Left side: Pressure/vacuum valves (PVVs). Right side: Tap (full stroke check lift) considered to be modified.

- The vacuum disc inside a pressure/vacuum valve (PVV) got stuck in open position during testing.

- Operational issue probably not identified as a potential problem during design.
- Template for the job safety analysis and testing tools to lift the vacuum disc needs improvement.
- The PVV replacement frequency has decreased from 4 years to 5 years.

- Evaluate to install isolation valves upstream PVVs that can be closed during preventive maintenance.
- Discuss with supplier if the design of the tap (full stroke check lift) can be modified to prevent the tap to be inserted all the way into the valve (easier to pull out if vacuum disc is stuck open).
- Update the template for the job safety analysis to include
  - Stop the ventilation fans to the inert gas generator room during testing.
  - Temporarily restrict nearby area to prevent personnel exposure.
  - Evaluate to block detectors in the immediate area (detectors that deteriorate the integrity of the safety system should not be blocked).
- Evaluate if alternative tools can be used to move the tap on the vacuum disc. For example use some type of screw mechanism (ters) to control the force and movement of the tap.
