Incident description: gas leak 2017

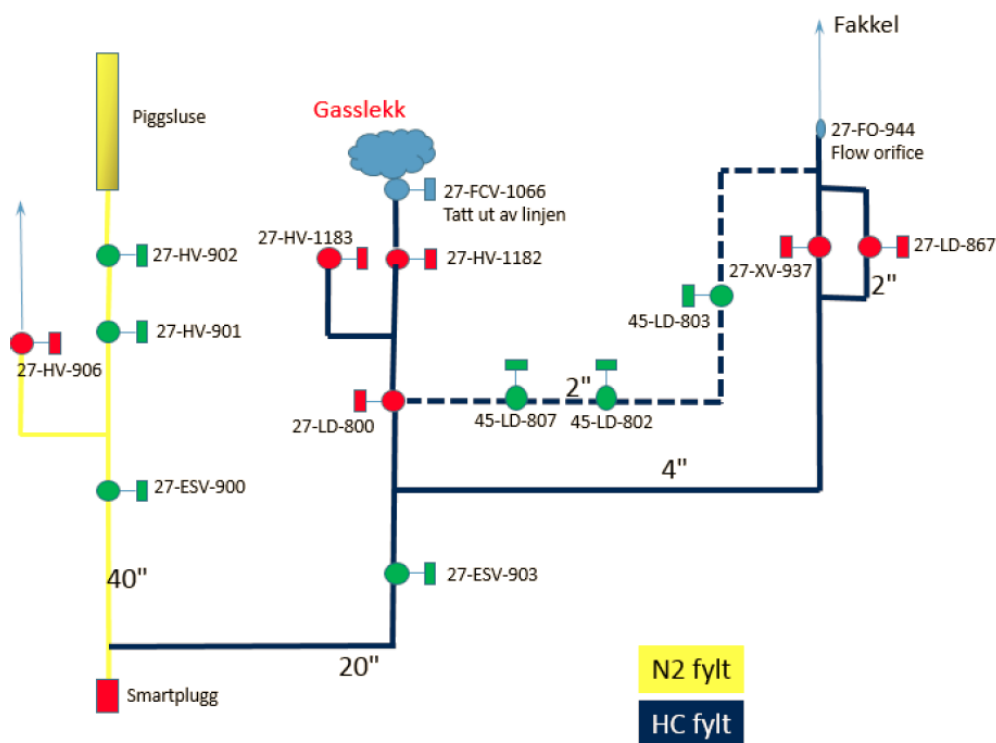
Ventilenes plassering og status forut for hendelsen

In preparation for major maintenance on the platform, the process plant was to be rendered gas-free by implementing an isolation plan. Plans called for an emergency shutdown (ESD) valve to be used as a barrier for the bypass job after a known leak in the valve had been repaired. During planning of the work, another solution was chosen which utilised two isolation plans (valve and blind lists). This would allow part of the work to start earlier than planned. However, the two new lists overlapped because several of the valves in the process area were included in both, but with opposite valve positions. The result was that one of the valves intended to serve as a barrier in the one V&B list was opened when the other list was set. This led to a gas leak in the order of 0.6kg/s, which lasted for 111 seconds to yield a total quantity of 69kg.

- Changes in the order of the jobs were not known to the whole organisation, and obtaining a complete overview was difficult.
- Assumptions in V&B lists were changed by altering bleed from 27-LD-800 to the flare system without adequate risk assessments in relation to other activities.
- Differences in understanding what the function of barrier valve 27-HV-1182 was. Not tested under low pressure.
- Two V&B lists (148833 and 144403) which overlapped but which had valves in opposite positions.

- Unclear to the organisation how far the procedure for smart-plug setting governed the operation. Checklists for the procedure were not signed out.
- Failure to notice that 27-HV-1182 could leak with low or no pressure difference over the valve.

- Inadequate risk assessment/faulty assessment of the hazard potential
 - The changes made to V&B list 148833 meant that three valves had the opposite position to that specified in V&B list 144403.

- Ensure expertise is available on valves, how they work and their functions.
 - Particular focus on valves included in shutdown plans.
 - Precondition for a sealed barrier valve with a given design.

- Ensure that plans are complied with, and take decisions sufficiently early for the organisation to have enough preparation time.
- Ensure good management and documentation of risk assessments in the event of changes.

- Verification of isolation plans.
 - Use of change logs.
- Increase awareness of the need to comply with internal company requirements concerning work permits and safe job analyses.
