Incident description: gas leak 2017

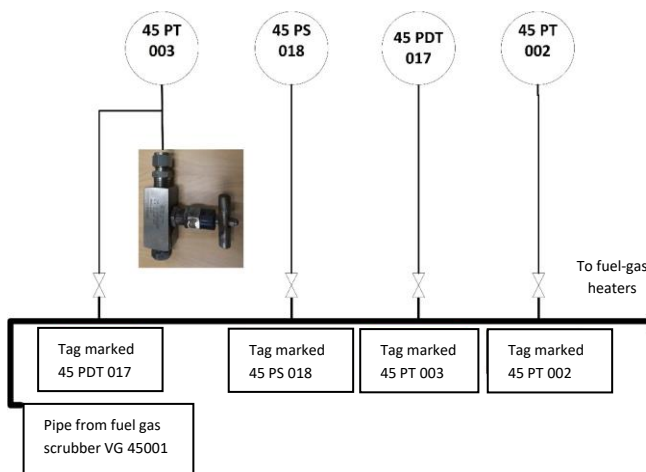
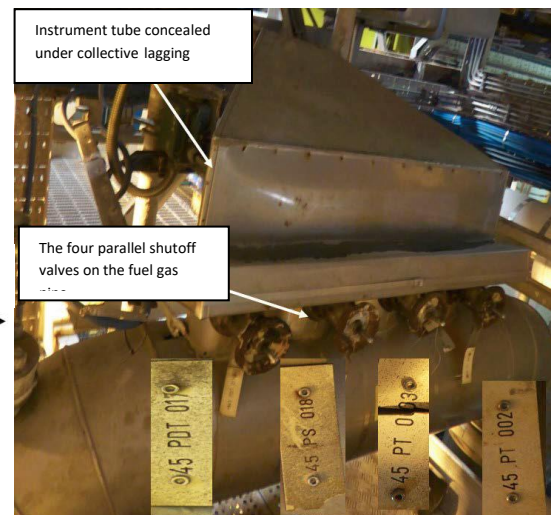
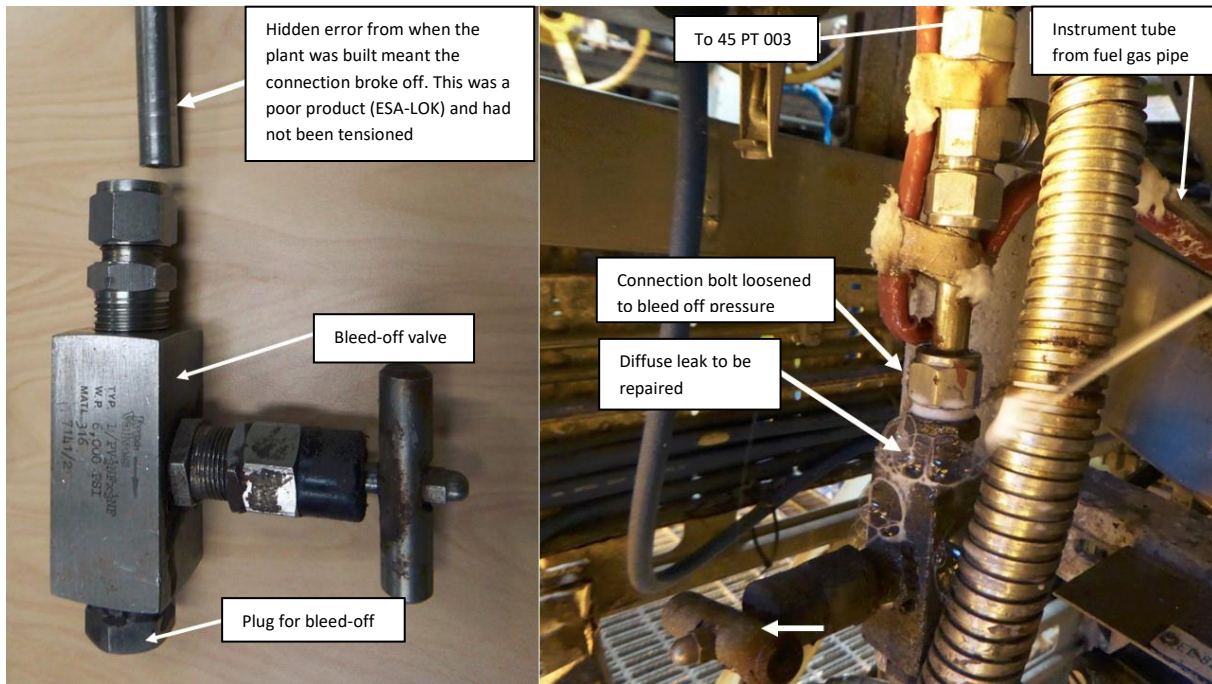
The operator and technician in the field ascended the scaffolding again. The operator began to close two of the valves, while the technician handled the third. Once the valve tagged 45 PDT 017 was closed, the leak stopped and the area operator reported this to the control room. The three gas detectors shortly returned to zero gas detection. The gas leak is calculated at 0.25 kilograms per second (kg/s) for three-four minutes. The flammable gas cloud could have extended over about 30 metres in the local area with flammable gas in the order of 16 cubic metres.

- No closure towards the work site because valves in the plant were incorrectly tagged.
 - Incorrect tagging when the plant was built.
- The instrument connection was of poor quality, insufficiently tensioned and came loose.

- The connection was an ESA-LOK type. A number of problems have been experienced with this product, including leaks, and production has therefore ceased. Had the connection been the right quality and correctly tensioned, it should not have come loose.

- Work was conducted on the instrument connection under pressure.
 - The automation technician opted to bleed off the trapped pressure by unscrewing the nut on the connection even though the management system specifies that no work must be done on pressurised fittings and that the connection nut must never be unscrewed to release or bleed off system pressure. He was aware that this was not good practice nor in line with the training in the mandatory course on instrument connections. Good work practice would have been to screw open the bleed-off plug and bleed off the pressure in a controlled manner with the bleed-off valve. The area technician was also aware that the chosen method was not good practice.

- Develop and implement a course for control-room operators.
- Prohibit work on pressurised fittings – ensure conformity with consistent practice across shifts, as well as precautions where the plant has not been built with bleed-off points and nonconformity is therefore necessary to carry out the work.

- Measures to ensure conformity between the plant as built, drawings and markings in the field.
- Secure an overview of where ESA-LOK fittings could still be found, inform automation and operational personnel about the risk associated with this type of fitting, and replace them during planned interventions.
