2017-E: Leak in pipe nozzle on condensate pump

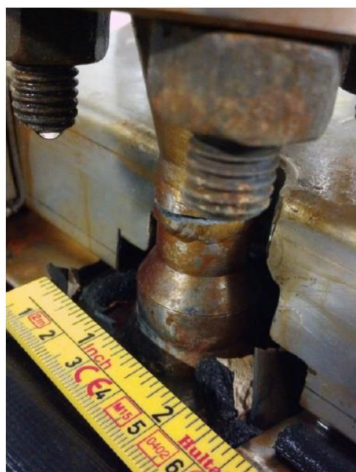
Figure 1 The leak point.

- Fatigue failure in a weld on a half-inch pipe nozzle from the condensate pump as a result of vibration in the pump.

- *Design:* Vibration in the pump caused fatigue stresses in a welded joint because of the 11.5-cm-long pipe nozzle with a 3.6-kg manual valve mounted on top. This created a torque with associated bending stresses.

- *Welding execution:* The weld was made with inadequate joint preparation and lack of penetration as well as some misalignment between the pipes welded together. The welding was done in connection with manufacturing the pump.

- Process safety/operations
 - Evaluate/improve barrier strategy and panel
 - Evaluate support of small-bore tubing
 - Evaluate/improve plans for preventive maintenance of safety-critical equipment
 - Evaluate the spare parts regime for safety-critical equipment
 - Measures to ensure a robust and shared understanding of the testing regime for safety-critical equipment
 - Processes to ensure that management gives attention to work on safety-critical equipment
 - Evaluate/improve nonconformity system

- Evaluate the interface between the engineer with system responsibility, the person responsible for equipment, and the person with offshore system responsibility
- Other platform-specific measures
- Projects
 - Ensure that the welding standards set by equipment suppliers are reviewed, and that welds are subject to quality control
 - Secure valves and other mechanical equipment in line with the operational environment and the operating conditions where the equipment is to be used
 - Ensure that preventive maintenance plans are reviewed and updated before delivery to operations

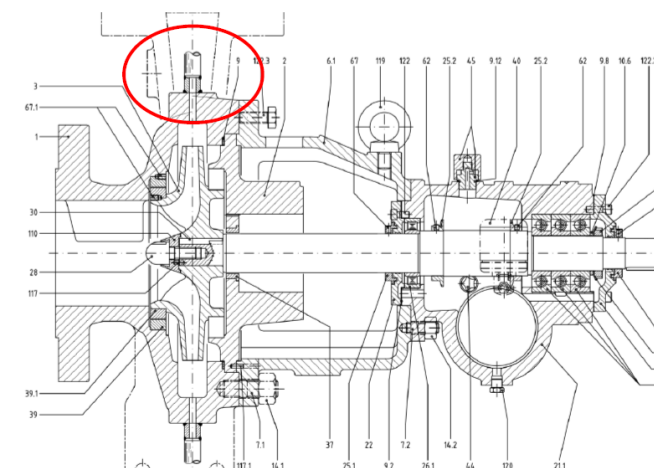
The pressure out of the condensate pump was about 26 bar. When the pump stopped because of the ESD, pressure in the leak was reduced to the static level in the fluid column upstream from the leakage. The leak is calculated at 1.25 m³ of condensate with an initial rate of 1.06 kilograms per second and a duration of about 30 minutes.
