2017-G: Gas leak from bolt tightening with wrong torque

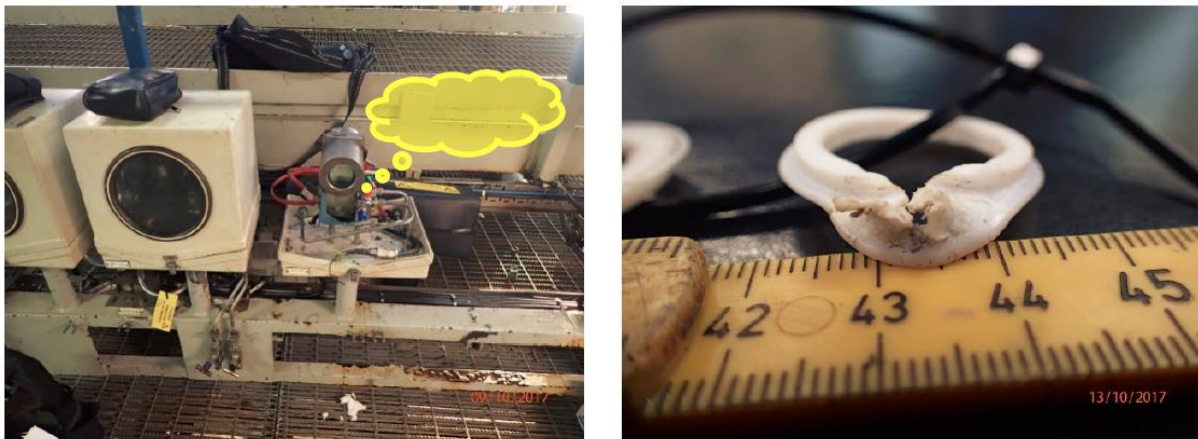
Figure 1 Left: the leak site. Right: deformed gasket.

- The bolts lost pretensioning because of creep (cold flow) in a teflon gasket after the wrong torque had been applied when tightening them.

- Using torque wrenches with this equipment was not normal practice for automation technicians
- The importance of using torque wrenches had not been appreciated by this discipline on board
- A description of the tightening method was difficult to find in the user manual for the instrument (176 pages), and the torque value for the relevant bolts was not mentioned in the quick installation guide
- Taking a course on bolt tightening, gaskets and use of torque wrenches was not established practice for automation technicians
- No expertise requirements for bolt tightening and seals were specified in governing documents
- Follow-up of measures in the wake of similar incidents on other installations in 2014-15 has been inadequate. After a leak in 2015, measures which should have applied to all automation technicians were directed only at a sub-group which works on fiscal metering equipment

- Correct tightening of bolts
 - If bolts are to be tightened on instrument systems, include a qualified mechanic until automation technicians have acquired the correct expertise

- Inform all automation technicians about the need to tighten bolts on valve blocks with the correct torque to ensure that gaskets do not give rise to leaks over time

- Extend automation-technician expertise to include the use of torque wrenches for bolt tightening
 - Expand the content of course curricula to include the importance of the correct tightening torque on gaskets, use of torque tools and additional tightening after a few hours to compensate for cold flow. This expertise requirement should also apply when suppliers carry out work on instruments, both on land and offshore

- Assess review of instruments already installed
 - Each unit should conduct a review of instruments installed in hydrocarbon gas systems with teflon gaskets where it is not possible to confirm that bolts have been tightened using the necessary torque specified in the supplier’s recommendations

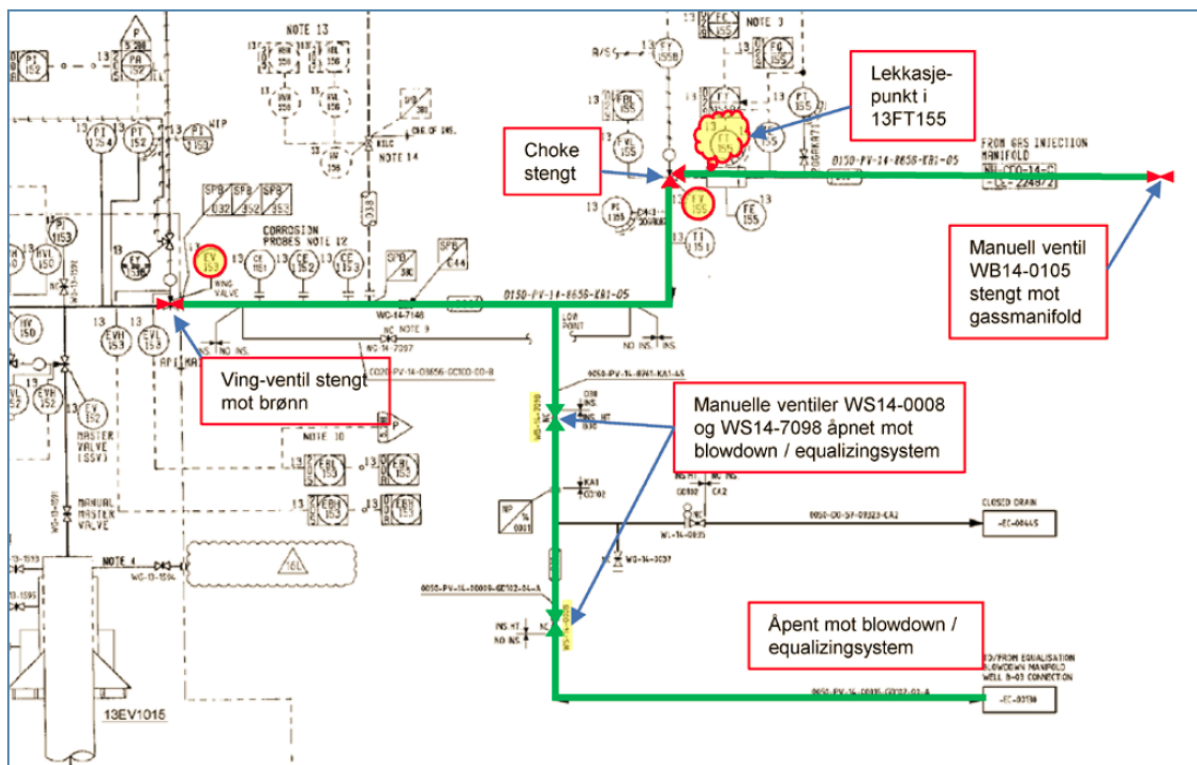
Figure 2 P&ID which shows the leak point and the valves closed (red) and opened (green) to restrict the leak.
