Investigation report

Report	
Report title Investigation report after the fire on Statfjord A of 16 October 2016	Activity number 001037031

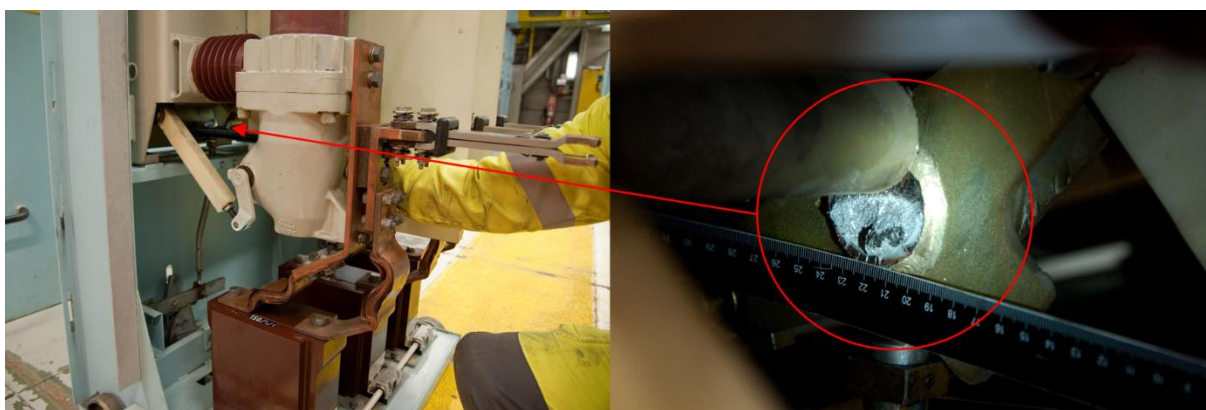
Investigation of the circuit breaker for loading pump D revealed a fracture in the shaft which operates connection/disconnection of the three current phases to the pump. Phase L1 was found to be correctly disconnected, phase L2 was in an intermediate position so that an electric arc occurred in the circuit-breaker cabinet, and phase L3 was still connected.

Photograph 2 - Fractured shaft in the circuit breaker for loading pump D.

The broken shaft in the circuit breaker for loading pump D was sent to Statoil's material technology department at Rotvoll for investigation. This concluded that the fracture was caused by fatigue. See appendix B to the *Materialteknisk undersøkelse av brukket stag fra brytervogn, SFA* report.

The direct cause of the fire was a fatigue fracture of the shaft in the circuit breaker to FP-3001-D (loading pump D). This failure meant that neither the manual stop signal to the pump nor automatic trip functions had any effect.

Following the incident on 16 October 2016, ultrasonic and penetrant inspections have been conducted on shafts for the other circuit breakers in switchboard 1. This identified early crack formation in another three breakers.

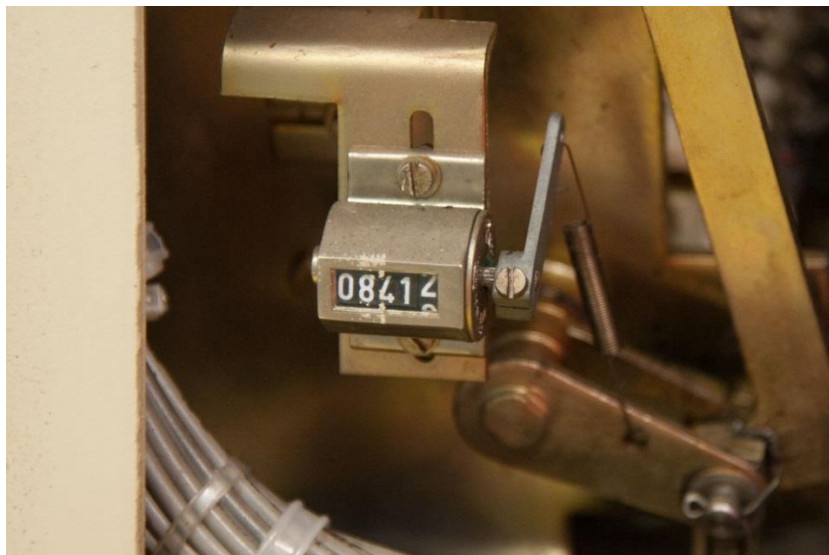
Photograph 3 - Meter showing number of connections/disconnections² for pump D.

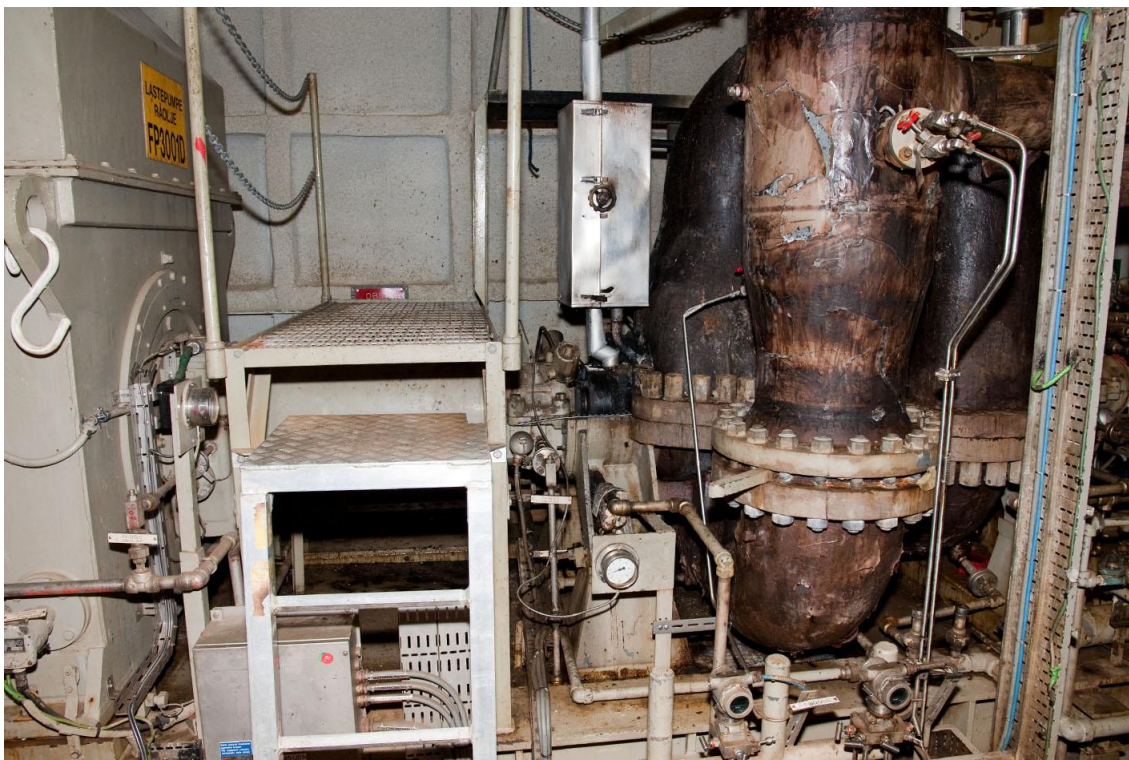
Inspections of the site showed clear signs that the temperature of the crude oil in the pump had been high, and that there had been naked flames at the seals on both sides of the pump as well as inside an insulation box.

Photograph 4 - Fire damage at the drive end of loading pump D.

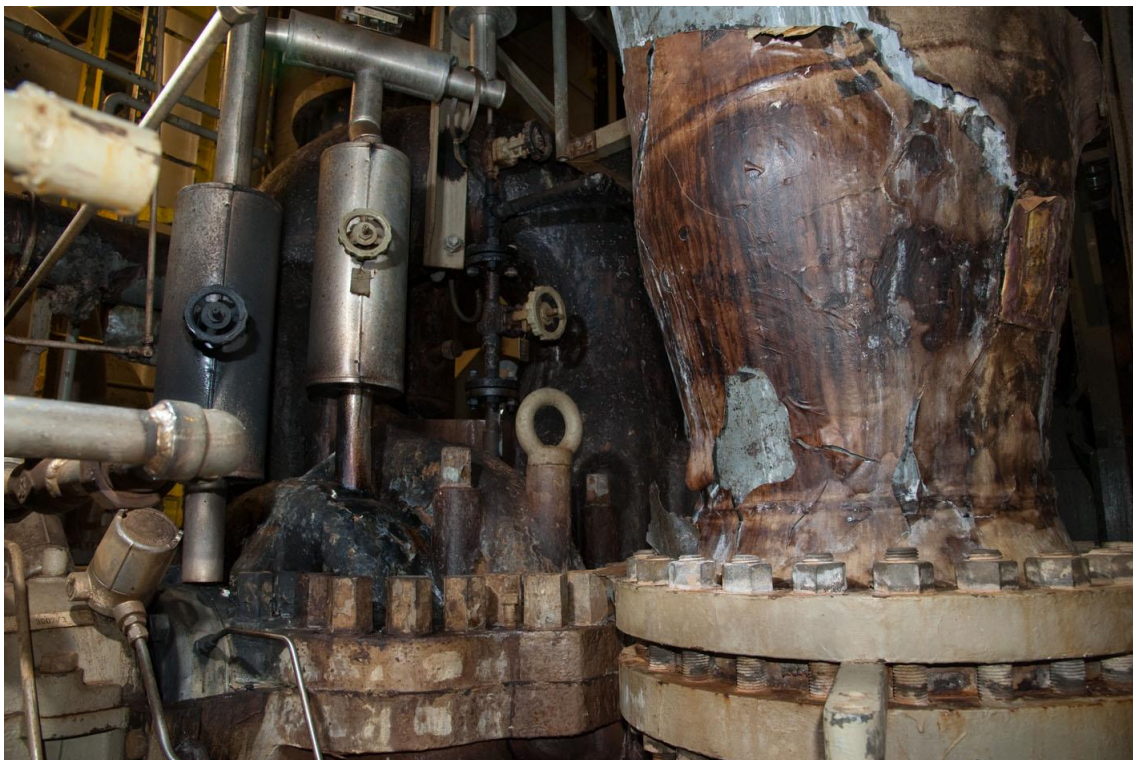
Photograph 5 - Fire damage at the free end of loading pump D.

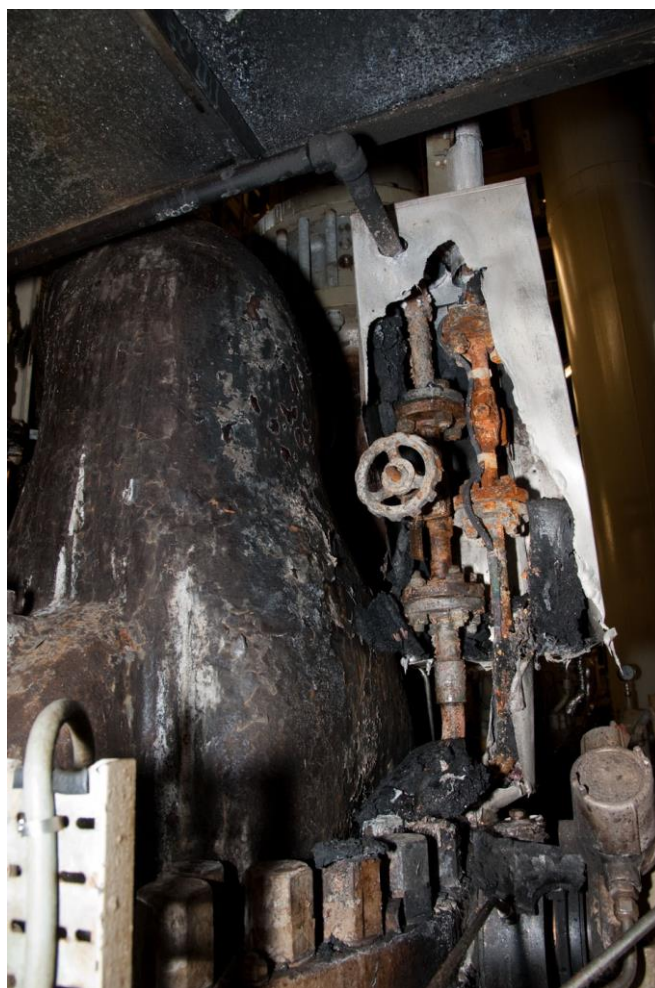
Photograph 6 - Melted insulation box at the drive end of pump D.
