Investigation report

Report	
Report title Investigation of hydrocarbon leak on Gudrun of 18 February 2015	Activity number 001025017

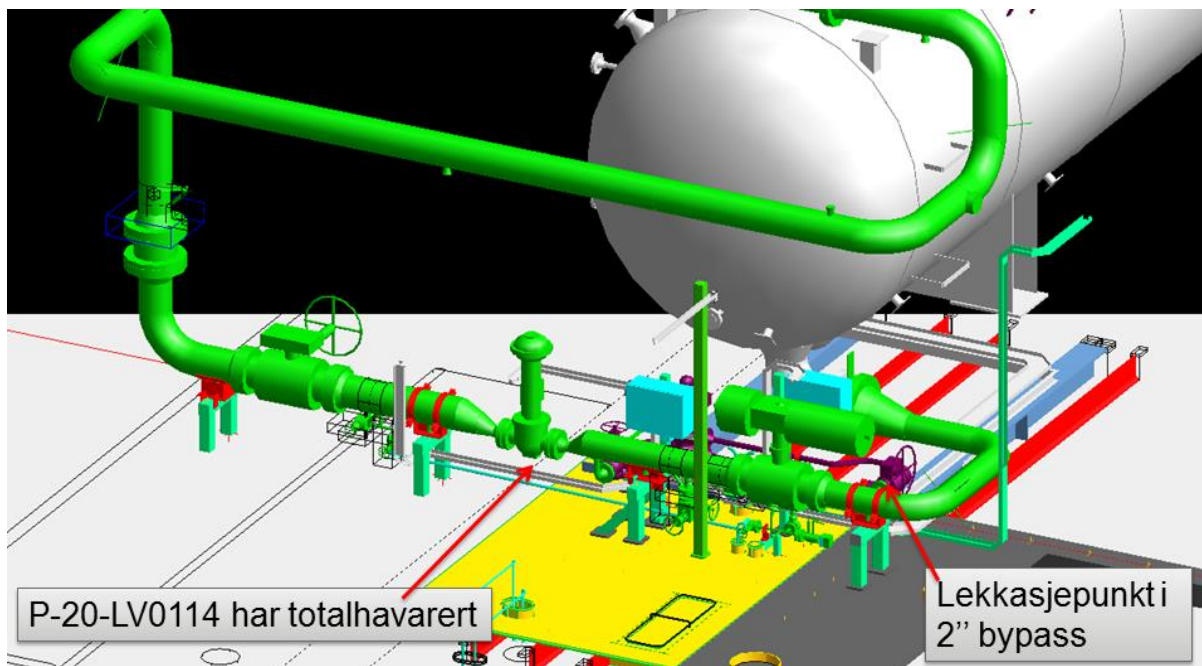
Figure 6: Piping downstream of first-stage separator. (Illustration: Aibel 3D-model)

Key: P-20-LV0114 totally destroyed Leak site in two-inch bypass

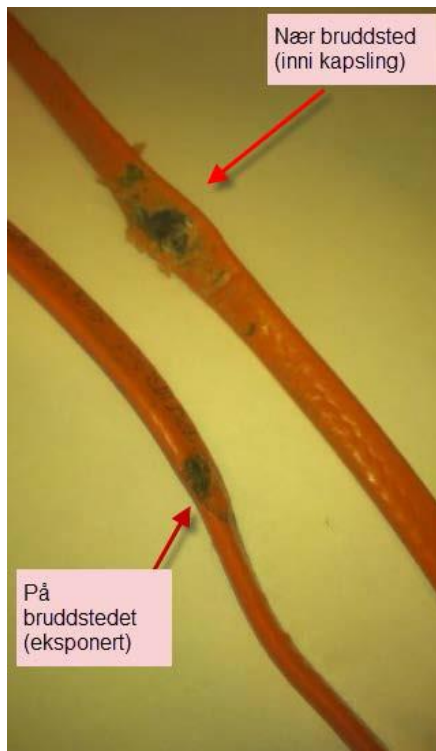
The heating cable has earth fault protection. The damage it suffered led to an earth fault, and the earth fault relay disconnected the cable automatically. That occurred about 90 seconds

before the leak, and coincides with the first video observations of vibration. This could equally well have happened when the vibration resumed, presenting some risk of a spark capable of causing ignition while gas is present.

Figure 9: Damage to heating cable. (From Statoil’s investigation report)

Key: Near rupture site (within insulation) At the rupture site (exposed)
