Investigation report

Report title Investigation report following a condensate leak on GjØa	Activity number 027153036
--	------------------------------

A condensate leak occurred in the GjØa process module at 20.01 on 21 June 2017. This incident led to gas detection, a general alarm, automatic shutdown of the process plant, pressure blowdown and mustering in accordance with the alarm instructions.

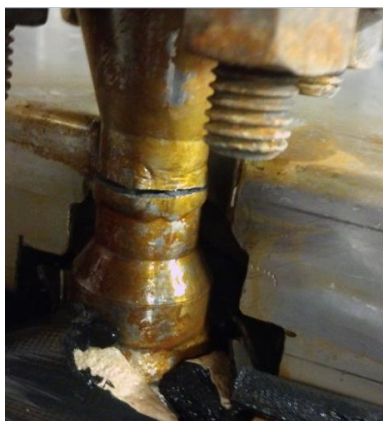
An X-ray examination established an internal welding fault in the pipe nozzle which led to fracturing. In addition, the same type of fault was identified in four of five similar nozzles on the other condensate pumps.

*Figure 1 - Fracture in the pipe nozzle out of the condensate pump.
The photograph belongs to Engie E&P*

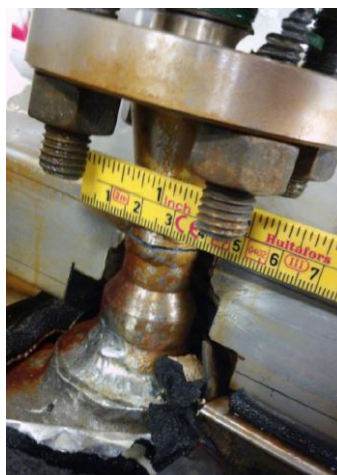
Figure 3- Crack in pipe weld which led to a condensate leak. The photograph belongs to Engie E&P

The condensate leak resulted from a fatigue fracture in a weld on a ½-inch pipe nozzle attached to condensate pump 23PA005B. Vibrations from the pump set up fatigue stresses in the weld because the 11.5cm-long pipe nozzle with a 3.6kg manual valve installed on top gives a moment of force with associated bending stresses. The welding work appears to have been deficient in terms of both joint preparation and lack of penetration, as well as some misalignment between the pipes being joined. This is the reason why fatigue cracking was initiated in the weld. A sharp crack arose internally around the whole pipe, which created high local stress intensity. The fatigue crack thereby began to grow from the inside of the pipe weld. Had the weld been subject to volumetric NDT, the fault should have been detected. It would not have satisfied the general criteria for good welding performance with acceptance criteria. How the weld was designed with welding procedure specification or qualification has not been clarified, but the weld should have a V joint with root gap and full penetration.

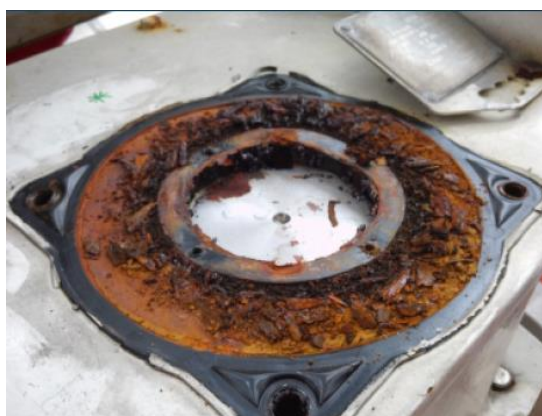
Faults in two of the ESVs were caused by water intrusion in the actuators and consequent corrosion over a long period. Results from the regular tests of these valves show that the problems have been known for a number of years. The investigation shows that Engie has not taken sufficient measures to ensure that the ESD system – which is a safety system – retains its functionality. Lack of maintenance of the actuators has resulted in two of the ESVs failing to function as they should during the incident.

Figure 5- Opened actuator housing of the ESV, showing corrosion on the inside of the gasket. The photograph belongs to Engie E&P

The ESV failed to close because the actuator had suffered water intrusion and corrosion over a long period. Combined with an inadequate maintenance programme for the actuators, this means that the barrier function of the ESV has not been maintained.

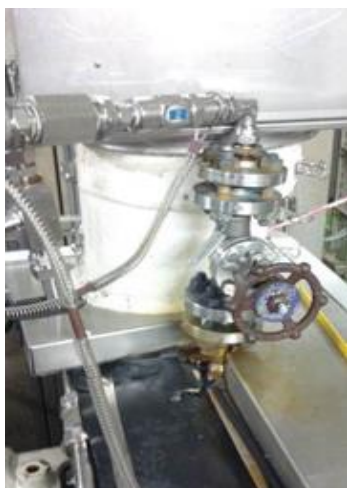
A pipe nozzle with a manual valve is installed on the condensate pump for maintenance flushing of the pump. The relevant nozzle with pipe, flanges and valve weighs altogether about 5.3kg. The length from pump housing to the valve centre is 18.5cm. No support is provided for this valve arrangement. The actual pipe is specified in the drawing with a 3/4-inch dimension, but a 1/2-inch dimension in duplex steel and schedule 160, which gives 4.78mm of nominal wall thickness, are found to have been used on both pumps. According to the DNV GL report (2) and X-ray images, the internal diameter of the pipe is virtually identical on both sides of the weld. The external diameter of the pipes varies somewhat because of differing material thickness in welded piping. Pipe nozzles and pipes welds do not have a full V joint or full penetration. That creates an internal crack point for possible fatigue.

Figure 10 - Pipe nozzle and manual maintenance valve installed on condensate pump 23PA005B.

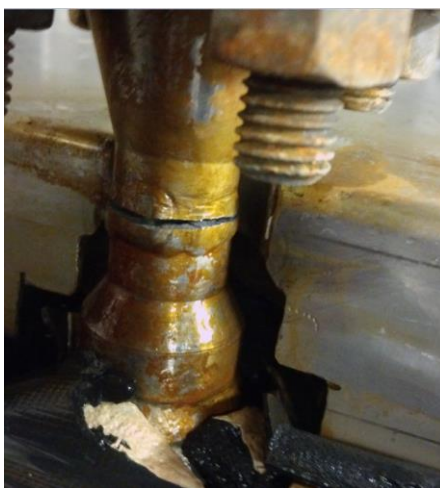
Figure 11 - Fracture in the weld on 1/2-inch pipe nozzle. Duplex steel.

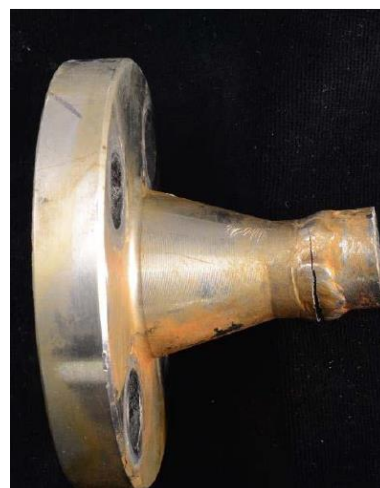
Figure 12 - Fracture surface seen from the side in connection with DNV GL investigation.

The butt weld in the relevant ½-inch pipe nozzle investigated by DNV GL has a more or less similar internal diameter and wall thicknesses of 3.6mm towards the flange and 4.7mm towards the pipe. See the figure below, taken from DNV GL's report on the technical material investigation (2).

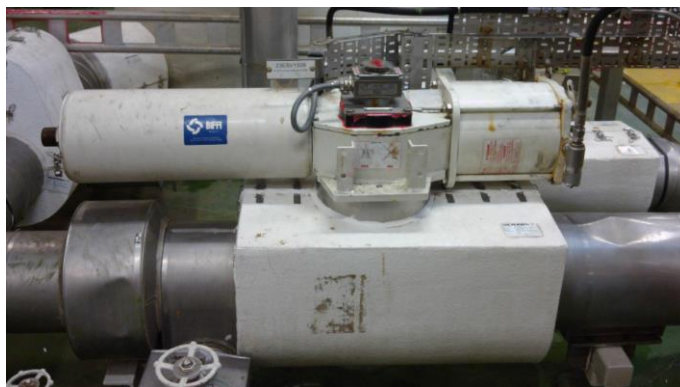
Two ESVs failed during the Gjøa incident. One of these, 23ESV1509, was positioned between the fracture site and the scrubber tank which the pump was connected to. The valve is intended to reduce the volume and duration of a possible leak. This six-inch ball valve has a pneumatic actuator installed. It transpired that several actuators are exposed in such a way that water has penetrated them and caused corrosion.

Figure 13 - ESV with installed actuator 23ESV1509, which failed during the incident. The photograph belongs to Engie E&P

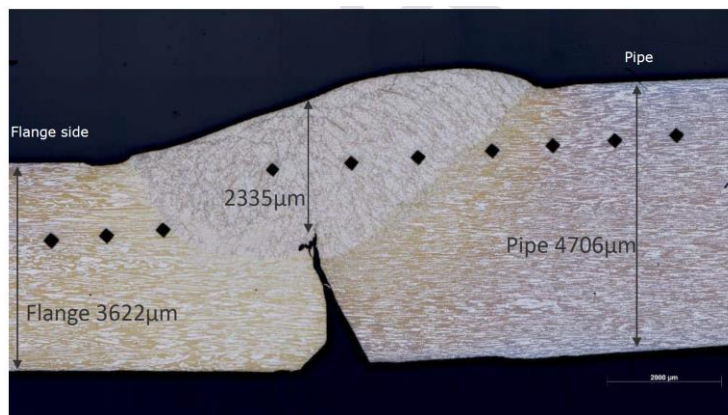
Figure 14 shows a pipe weld with internal crack point for possible further fatigue development. This primarily reflects faulty joint preparation for welding. There should have been a V joint here with a root gap, so that the welder can do the work correctly and achieve full weld penetration. That could have avoided the fault with lack of penetration.

Figure 14 - Metallographic image of the fracture site on the pipe nozzle, showing lack of penetration in the weld. The photograph belongs to Engie E&P
