## **Offshore Platform Well Control Incident**

## **After Action Review Summary**

During pulling of old 9 5/8 x 10 3/4 " tie-back string from a oil producer with gas lift a well control incident occurred involving release of gas to rig floor and mustering of personnel.

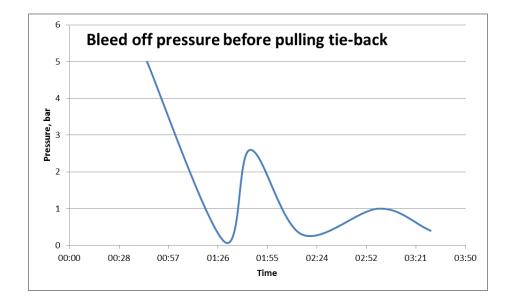
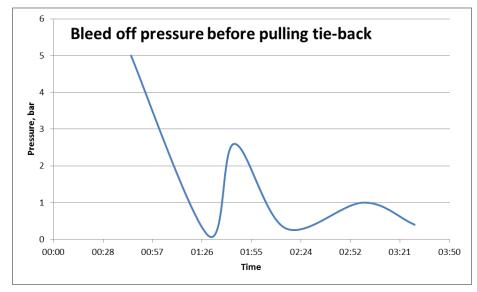
- Prior to pulling tie-back, 5 bar was observed on Bannulus.
- Bled off pressure to 0 bar in steps as on graph.
- Flow checked well for 10 minutes OK.

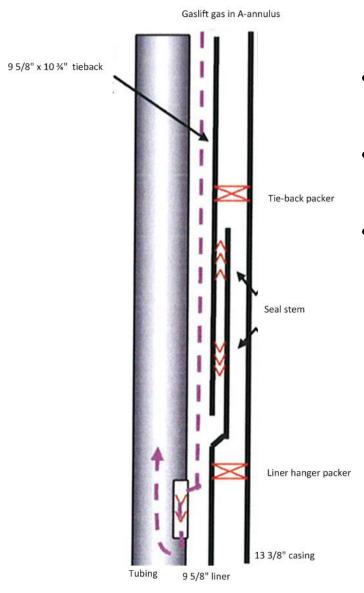
## Root cause

- Small volume between seal stem and tie-back packer.
- Difficult to know what's being tested under installation.
- Tie-back packer can fail without noticing under installation

- The gas combined with the precipitation of barite should have been better defined.
- Close annular while stripping casing/tie-back
- Consider use of casing ram
- Consider to cut tie-back at 100-200m first and pull out the upper part so that there is an interval with drill pipe in the well while pulling rest of casing (same risk will be there for the first part)
- Understanding risk of initial well design
- Construction phase; Consider to run tie-back in brine instead of mud.

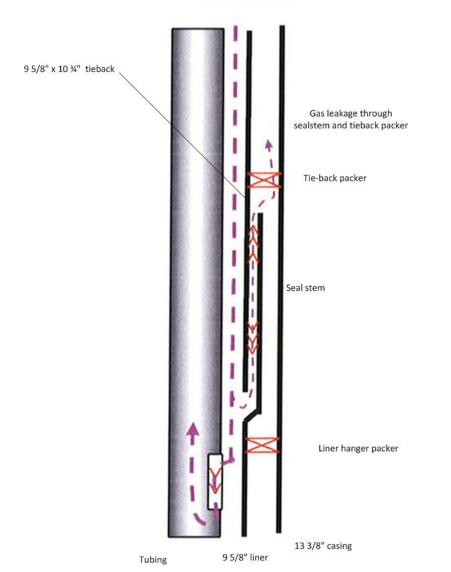
### **Root cause continue**

Gaslift gas in A-annulus

- Gas leakage through seal stem and packer
- When gas is entering in annulus B this will make the mud unstable and the precipitation of barite may start.
- This barite will end in dunes around pipe and couplings.
- This could be a collection point for gas which will be released when the casing is pulled.
