Norsk olje&gass

# "Sharing To Be Better"

Influx through failed cement in shoetrack during completion operations

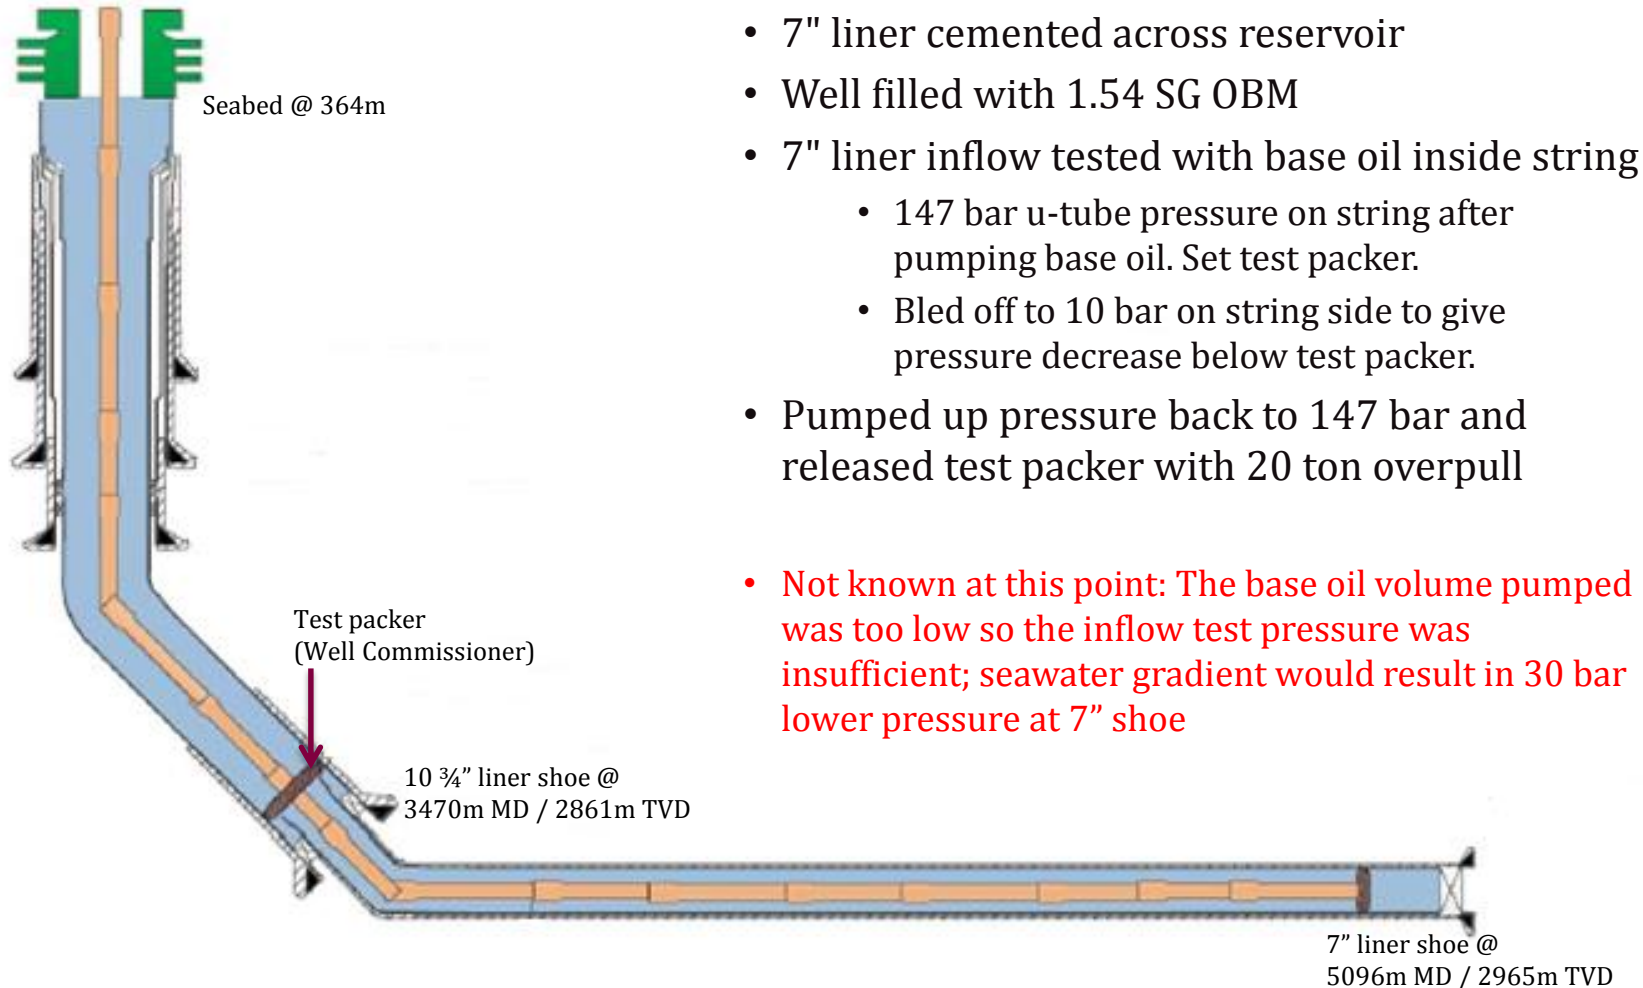
# Well status – completion operations

- 7" liner cemented across reservoir
- Well filled with 1.54 SG OBM
- 7" liner inflow tested with base oil inside string
  - 147 bar u-tube pressure on string after pumping base oil. Set test packer.
  - Bled off to 10 bar on string side to give pressure decrease below test packer.
- Pumped up pressure back to 147 bar and released test packer with 20 ton overpull
- **Not known at this point: The base oil volume pumped was too low so the inflow test pressure was insufficient; seawater gradient would result in 30 bar lower pressure at 7" shoe**

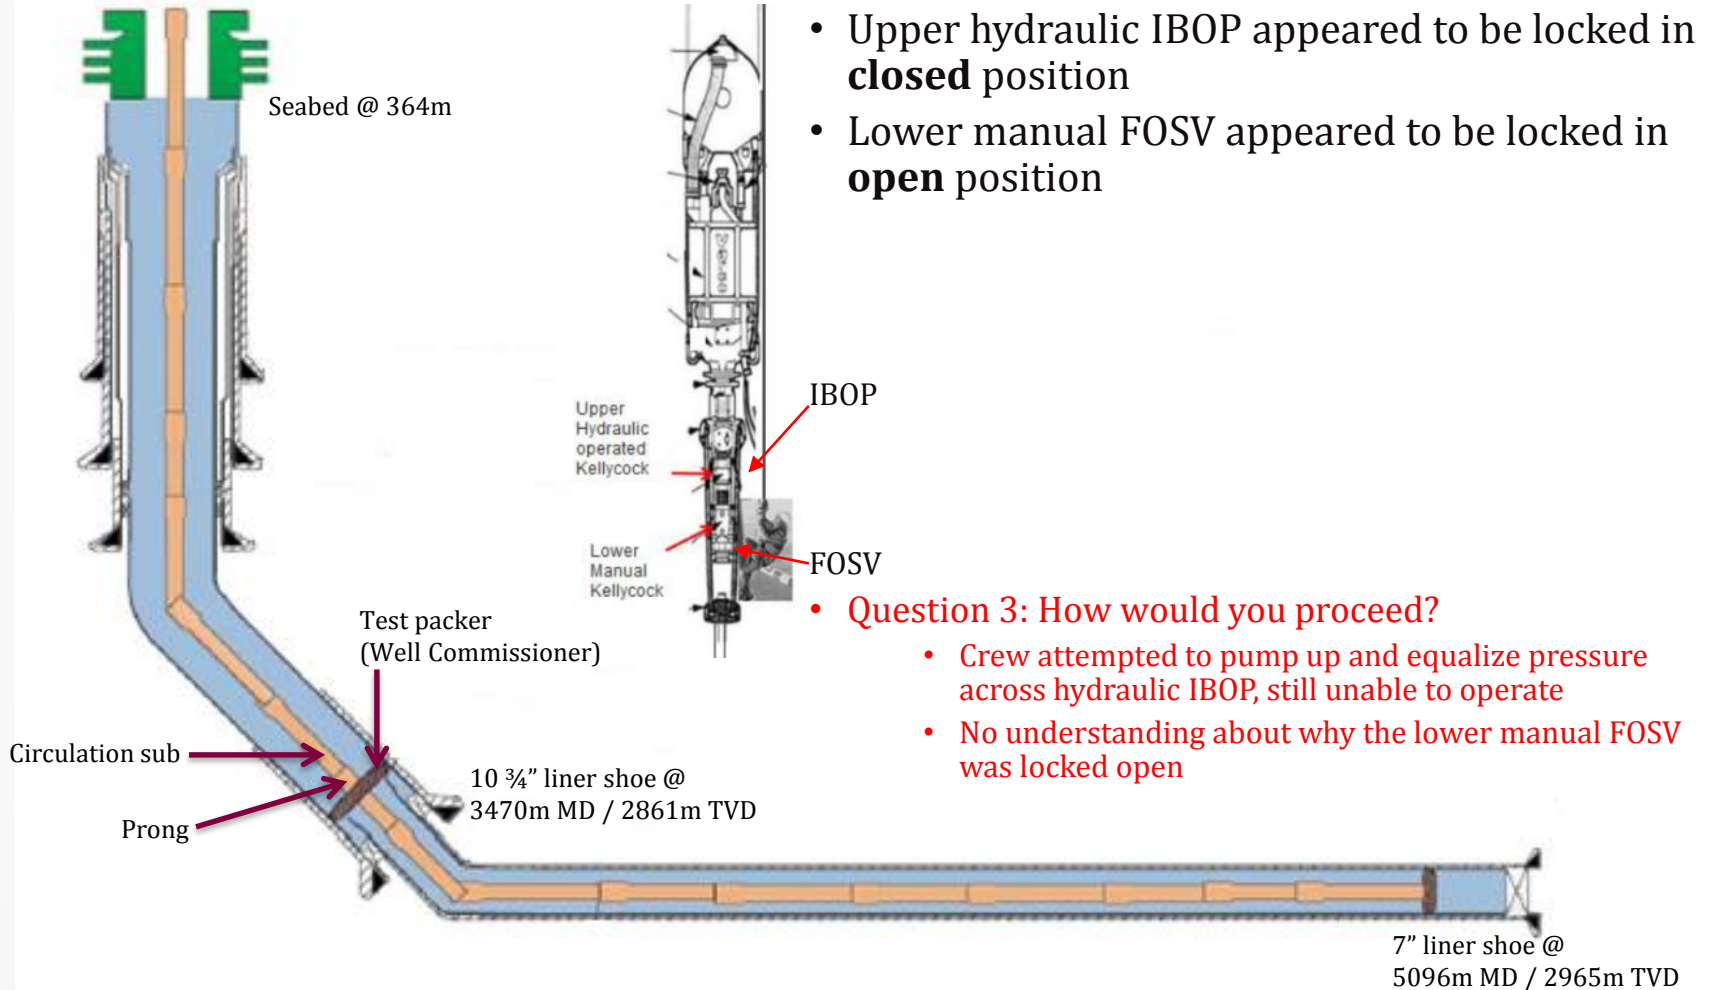
# Well shut in with 80 bar SICP

- Upper hydraulic IBOP appeared to be locked in **closed** position
- Lower manual FOSV appeared to be locked in **open** position

- **Question 3: How would you proceed?**
  - Crew attempted to pump up and equalize pressure across hydraulic IBOP, still unable to operate
  - No understanding about why the lower manual FOSV was locked open

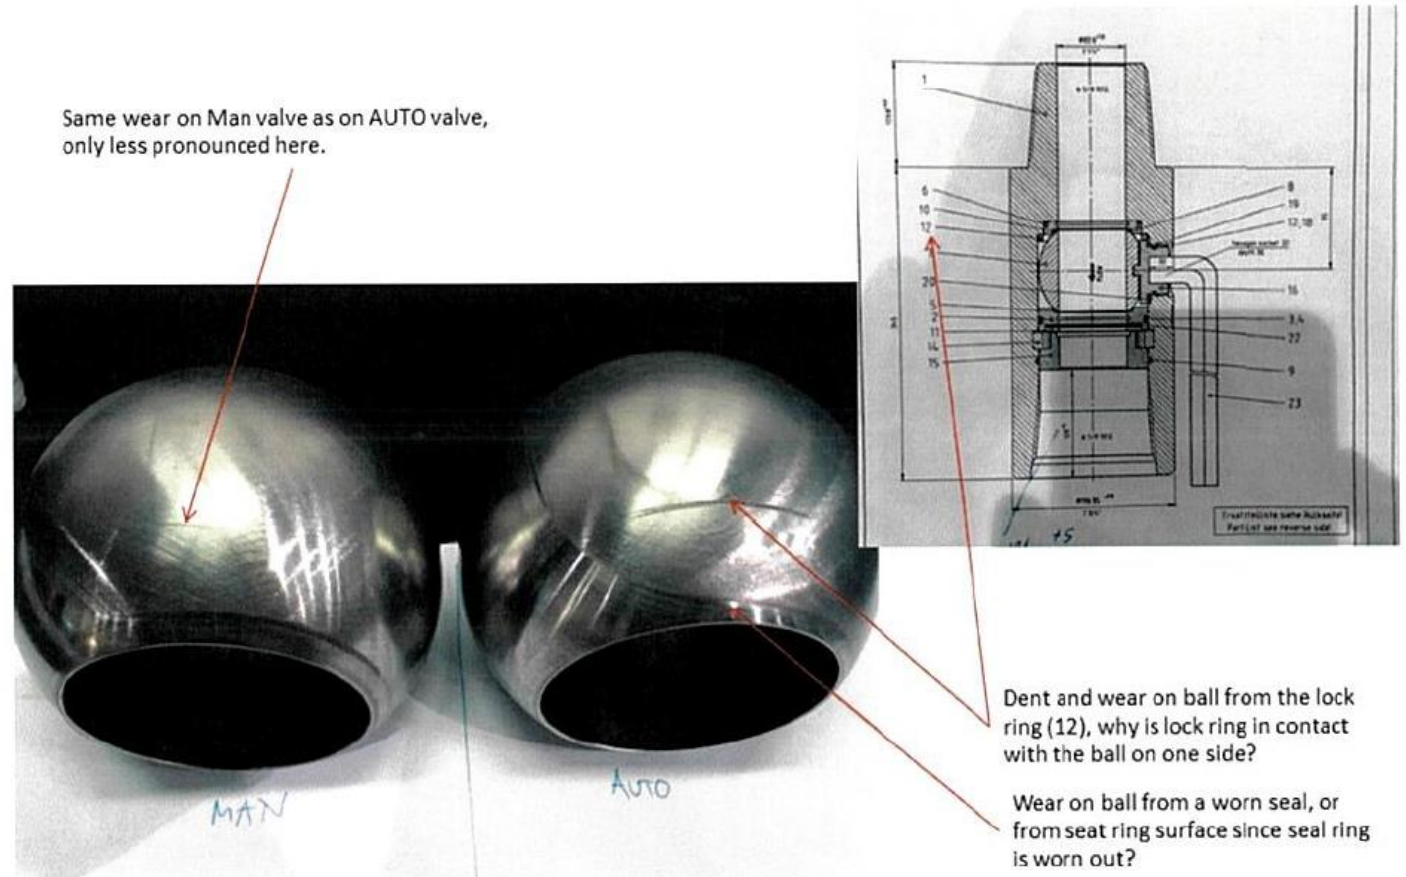
## Managed to reproduce the high operational torque in workshop

- Wear marks on ball indicating contact between ball and lock ring above

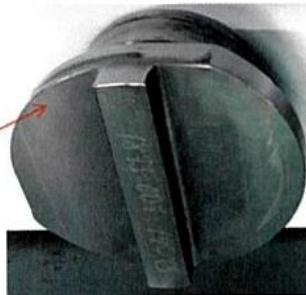
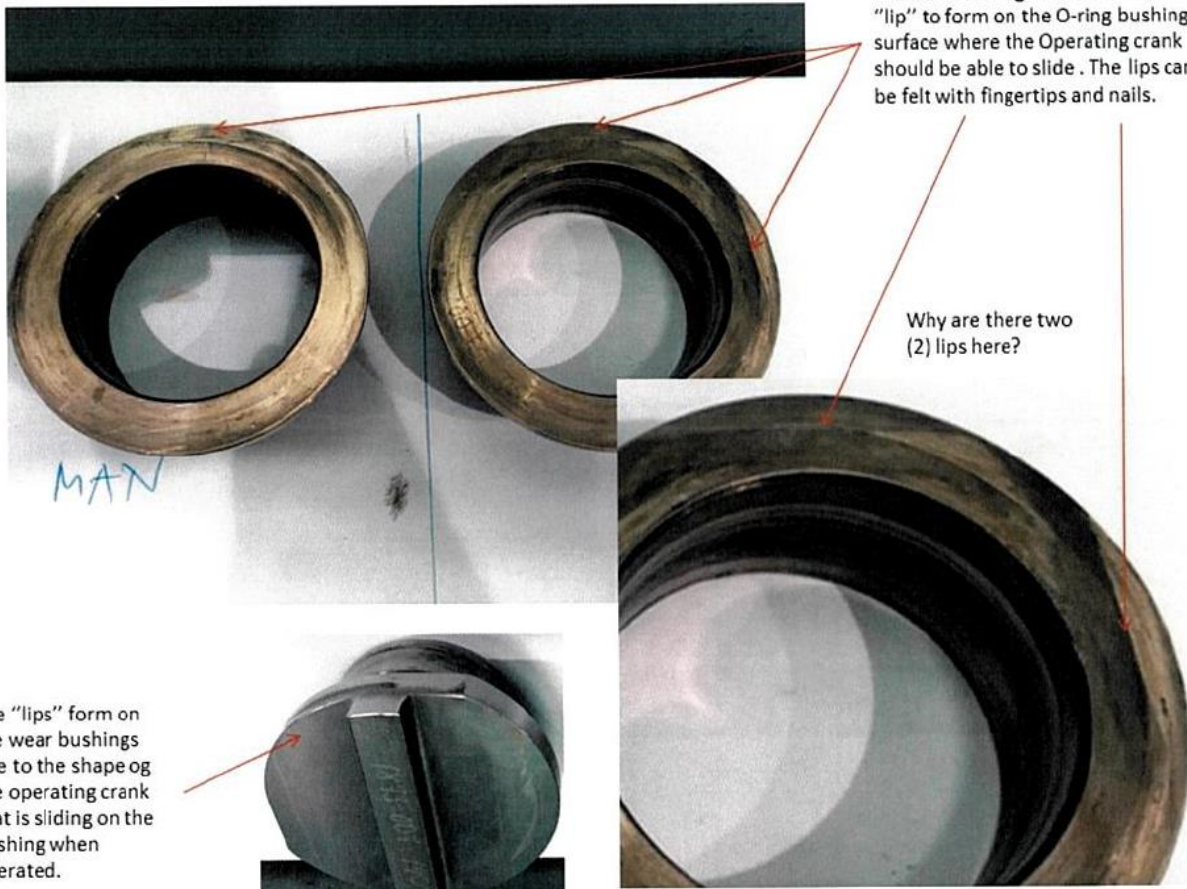
Wear on bushings have caused a "lip" to form on the O-ring bushing surface where the Operating crank should be able to slide. The lips can be felt with fingertips and nails.

Why are there two (2) lips here?

- 2 wear lips on bushing surface indicating possible rotation of bushing vs. crank
- No maintenance history found. Function testing under pressure not implemented.

The "lips" form on the wear bushings due to the shape of the operating crank that is sliding on the bushing when operated.

- Inflow test pressure was insufficient, due to insufficient detail in operational procedure
  - Include both volume and expected pressure in operational procedure
  - After inflow test, the well shall still be monitored
- No tracking system for valve maintenance
  - Notify contractors of expectation
- Valves had significant wear while still passing pressure tests
  - Suggest review of existing FOSV's and stab-in kelly-cocks
  - Recommend to use improved valve designs, available on the market
  - Establish routines for change-out based on operational history
- Weakness in valve design was not uncovered during routine testing without pressure on valve when operating it
  - Acquire vendor operational torque values to operate valve. To be available on drill floor.
  - Discuss with vendor about routinely test-operating the valve under pressure.
