# Investigation report

| Report | |
|--|---|
| Report title<br>Hydrocarbon leak on Oseberg C, 12 September 2008 | Activity number<br>001053007 |

In connection with maintenance of a valve, a hydrocarbon leak (DFU01) occurred at 17.28 on 12 September 2008 on StatoilHydro's Oseberg C (OSC) installation.

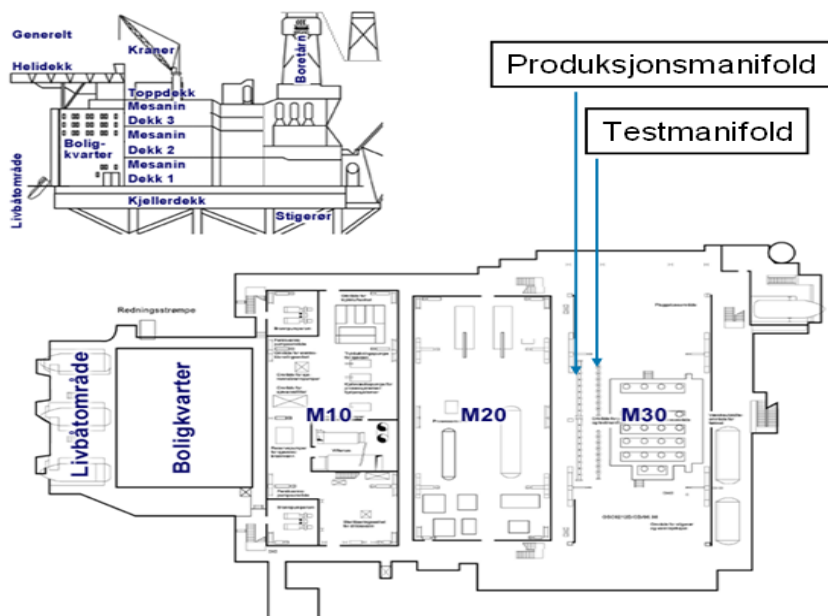
Fig 3.1

The wellstream from each well can be sent to either the test or the production manifold located in the M30 wellhead area (see fig 3.1).

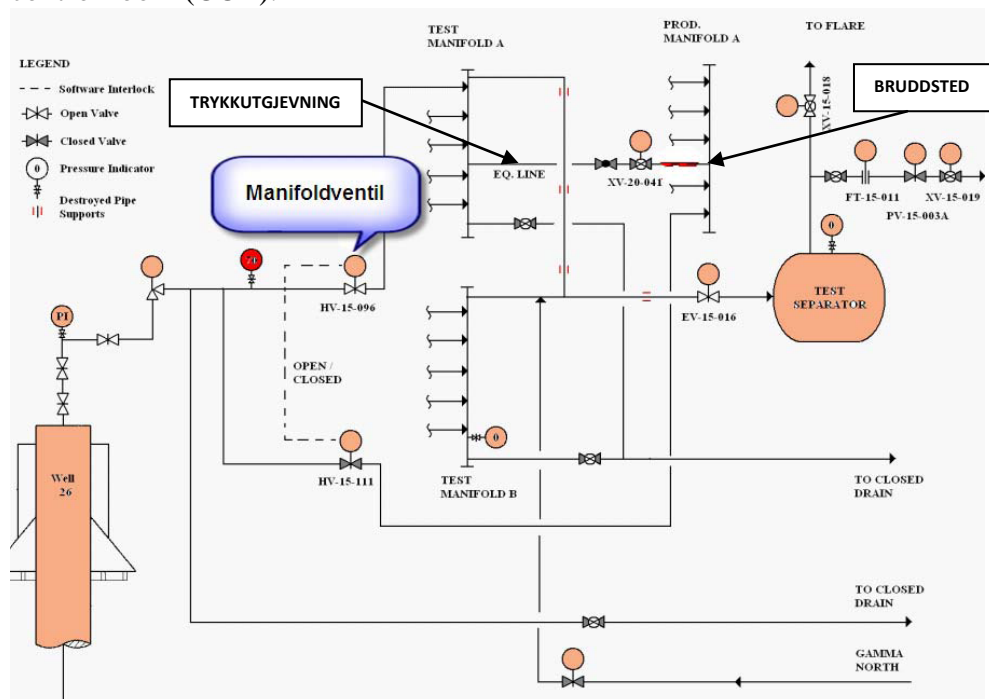
Fig 3.2

Manifold valves shut off or open for the wellstream from each well into the test or production manifold respectively. See fig 3.2. These valves are automatically controlled to leave one shut when the other is open (software interlock). They are normally operated from the central control room (CCR).

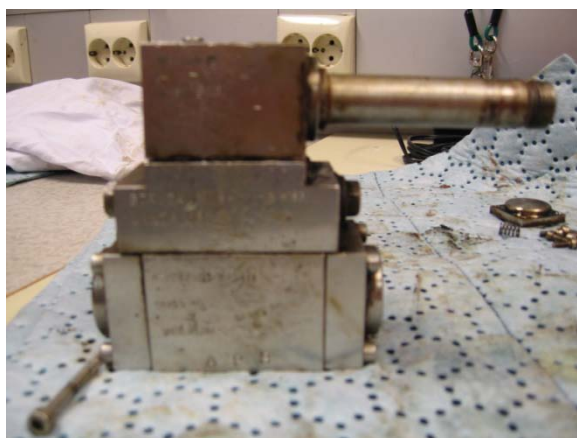
The hydraulic control block due to be installed had been taken from the store. The electrical control signal was isolated and inlet and return lines for the hydraulic oil were shut off to the manifold valve. The hydraulic control block (see pictures 1 and 2) was dismantled from the manifold valve. It was then discovered that the control valve was the mirror image of the one taken from the store. See picture 3. An investigation was launched to discover whether the part could be used, without contacting the discipline leader. Transferring the solenoid to the other side of the block was impossible. Nor could it be turned around. It could only be installed one way if hydraulic oil was to flow through the blocks. The other manifold valves were investigated out in the field, and it was concluded that the hydraulic control valve pointed both up and down. See picture 4. (With hindsight, it transpired that no account was taken of the fact that the hydraulic system was installed on the other side of the installation plate and that the control valve accordingly pointed the same way). On this basis, it was decided to install the hydraulic valve.

Picture 1, hydraulic control block

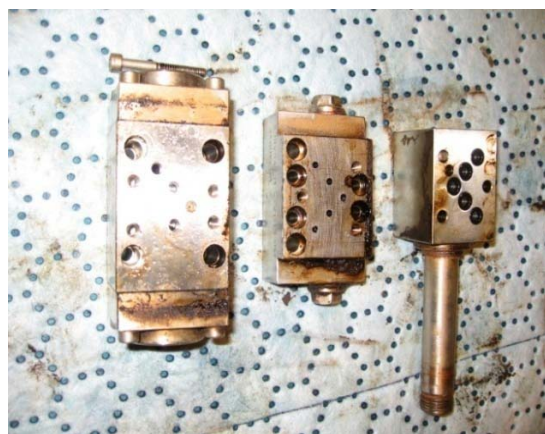
Picture 2, hydraulic control block disassembled

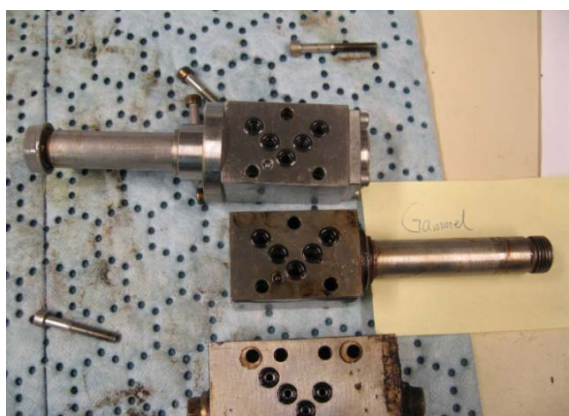
Picture 3, new and old hydraulic control valves

The direct cause of the pressure shock was the rapid opening of well C26 into the unpressurised test manifold. The fail-safe position of the installed control block opened the valve, while fail-safe for the removed block closed it. This meant that, when hydraulic oil was introduced to the block, the valve opened rapidly and unintentionally. That was later verified by testing from the control room. When the control room gave the open signal, the valve closed and vice versa.

The wrong spare part remained in store after a modification during the commissioning phase. This component had the right part number except for one letter.

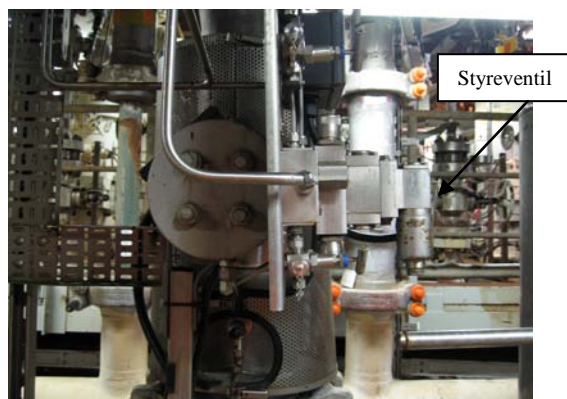
Picture 4, hydraulic system installed on the valve

The hydraulic block was installed and put back into place. Hydraulics, both inlet and return, were connected up. In order to leak-test the hydraulic block, the process operator opened the inlet line to hydraulic oil. Since the hydraulic system had been drained down and air-filled, the speed regulator did not work and the manifold valve opened rapidly and unintentionally. A pressure shock occurred in the test manifold and a two-inch pressure equalisation pipe was torn off the production manifold. The three people involved moved to a safe area. Production was swiftly shut down and pressure-relieved because gas was detected. The initial leak rate was calculated at 26 kg/s. Gas was detected at the air intake to the utility area. This led to the emergency shutdown of main and emergency power (ESD1).
