### Incident description: Gas leak 2013

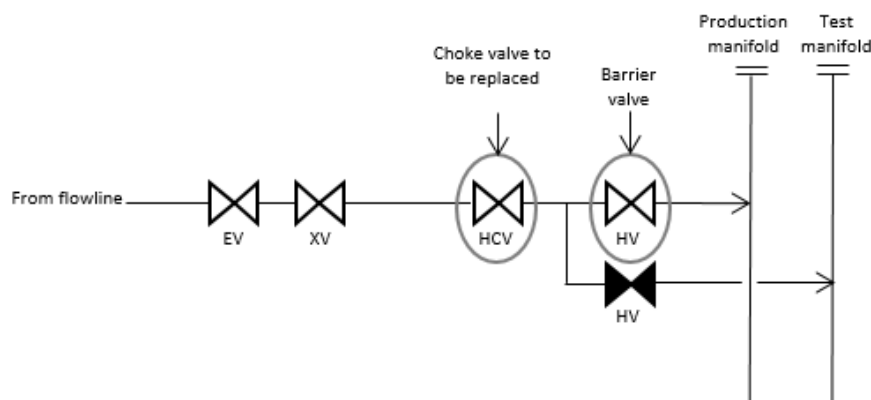
The gas leak occurred in connection with startup of the production after an unintentional shutdown. A choke valve on a production pipeline was to be replaced. An isolation plan for the job was prepared. A part of the isolation plan was a double expanding gate valve<sup>1</sup>, in the following referred to as the barrier valve, located between the production pipeline and manifold. The barrier valve was closed with an electric actuator and leak tested according to requirements. It was confirmed sealed by verifying no flow from the bleed valve down to the closed drain system. The bleed valve was left in open position. The location was considered to be a safe area; the platform practice was to use the gas detection system to detect barrier failure via bleeding.

After the trapped volume upstream of the barrier valve was depressurised, gas was discovered from the open bleed valve. The barrier valve was thus tightened using the valve wheel and confirmed sealed by verifying that no more gas was flowing from the bleed valve. The bleed valve was still in open position.

The barrier valve was not sufficiently set; full mechanical closing was not achieved.

- The closing method of the barrier valve was changed from its original design (due to earlier problems with wedging of valves after long closing).
- New method for complete expansion of valve for barrier function was not sufficiently known in the organisation or satisfactorily documented.

- Changes in pressure and temperature occurred compared to when the barrier was originally established and tested.
- The functionality of the barrier valve was affected by the temperature changes.
- The Norwegian Oil and Gas Association recommendations<sup>2</sup> regarding bleeding were not followed.

- Ensure that Norwegian Oil and Gas Association recommendations<sup>2</sup> are implemented in governing documents, along with measures to ensure that these are actually being followed. This includes closed bleed with manometer or hoses in accordance with applicable guidelines.
- Follow internal requirements for bleeding (the bleed valve was left in an open position in what was considered a safe area, which was a deviation from internal requirements).
- Detail and make known the procedure for handling electric actuator controlled double expanding gate valves as barriers.
- Ensure that the procedures take thermal effects into account and how the valve must be followed up to ensure adequate barrier function.

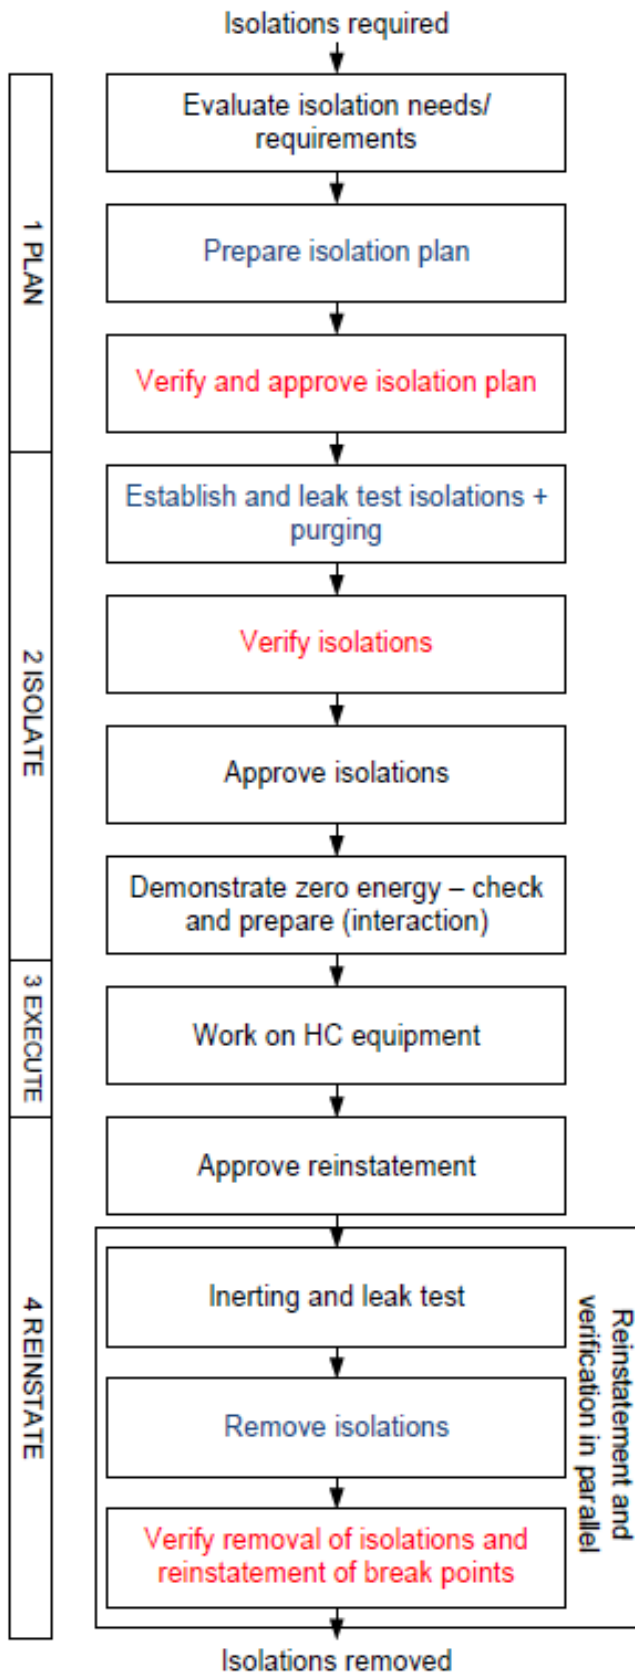
**Status for steps in best practice document**

- 1 Executed
  - 1 Executed
  - 1 Executed
  - 2 Error in isolation (valve not sealed)
  - 1 Leak test executed
  - 2 Error in verification (insufficient qualification)
  - 4
  - 1 Executed
- Gas leak 0,1-1 kg/s, 4 minutes
