### Incident description: Gas leak 2013

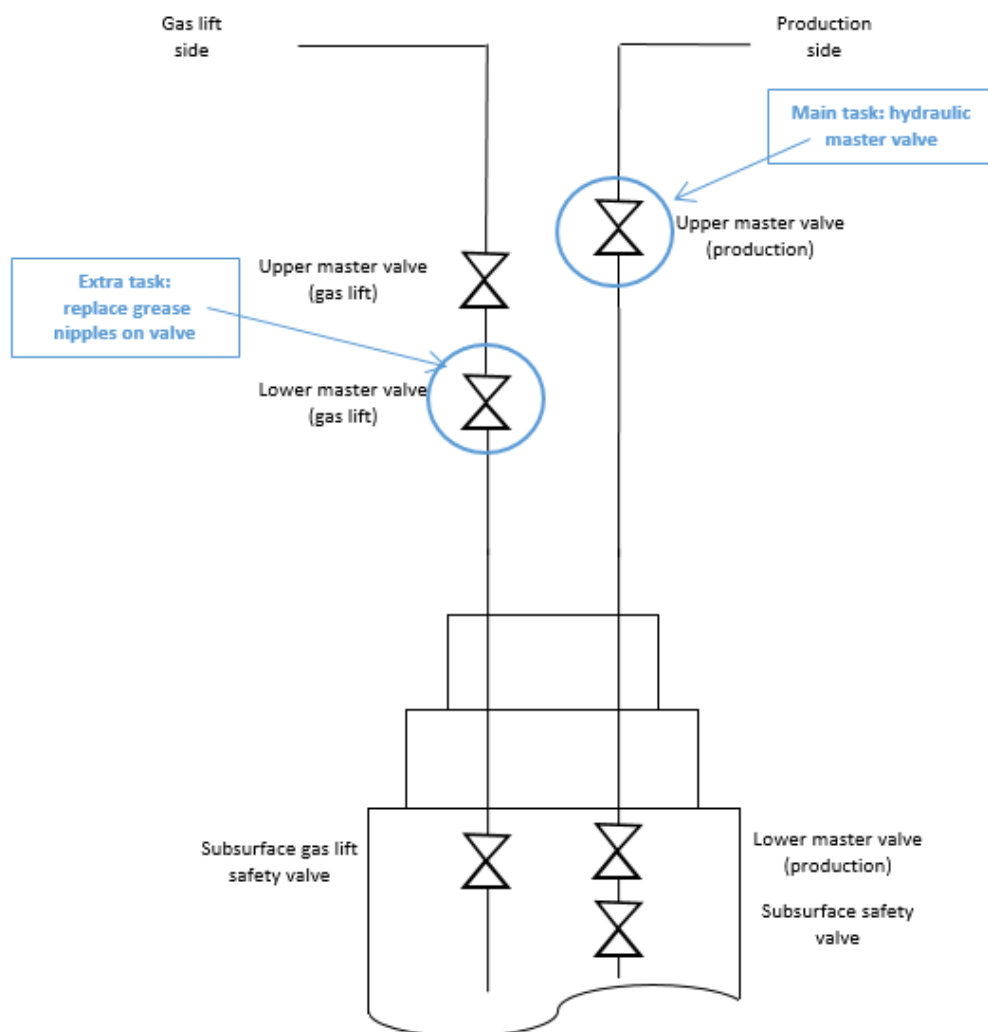
The gas leak occurred during replacement of gate and seat of a hydraulic master valve on a double wing Christmas tree. The master valve was located on the production side of the Christmas tree. In a planning meeting four days before the leak occurred, it was informally discussed that one must remember to replace the grease nipples (located on the gas lift side of the Christmas tree), while the well was still plugged (see the figure below). Following the planning meeting an additional task was thus included in the work order for replacement of gate and seat of the master valve, «Replacement of grease nipples on valves».

The mechanic started working on grease nipple on the gas lift side. This led to a gas leak at ca. 0,16 kg/s of duration 5-10 minutes, total emissions ca. 38 kg gas.

A grease nipple was released on a pressurised system which hadn't been prepared for maintenance.

- Ensure that Norwegian Oil and Gas Association recommendations<sup>1</sup> are implemented in governing documents, along with measures to ensure that these are actually being followed.
- Train involved parties in "conversation in the field" to ensure that risk elements are included.
- Physically ensure that the system is depressurised before starting the job (as an interaction between Mechanical and Operations).
- Approve the WP at the work site, also when extending the WP.
- Ensure that new personnel joining a task are informed about orders issued in the WP, and sign for these.

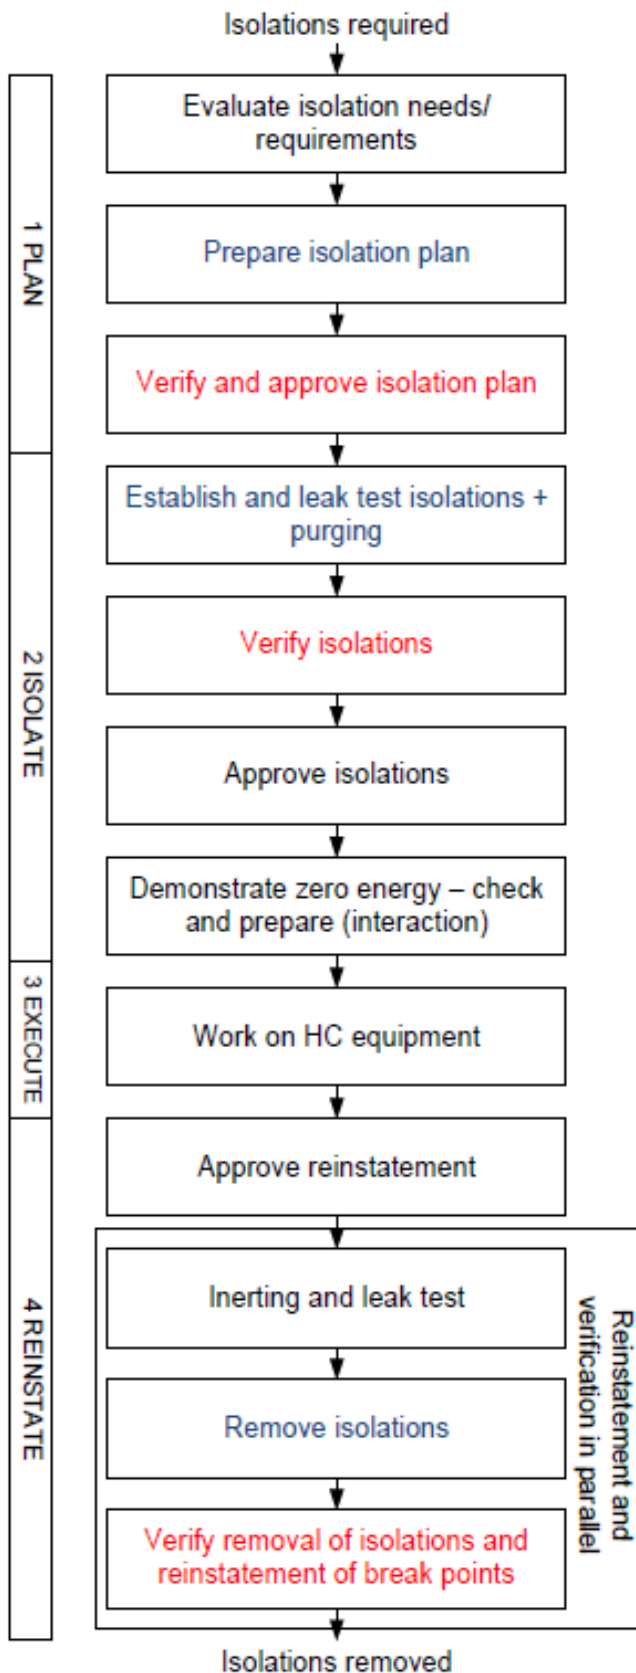
**Status for the steps in best practice document**

Status during the incident:

- 2: It was unclear whether the grease nipples was a part of the job or not
- 3: Isolation plan for the additional task (grease nipples on the gas lift side) was not prepared.
- 3: Not executed for the additional task
- 3: Not executed for the additional task
- 3: Not executed for the additional task
- 3: Not executed for the additional task
- 3: Area technician was not summoned/present before breaking

Gas leak 0,1-1 kg/s. Total 38 kg.
