Incident description: Gas leak 2013

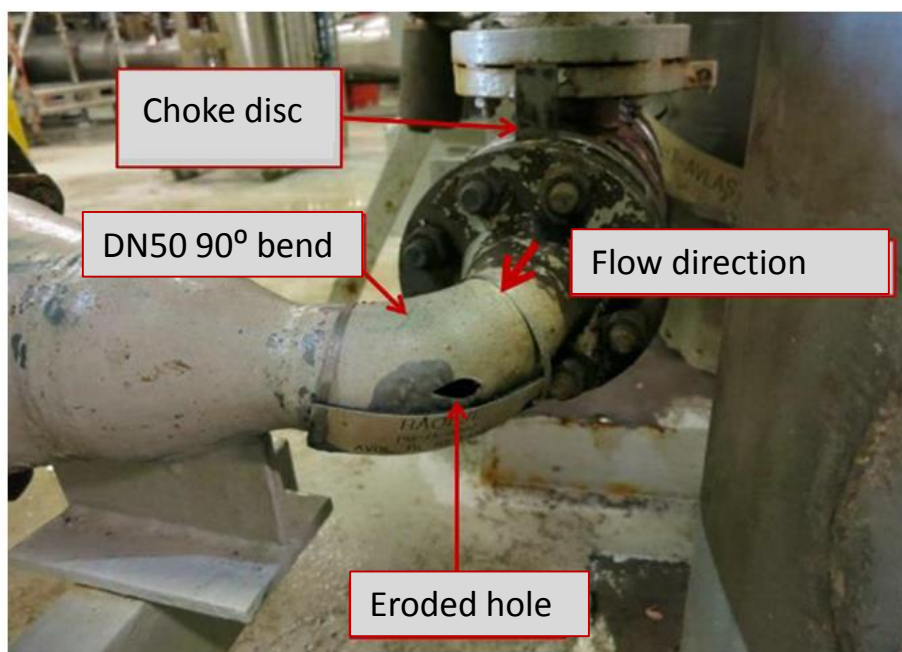
Unstable flow (slugging) from well B resulted in a shutdown of the test manifold, along with the wing and master valves for well A and B. The pressure in the test manifold, however, continued to rise. Pressure from the gas injection on the closed valves on well A resulted in a leak via the choke valve into the test manifold. A pressure relief valve opened in order to reduce the pressure. Sand lying in the pipe followed the gas flow through an orifice plate, where the flow velocity increased. A jet of sand and gas was formed eroding a hole in a 90° pipe bend installed just downstream of the orifice plate. Gas flowed out. The image below shows the pipe bend that was hit by sand from the well stream.

A jet of sand and gas eroded a hole in a 90° pipe bend during depressurisation.

- Insufficient requirements in steering documentation and inadequate strategy for management of sand production for the processing plant.
- Not proper design with 90° pipe bend immediately following the orifice plate

- Improve design, alternatively establish inspection program, for similar design solutions with:
 - Change of direction just downstream of orifice plates.
 - Shape of parting which may give sand in security and pressure relief lines.
- Review, assess risk, update and possibly establish new work descriptions related to gas injection and operation of the processing plant.
- Finalise and document sand management strategy for the processing plant.
