Incident description: Gas leak 2013

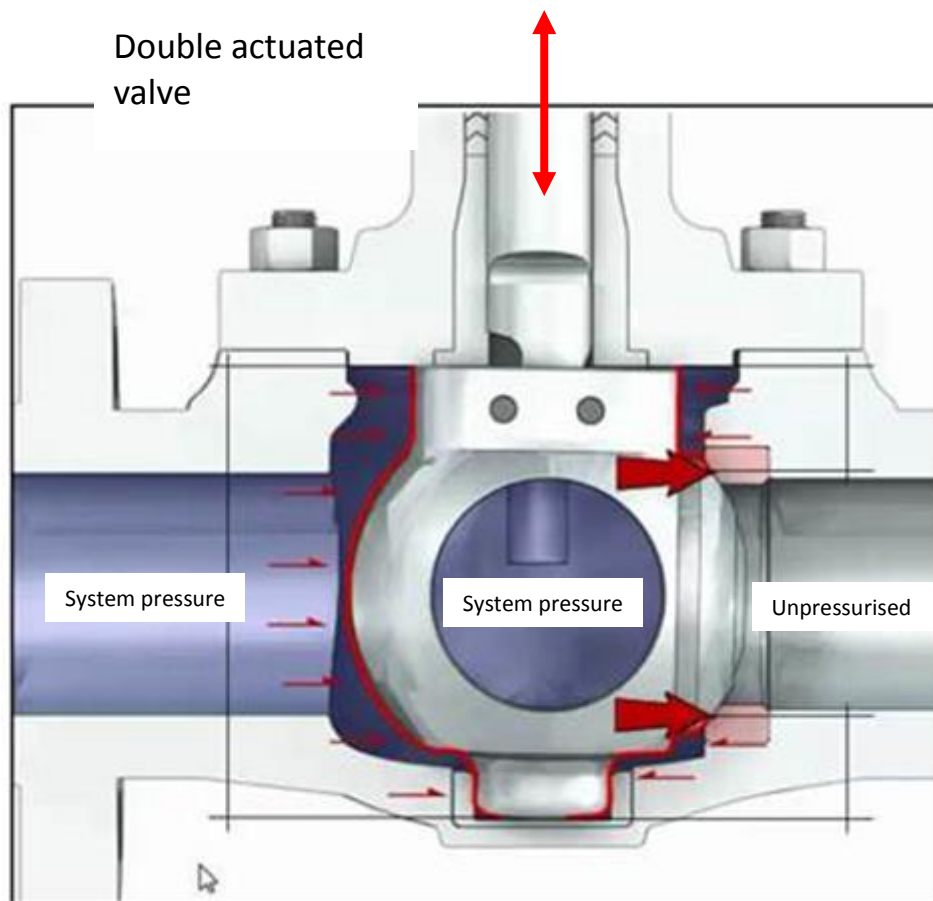
Figure: Sketch of ball valve.

The ball valve contains a ball which rotates 90 degrees to close/open. The actuator does not have a rotating stem, but moves up and down. It is made with a spline in a way that forces the ball to rotate while the stem moves up / down. The ball valve is so designed that it needs a supply pressure to keep the ball in the seat and in a closed position. If the actuator loses power supply, the ball could become detached from the seat if the system pressure is equal to the pressure on the back side. When the system pressure then increases after a pressure equalisation, the process stream may be able to rotate the ball to open position. A sketch of the valve is shown in the figure below. A system pressure higher than the pressure on the back side of the ball will help to keep the valve closed.

Lack of air supply to the actuator meant that the ball valve did not have closing pressure and was thus gradually opened by the process pressure. The bleed to secure area was thus unintentionally pressurised. This resulted in a leak for about 3 minutes, with a leak rate of 0,73 kg/s.

Securing of actuator for ball valve was not correctly/adequately performed.

- Procedure for securing barrier valves was too general (in order to cover several valve types).
- Verification of isolation was performed by personnel without the proper expertise on actuated valves.

- Ensure that procedures describe how different valve types need to be secured in order to function as a barrier.
- Implement mechanical lock for valves that require external active power supply in order to function as a barrier.
- Ensure that personnel performing verification tasks has proper competence.

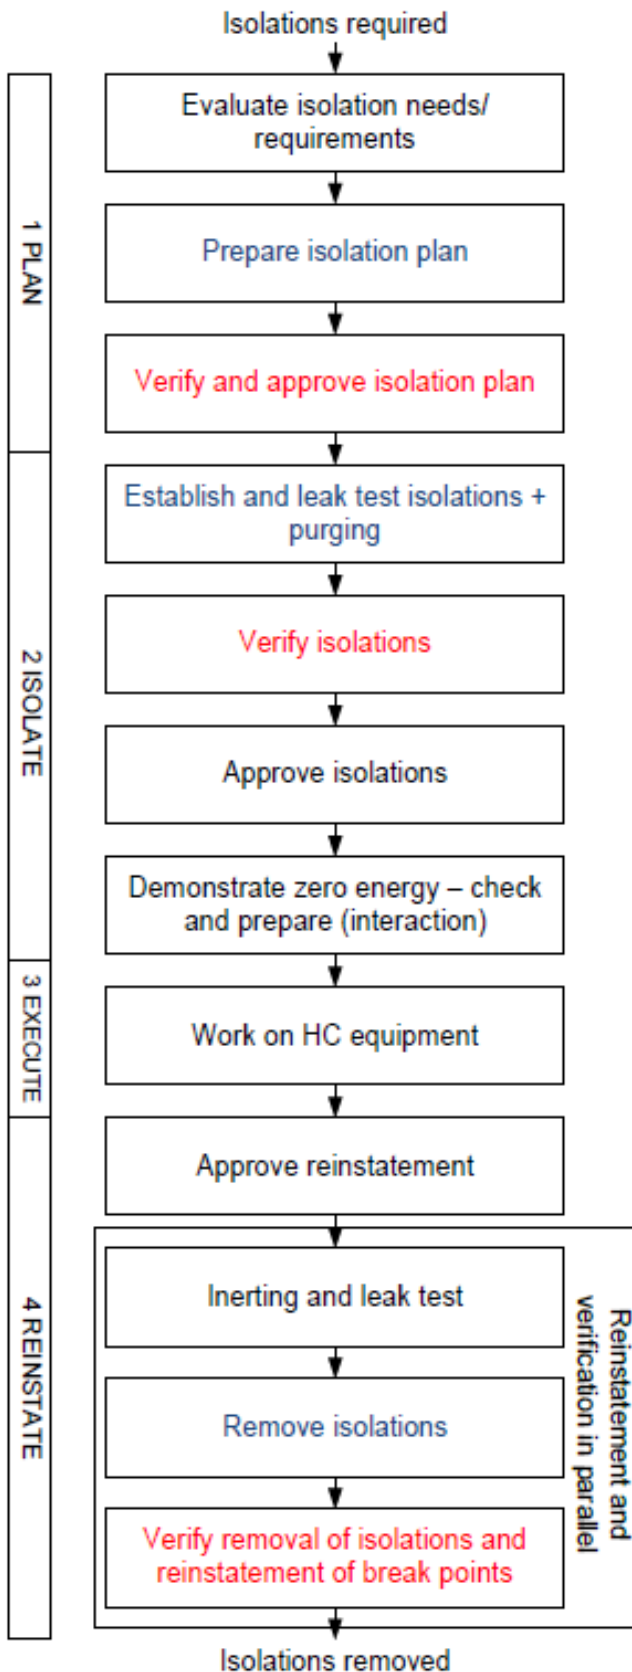
Status for steps in best practice document

- 1
- 2 Executed (but the plan did not describe the necessary conditions for securing the valve position)
- Uncertain
- 2 Executed (but the ball valve was not adequately secured)
- 2 Executed (but personnel did not have proper competence)
