Incident description: Gas leak 2013

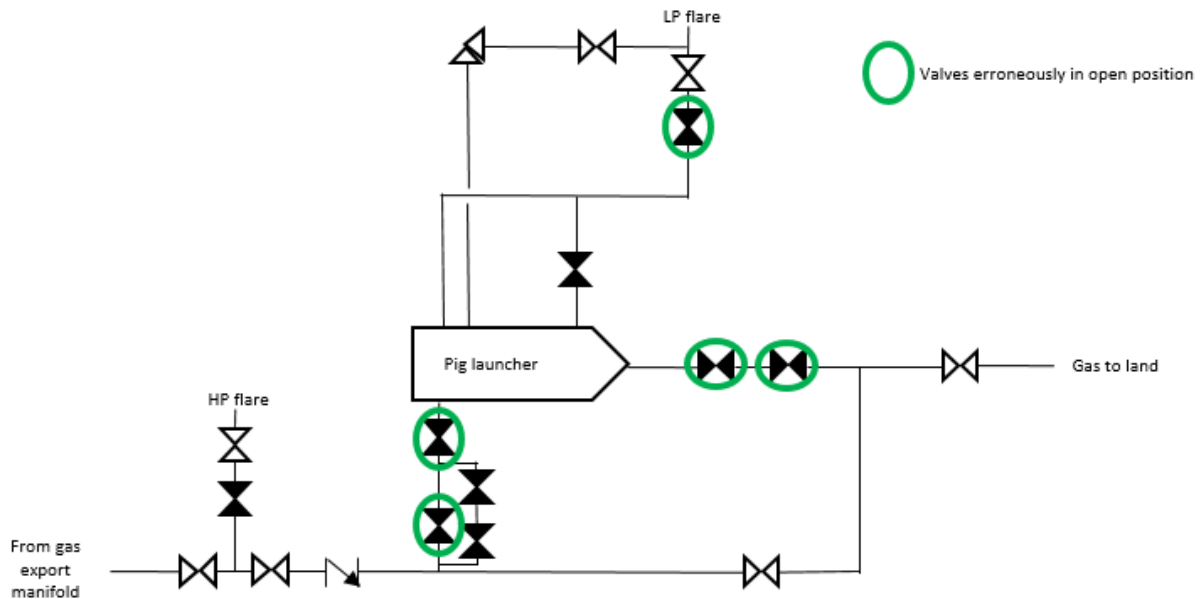
The gas leak occurred in a pig launcher in connection with preparation for turnaround. The preparation process also included testing of safety systems (PSD, ESD, APS and MEI¹). After the platform was depressurised a drainage of residual condensate was started. This operation is performed by using a small amount of gas to drain the condensate. The export manifold was then pressurised to 17 barg. The valves between the manifold and the pig launcher are normally in closed position, but during the pressurisation of the manifold, five of these valves were in open position (marked in green in the figure below). The reason for this was that the control logic for the valves (SAS²) was programmed to send an opening signal to the pig launcher valves when resetting after a power failure (full APS test). A simplified illustration is shown below.

Because the valves were opened, the pressure increase of the manifold led to pressurisation of the pig launcher to 17 barg. The pig launcher is designed to withstand a pressure of 142 barg. The gasket around the pig chamber door had previously been exposed to condensate and had over time been degraded. This resulted in a gas leak at ca. 0,8 kg/s of duration 1-3 minutes due to the degraded gasket. Total emissions were approximately 150 kg gas.

The gasket in the pig launcher door was degraded, and a leakage occurred.

- Condensate inside the pig launcher had over time degraded the gasket around the pig chamber door.
- Five valves were in open position. These should have been in closed position when pigging was not ongoing.
- The five valves were open because the SAS system sent an opening signal to the pig launcher valves when resetting after a power outage (full APS test).
- It was not discovered that the pig launcher valves were in open position before the pressurisation of the export manifold started.
- Drainage of residual condensate in the export manifold was performed simultaneously with the ongoing MEI-test. This resulted in a high workload with a huge amount of alarms that had to be acknowledged. In such conditions it can be challenging to keep the overview.

- Do not perform other activities simultaneously when testing of PSD, ESD, APS and MEI is in progress.
- Complete APS testing and reset and verify all systems before the MEI test starts.

- Review which systems fall out, with associated alarms, when testing of appropriate safety systems.
- Update checklist with ensuring that all logging systems starts normally after APS testing (to avoid loss of important data logs if systems do not start as intended after power failure).

- Establish operational routine for drainage of condensate from pig launcher between inner and outer gate valves.
- Establish operational routine for pressurising pig launchers with nitrogen (for improved detection of gate leakages, as well as preserving the gate).

- Change interval of replacement of pig chamber door gasket (from 12 to six months), alternatively switch to another type of gasket.
- Install alarm in control room for pressure increase in gates, and for position change of gate valves.
