### Incident description: Gas leak 2013

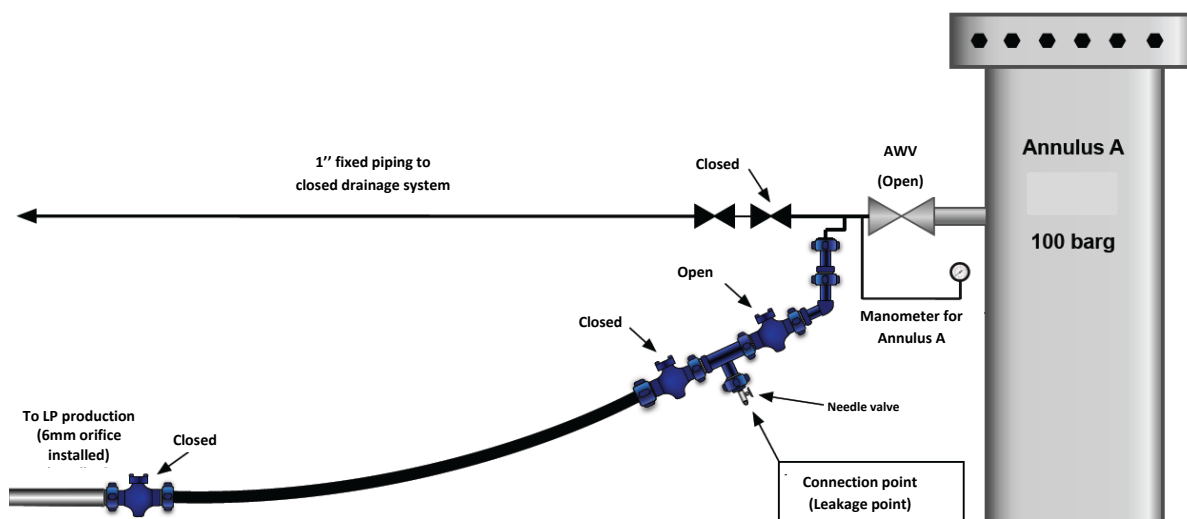
The incident occurred in connection with testing of the gas lift valve on a well. The annulus contains large volumes of gas, and in order to reduce the need for flaring most of this gas was going to be produced. During the night shift a temporary chocksan line was installed for this purpose, ref. the figure below. During leak testing a leak was discovered in the manifold for connection of the leak metering system (LMS). The manifold was thus disassembled, and a needle valve was installed. This temporary system was leak tested at 280 bar, and the annulus wing valve (AWV) was then opened such that the chocksan line was pressurised.

Disassembly of the needle valve and installation of manifold for connecting the LMS was to be carried out by the subsequent day shift. An area technician and a LMS operator went to the well to begin this work. The area technician moved the AWV wheel to ensure that the valve was closed. He concluded that the valve was closed, even though it was actually in open position (according to internal procedures the valve should have been labeled if it had been closed). The manometer showing the pressure on the segment that was about to be opened, was not checked. Verification that the segment was depressurised was performed by partially opening the needle valve. At first a little grease/oil emerged from the needle valve. The valve was then further opened to about 2/3 opening. This led to a gas leak, as a barrier against the annulus (closed AWV) had not been established. The leak rate was 0,8 – 1 kg/s. The area technician had his hand on the needle valve and started closing the valve when the gas began to flow. It took approximately 5-7 seconds until the valve was closed. Estimated gas leakage to atmosphere is 5-7 kg.

Needle valve was opened to verify that the system was depressurised without conducting required verification steps.

- The task was considered a normal routine operation.
- Isolation plan was not established and verified.
- Leak test was not performed.
- Verification of valve position was not performed.
- It was assumed that the AWW was closed, despite missing labeling/locking.
- Chicksan line lacked a barrier against the needle valve.
- Checkout of Work Permit (WP) in the field was not executed. The WP for depressurising, drainage and closing of valve was signed, even though this task had not been performed.

- Ensure that Norwegian Oil and Gas Association recommendations<sup>1</sup> are implemented in governing documents, along with measures to ensure that these are actually being followed. This includes active use of valve and blinding list along with verification of isolations.
- Introduce more robust technical solutions to ensure a proper isolation standard on process equipment.
- Improve routine for handover between day and night shifts.
- Introduce measures to improve training and competence and checkout of personnel suited for area responsibility.

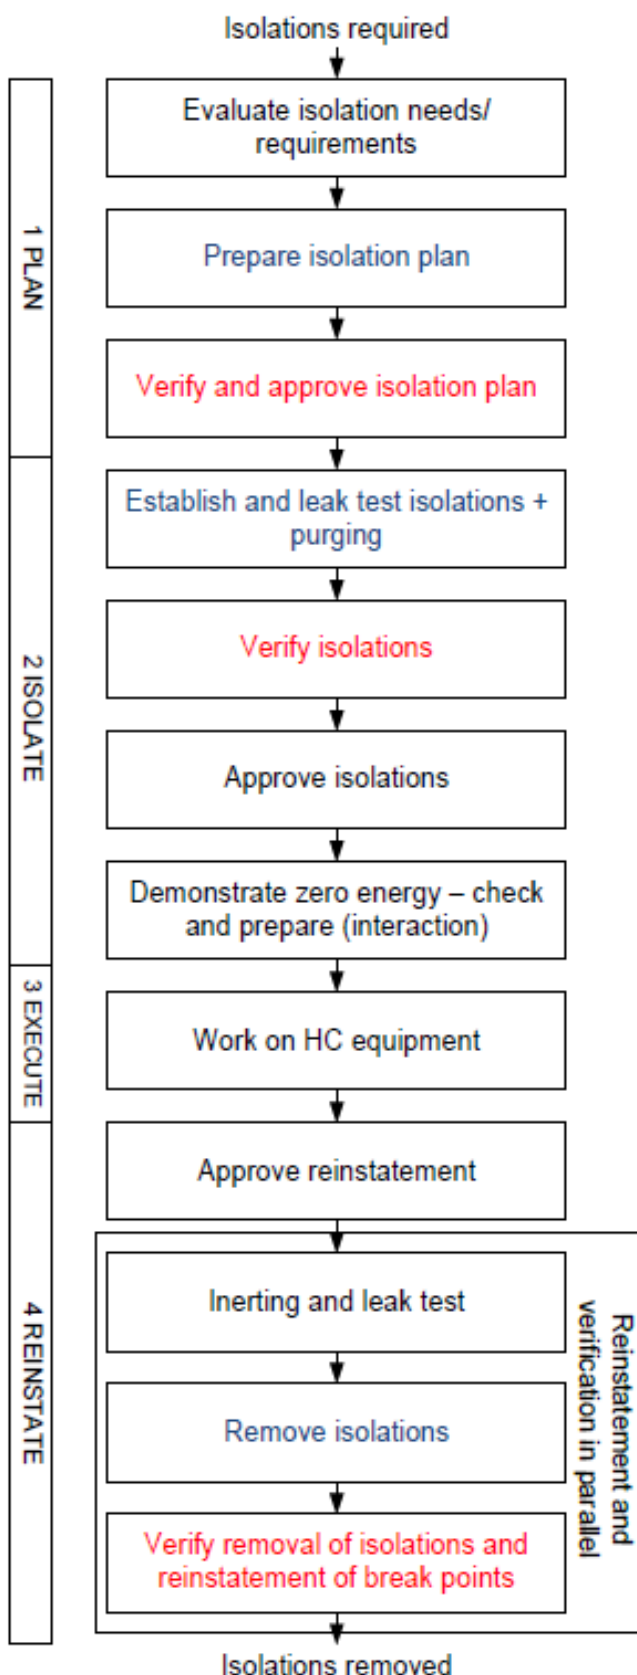
**Status for steps in best practice document**

Blue and red text indicate roles which are to function as independent barriers.

- 1 Was executed, functioning as intended
- 2 Was executed, but failed
- 3 Was not executed
- 4 Uncertain whether executed

- 2 The task was considered a routine task outside the scope of the best practice document.
- 3 Not executed
- 3 Not executed
- 2 Failure in isolation (AWV was open)
- 3 Not leak tested and drained
- 3 Not executed
- 3 Not executed
- 3 No checkout of WP in the field
- 4 Executed
- Gas leak 0,8 - 1 kg/s, 5-7 seconds
