### Description of incident : Oil leak 2014

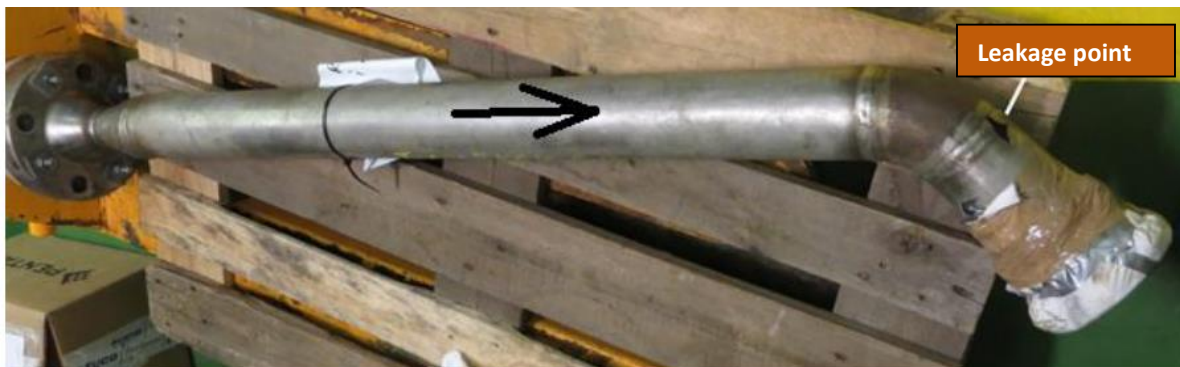
Start-up of a 'dead' well was initiated. The method for the attempt to start-up was reviewed. There were some difficulties getting the well started and the inlet was closed to empty the liquid part of the test separator. With low wellhead pressure, a minor well stream was maintained through the depressurisation line. Sand in the well stream caused a fracture due to erosion in the weld in the 45° bend in the depressurisation line, and a gas- and oil leak occurred. The initial leak rate was estimated to 0,12 kg/s, with a duration of 30 minutes. See the figure below.

*Figure: Depressurisation line with leakage. The arrow indicates the direction of the flow.*

Sand in the well stream caused a fracture in the depressurisation line due to erosion.

- The depressurisation line was not designed for sand content.
- Lack of procedure/work description for start-up of 'dead' wells.
- Insufficient risk assessment of the chosen start-up method.
- Lack of documentation for operation of the depressurisation line.
- No valid sand strategy.

- Stop this practice for operation of wells.
- Evaluate a more robust design of the depressurisation line.
- Finalise and document a sand treatment strategy for the plant.
- Consider to establish guidelines for start-up of wells with sand content.
- Execute erosion calculations for depressurisation lines.
- Revise the inspection program for depressurisation lines.
- Ensure adequate systems for management of change when the plant is operated in other conditions than it is designed for.
