Description of incident: Oil leak 2014

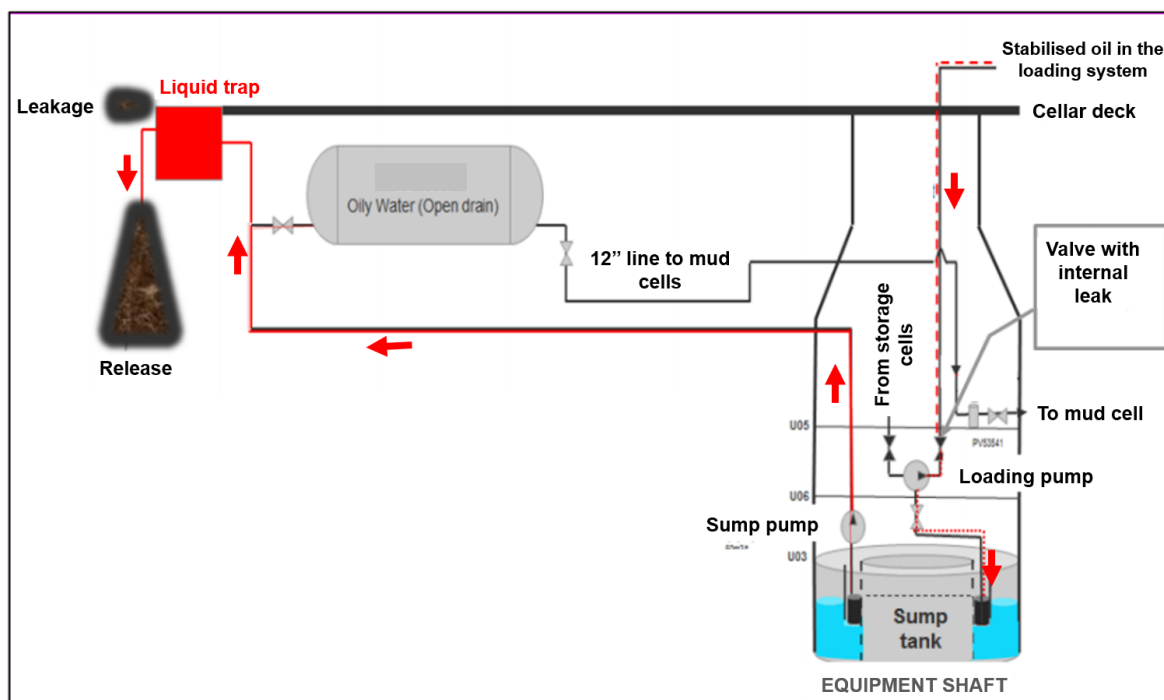
An internal leakage in the partitioning valve between the transferring and preparation locations was not known, and there was not established a preventive maintenance program for shut-in valves in the loading system. During drainage of stabilised oil, the oil was poured to the sump tank in the equipment shaft and was pumped three times to the oily water tank and further through the liquid locks to sea. The oily water tank was not drained down to the mud cell as assumed in the design. Approximately 10 m³ of stabilised oil was poured through the overflow of the liquid lock to sea, while approximately 2 m³ was spilled on the platform. The total rate was 20,8 kg/s.

Figure: Visual description of the incident (the red line indicates the oil flow when the leak occurred).

Drainage of a larger pipe segment than planned for to the sump tank.

- Not adequate monitoring of the pipe segment.
- Simultaneous operations not adequately evaluated.
- Internal leak in the partitioning valve between transferring and preparation locations was not known.

- Preventive maintenance program for shut-in valves in the loading system was not established.
- Liquid in the oily water tank and return line to the mud cell was replaced by stabilised oil.
- Lack of design and system understanding with regards to modifications and systems that affects the oily water tank.
- No alarm due to high level in the oily water tank.
- Level indicators in the oily water tank were removed, it was evaluated that pressure regulator was sufficient for level regulation.

- Ensure that leak test of shut-in valves is executed and that the drainage is being monitored.
- Consider to include requirements regarding limitations and/or compensating measures during simultaneous operations in the loading system.
- Review of design criteria for open drain system and evaluate these against different operational conditions for the oily water tank.
- Review of responsibilities and routines for maintenance of liquid traps.
