Incident description: Gas leak 2014

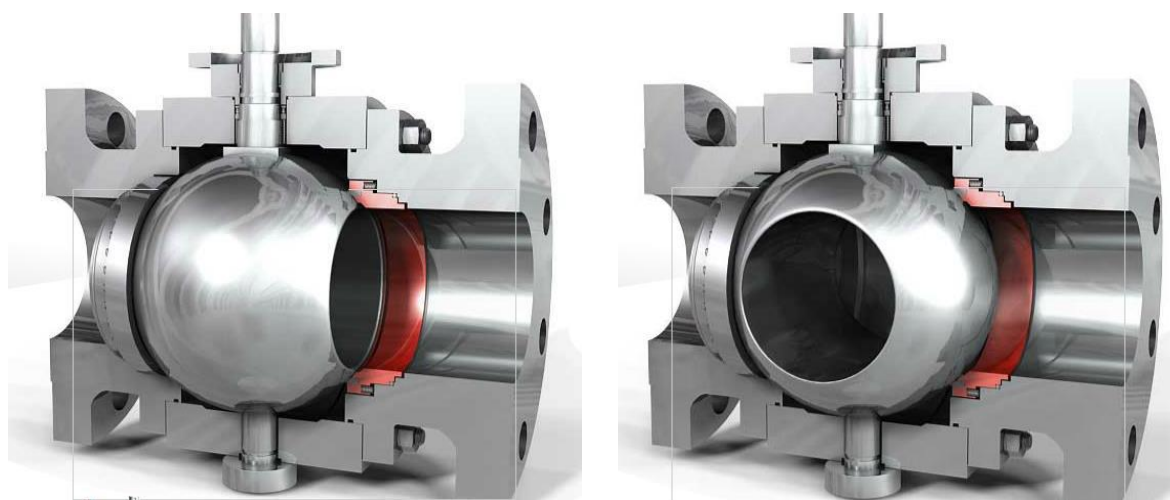
At the time of blowout of the plug, the valve was in open position, see Figure 1.

Figure 1: Ball valve in open position (left) and closed position (right)

It was attempted to close the valve manually, but this led to a brief pressure increase in the valve body since the gas volume in the valve opening was pushed into the cavity. The pressure was manually bled off via the valve body's bleed and it was possible to install a new plug.

The pressure in the line was 21 bar, and it is assumed that the pressure of the valve body was the same. The volume is uncertain. The rate is therefore calculated due to a short duration. The rate is assumed to be $< 0,1$ kg/s. The volume released is estimated to approximately 0,5 kg.

- Plug was removed from pressurised valve body.

- The WP process was not adhered to by the work team. The WP was not active when the work started, it was set to 'completed' in the WP-system (lack of self-check and preparation for work).
- The mechanic ignored the warning signs. It was questioned whether the system was still pressurised since the plug that was untightened was 'slow'. This was not followed up (lack of risk understanding/misjudgment of danger potential).
- Area technician was not contacted during start-up of the work.
- Lack of management of change. When the system was pressurised again, potential consequences of this was not handled correctly.
- Lack of planning of work. The component/system was not adequately verified for the operation.

- Review the WP-process with focus on follow-up in the field, routines when extending WP's and routines with filing of completed WP's.
- Conduct verification of work processes for work on pressurised systems, Work Permit (WP) and Safe Job Analysis (SJA)
- Review how changes are handled (management of change).
- Transfer of lessons learned for all shifts.
