Incident description: gas leak 2016

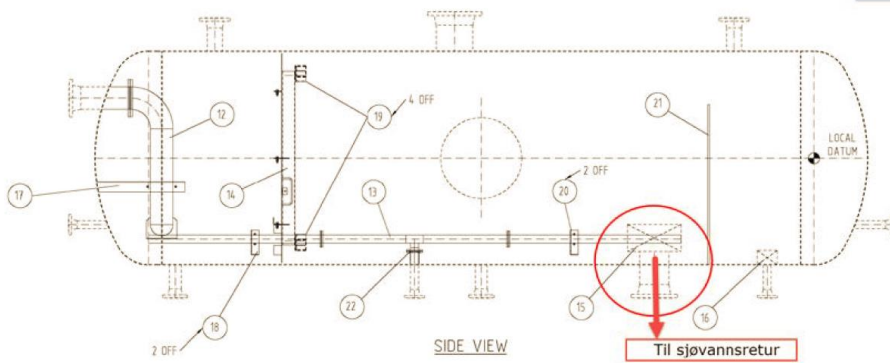
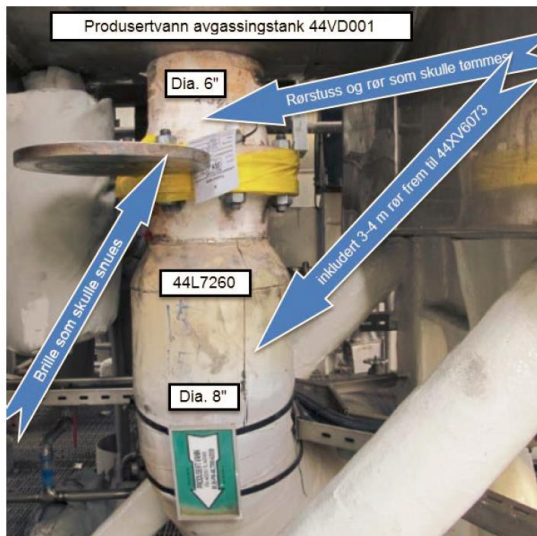
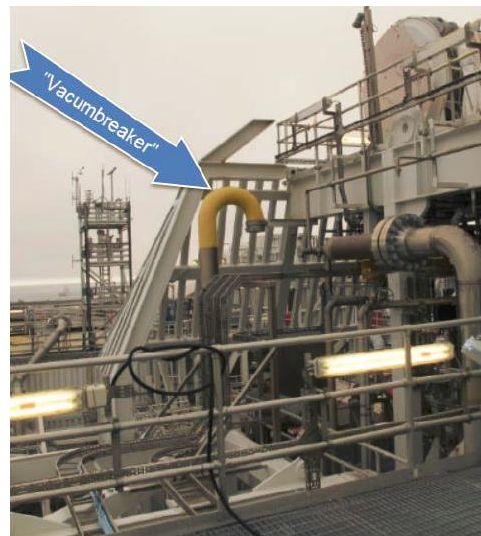
The initial leak rate is put at 0.5kg/s. The leak lasted for two minutes and totalled 60kg.

- The control valve stayed open for too long in relation to the fluid level and pressure in the tank.

- Insufficient ongoing risk assessment in relation to changes in the general procedure.
- Inadequate communication between personnel doing the work.
- No detailed procedure for the drainage job.
- Insufficient risk assessment in relation to draining the pipe spool to the seawater return line.
- Drainage of the pipe spool to the seawater return line was not in the detailed planning.
- Inadequate experience transfer/updating of governing documentation.

- Gas blowby is not an appropriate method for draining liquid to the seawater return line.
- Assess the location of the vacuum breaker, since HC gas can escape from it in certain conditions.
- Ensure experience transfer to other units.
