### Incident description: gas leak 2015

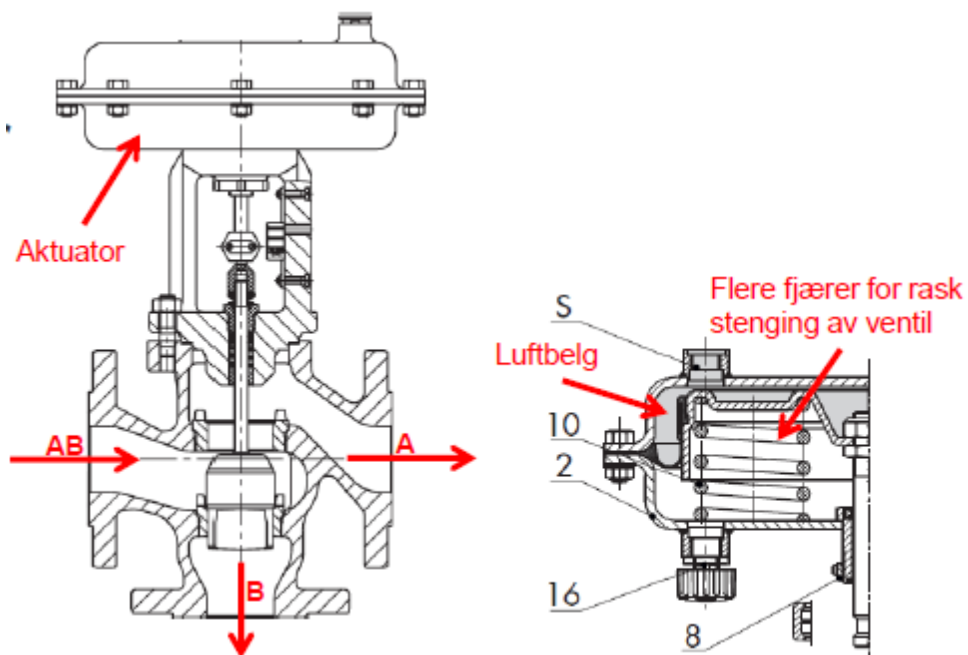
Valve 2 is a three-way valve with three functions:

- AB fuel gas in
- A fuel gas to main generator A
- B fuel gas to vent/safe location.

In the actuator, compressed air is led over an air bellows and depresses the spring. The stem will then push the valve plug down and close against vent (B). The valve is spring-based to fail open to vent (B). The air bellows in the actuator sprang a leak because it had perished. This leak meant that the bellows function was lost and the springs overrode the counterpressure. The valve was therefore put in an intermediate position, which allowed fuel gas to flow to both valve (B) and turbine (A). That resulted in a hydrocarbon gas leak through an inadequately plugged vent. The leak rate is estimated at 2.3kg/s, with a total discharge of 6.9kg.

Figure 2: Three-way valve similar to valve 2 in figure 1, as well as a cross-section of the actuator.

- The tubing for air supply to the actuator is incorrectly dimensioned. It was too small, so that higher pressure was needed to open the three-way valve quickly enough.

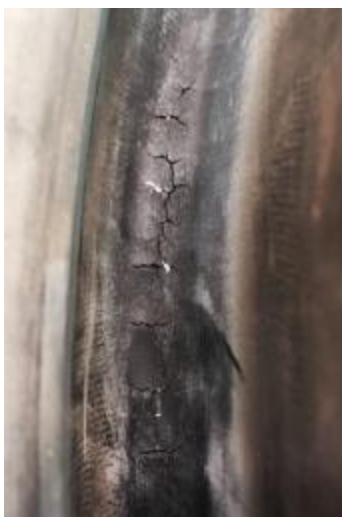
Figure 3: Perished and cracked air bellows.

- The air bellows was perished with clearly visible cracks. This meant the actuator lacked the power to open the three-way valve, which remained in an intermediate position and released gas to both turbine and vent.

- The criticality of three-way valves should be assessed and a preventive maintenance programme introduced. Should criticality be changed, a spare part assessment ought to be made.

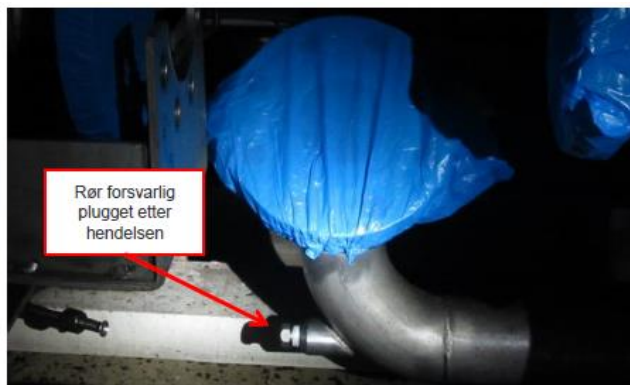
Figure 4: Gas leak turbine hood (skirt).

- Hydrocarbon leak as the result of leaking air bellows in the actuator.

- Inadequate plugging of tubing from packing boxes to vents (which were no longer in use).

- Assess the point for releasing gas to the safe location in relation to the gas quantity in the event of valve failure, and where the gas is vented to.
