TotalEnergies

USE OF SLOT-JET-ISOLATE FOR CASING RECOVERY APPLICATION

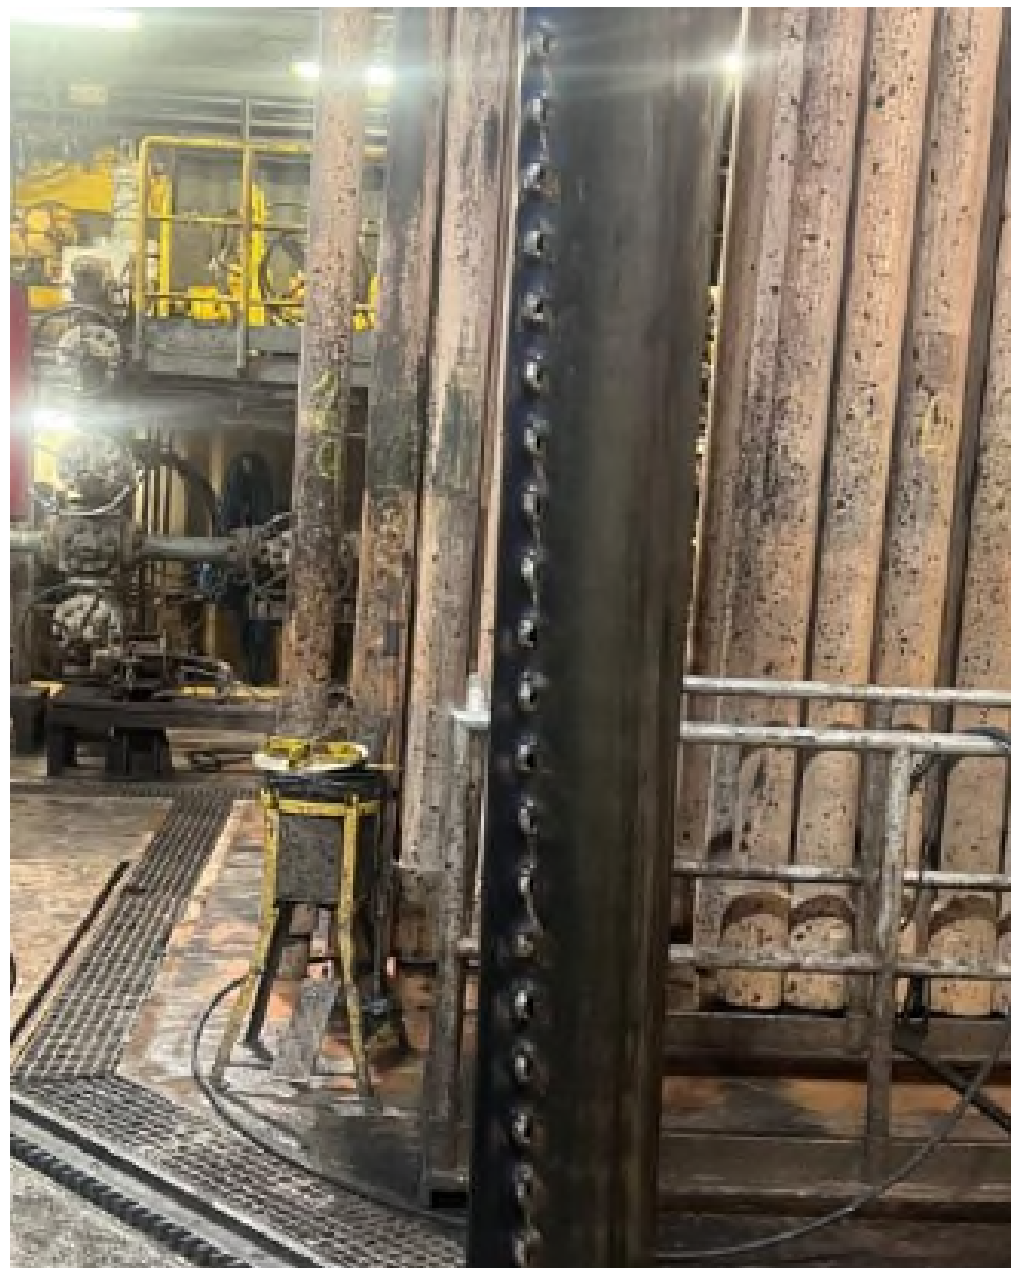
L7-H2 OVERVIEW

- Well was located on L7-H satellite platform, Dutch sector SNS
- Drilled in 1989
- Gas producer
- Well configuration:
 - J-shape well with max 30° inclination
 - Heavy-Architecture, with 2" and 7" casing
 - Completed with 4 1/2" tubing and perforated 4 1/2" liner
 - 2-7/8" coiled tubing velocity string (CTVS) installed in 2011
- Abandoned in Dec'22 – Feb'23

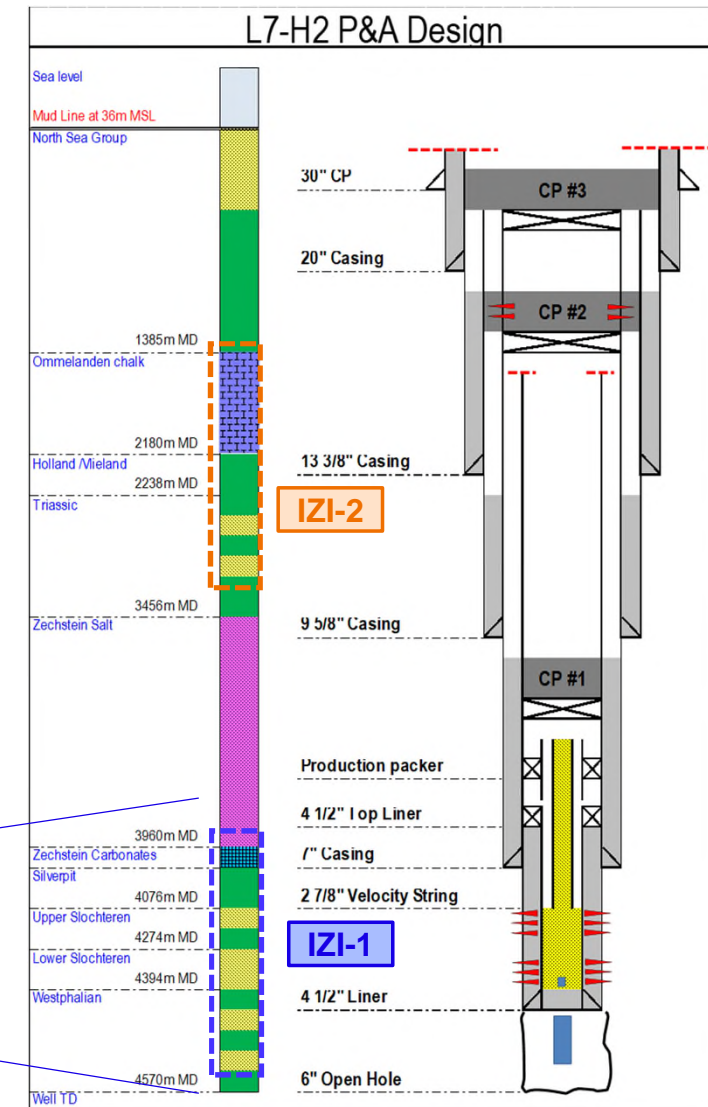
7" CASING CUT & PULL

- Reservoir was successfully abandoned after CTVS recovery
- Next step: intermediate water bearing flow zone abandonment (Ommelanden chalk):
 - Cut 7" casing at the top of Ommelanden. Pull to surface
 - Set abandonment cement plug by PWC

- Cut 7" casing at 1407m. Positive indications of cut.
- Attempt to displace 7" x 9-5/8" annulus w/ 130 bar – negative
- Attempt to pull 7" casing – negative with 180T HL (100T overpull)

- Conventional cut & pull in short sections
- Thor system from Archer
- Downhole jack
- Section milling / swarfless section milling
- **Slot-Jet-Isolate**. Selected based on:
 - Flexibility of the proposed solution
 - Availability (mobilized on short notice)

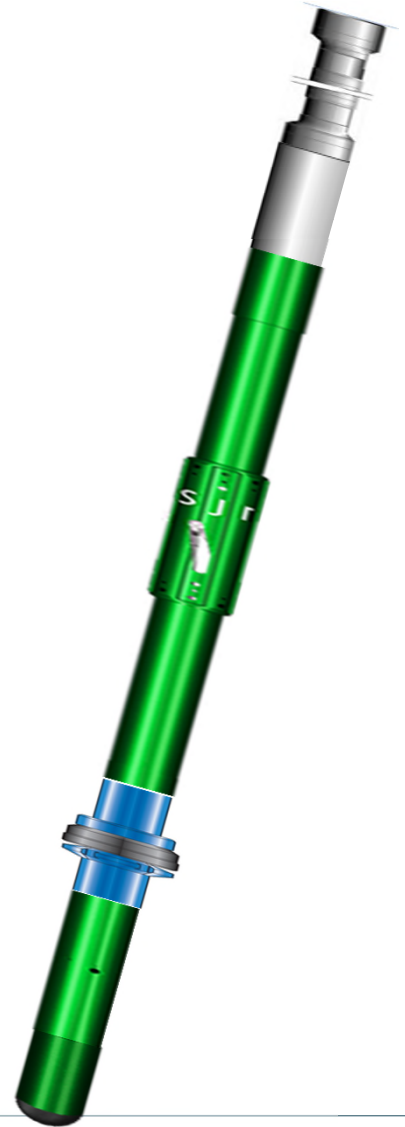
7" CASING SLOT-JET-ISOLATE

- Mobilize 2 x 5-7/8" SJ-I tools to the rig
- Mobilize 4-3/4" DC
- Perform CAST-CBL log to identify the intervals of settled solids
 - Interval of interest was in concentric casings configuration
 - Conclusive outcome of the log

Overall Interval (30 – 1387.5mMD)

- Increase in annular solids with depth is generally observed.
- Minor mud solids observed above 223m
- Fair amount of solids observed between 223m - 960m, particularly on the low side.
- Increased azimuthal presence of solids is seen below 960m and more uniformly prominent below 1063.
- Good agreement seen between ACE bond index and 3ft pipe amplitude trend, showing general increase in mud solids with depth.

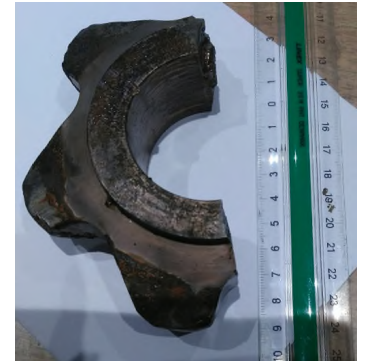
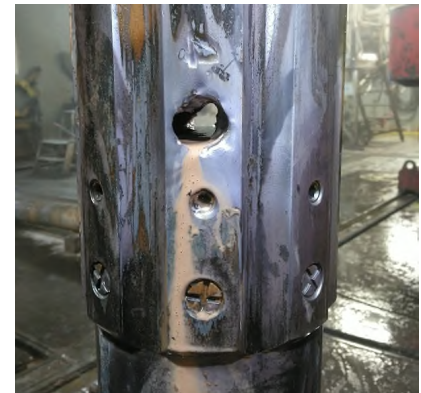
7" CASING SLOT-JET-ISOLATE

- P/U primary tool. Convert the tool for upward slotting
- Run to 900m. Slot 7" casing from 902m to 1170m (30-45 T overpull). **3,055 slots made (270m)** in a single row. **Lost overpull & slotting action.** Non-slotted interval: 1170 – 1255m (85m).

- Convert tool into washing mode (**3 attempts required**). Wash slotted intervals of 7" casing (circulation through the nozzles both above and below pack-off cup). **Sticky barite returns at shakers.**

- Position 7" pack-off cap in the unslotted section and wash the annulus behind the casing. Interpretation is complicated by part of the flow going above the cup, however, good indications of washing the annulus (barite returns, steady decrease in SPP).

- Repeat washing passes, circulate out Hi-Vis, POOH.
- At surface: slotting blade broken in 2 pieces (retained in the tool and recovered to surface), upper nozzle washed out, cup damaged, lower nozzles below the cup are OK.

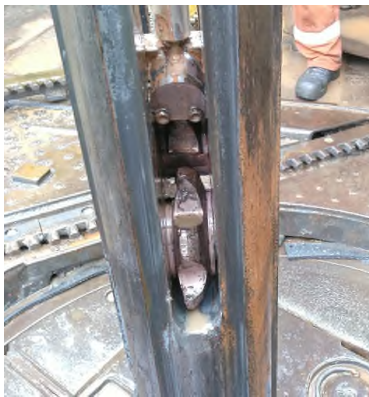
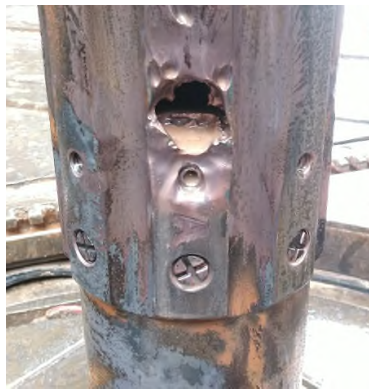
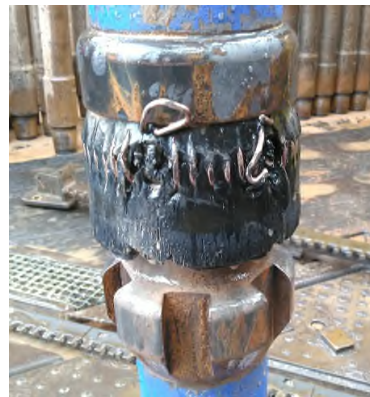
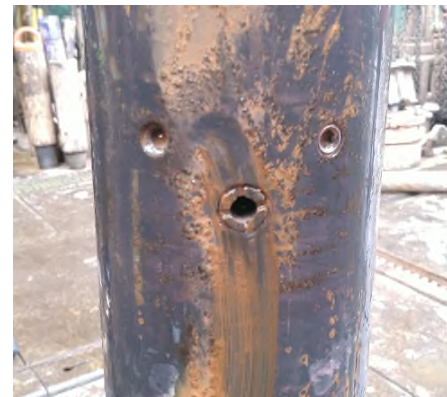
7" CASING SLOT-JET-ISOLATE

- Engage spear into 7-5/8" casing stump. **Pull casing free with 83 T overpull.**
- Pull and L/D casing.
- On 7 joints found slots in the elevator area and in the coupling, use torch and hammer to close the slots and smoothen the area
- Observed spiraling of the slotted line

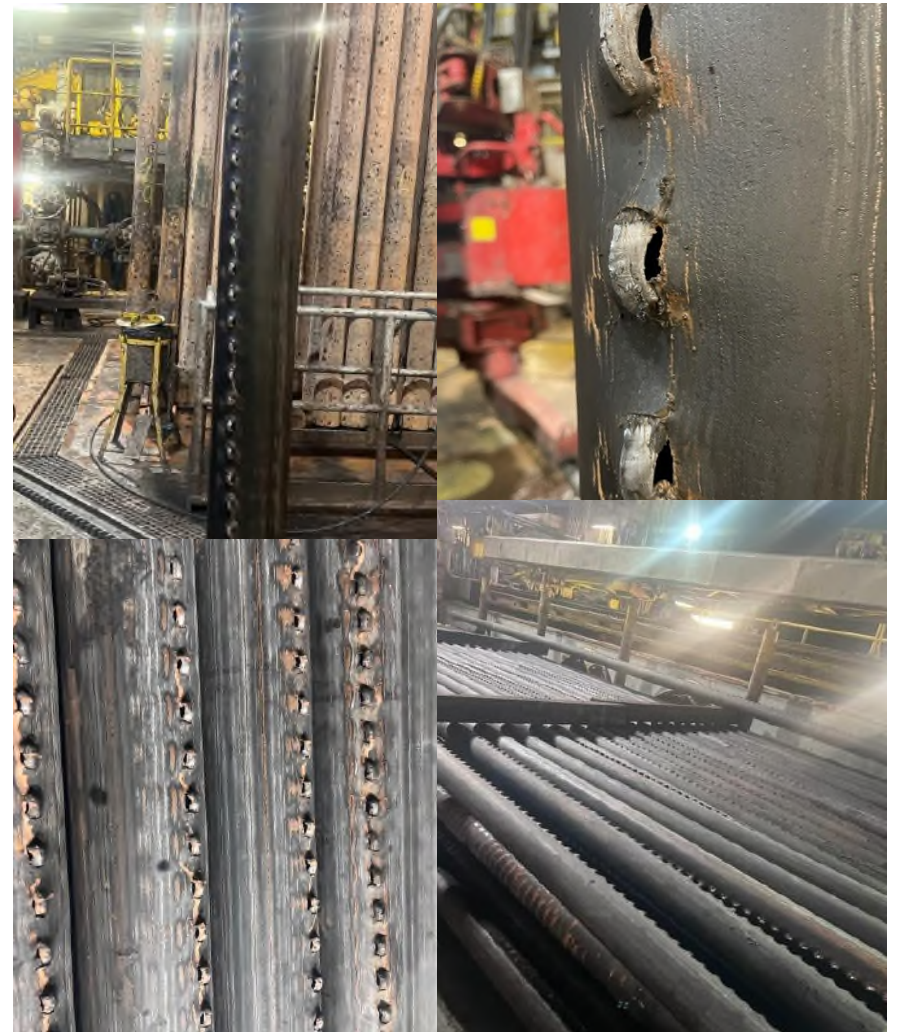
7" CASING SLOT-JET-ISOLATE

- Solution worked well to recover the casing stuck in settled barite
- Helped to avoid section milling, cut & pull in short sections, etc.
- Equipment is systematically mobilized to be available on stand-by during P&A in similar well configurations (planned cut & pull with heavy mud in the annulus)

- Nozzles layout, hard facing around the nozzles
- Multiactivation circ sub; design modification for the flow to be fully diverted below the cup in upwards slotting tool configuration
- Blade strengthening (broken pieces sent for metallurgical testing and evaluation)
