# Light Well Intervention Vessel Operations for Phase 1 Subsea Well Abandonment

MacCulloch Field Abandonment

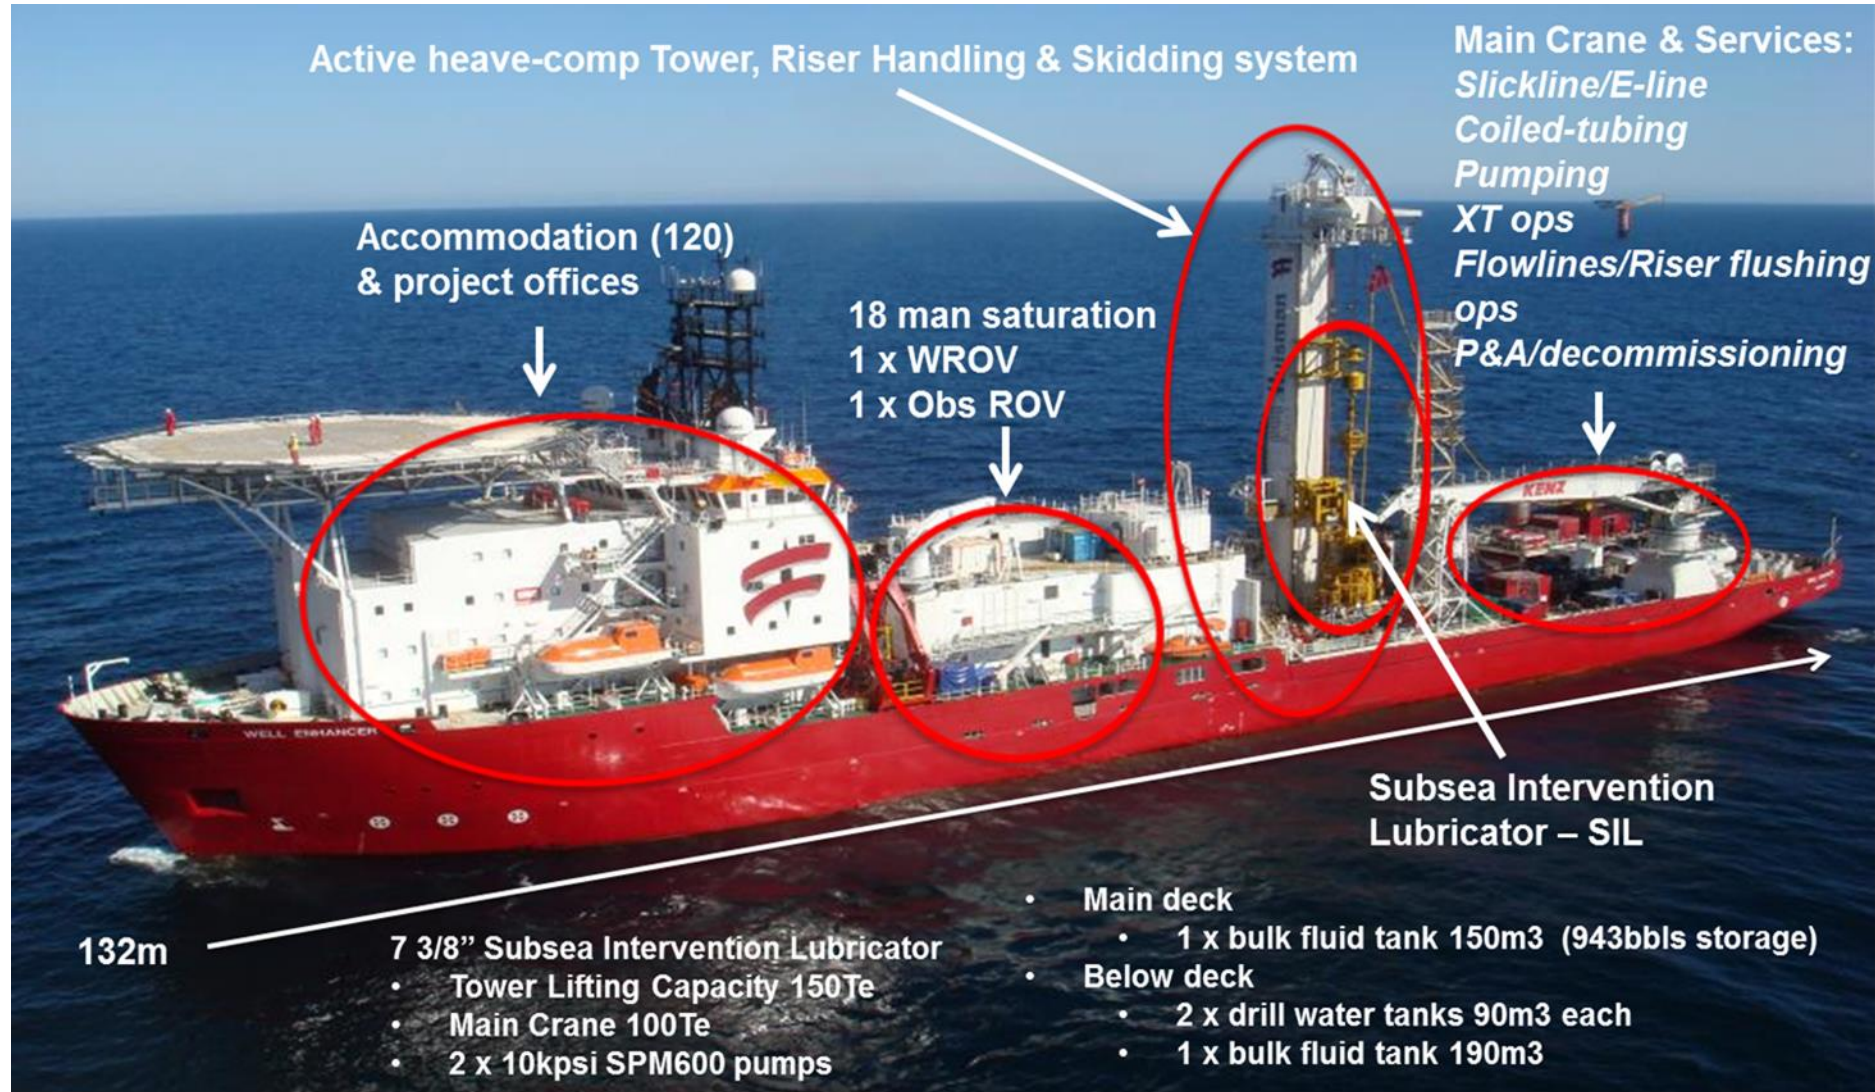
# Helix Well Enhancer

1	Transit to Field, DP trials & enter the 500m zone
2	Recover debris cap, pressure wash tree and establish guidewires
3	Deploy tree cap running tool (TCRT), lock and overpull
4	Divers pressure test barriers for tree cap recovery
5	Unlock and recover tree cap to vessel
6	Deploy Subsea Intervention Lubricator (SIL), lock and test interfaces
7	Rig up Digital Slickline (DSL)
8	Run a drift to the completion tailpipe
9	Punch tubing just above production packer
10	Rig down DSL & deploy 2" subsea hose to SIL
11	Bullhead the tubing and annulus contents to reservoir
12	Recover 2" subsea hose & rig up DSL
13	Set a deep plug in tubing tailpipe, top up well and pressure test plug and production packer (primary suspension barriers)
14	Cut tubing above production packer
15	Set a hold-open sleeve across the DHSV
16	Set a shallow plug c/w wireless acoustic gauges in the completion tubing below the tubing hanger. Pressure test the plug (secondary suspension barrier)

17	Recover SIL, reconfigure for annulus operations, deploy SIL and test interfaces
18	Set a plug in the tubing hanger annulus profile and pressure test (secondary suspension barrier)
19	Recover SIL and install debris cover

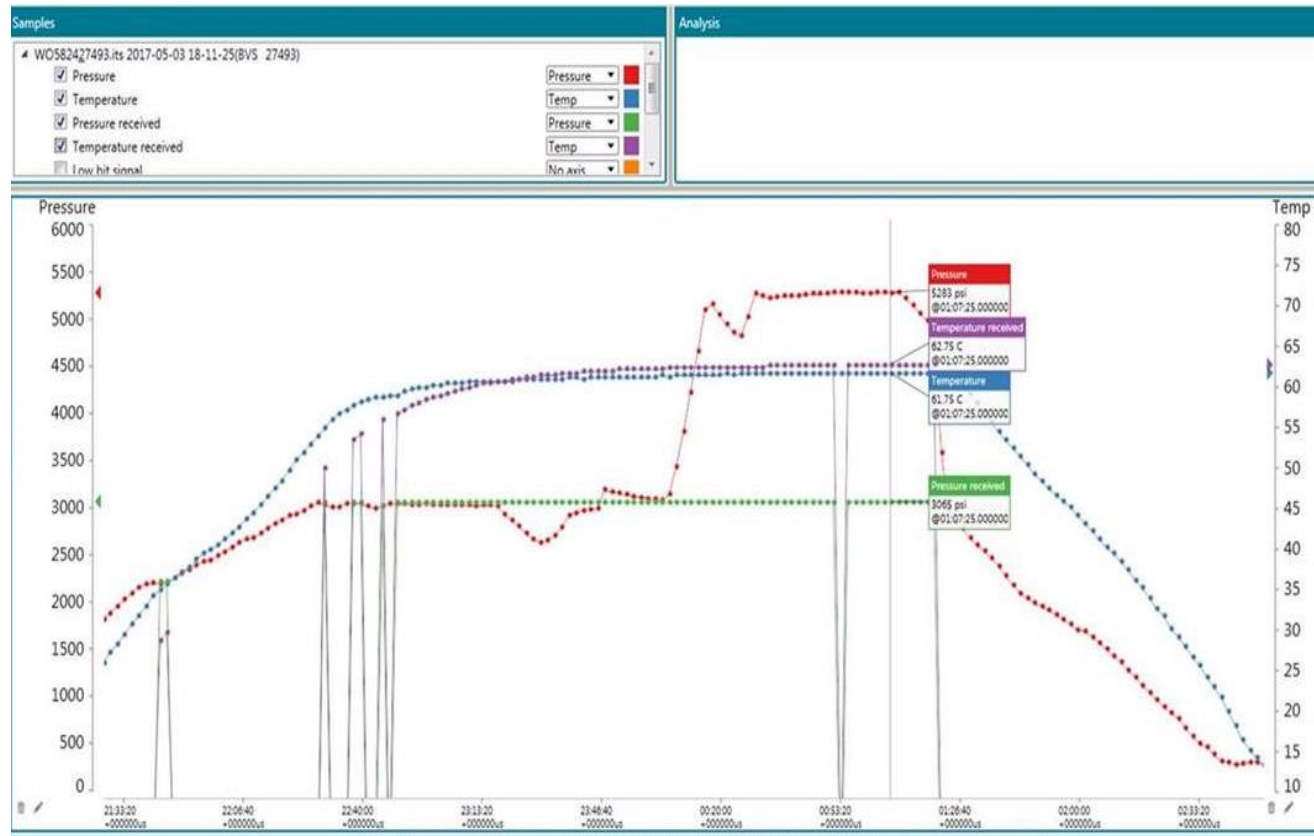
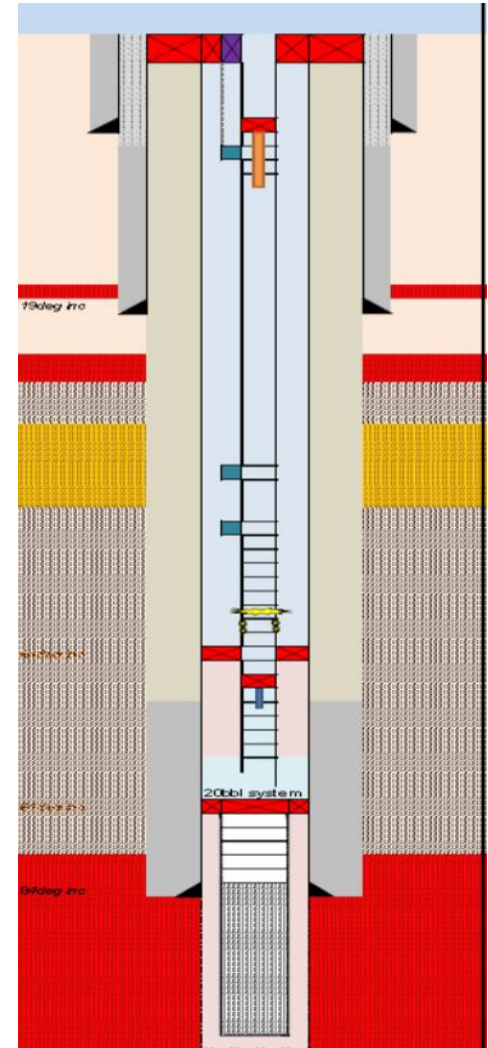
# New Technologies/Approaches

- Interwell Barrier Verification System (BVS)
  - Failed first run
  - Proved deep plug when working

- Don't have to use OEM for intervention equipment preparation
- The vessel is efficient, but has one speed
- Divers were indispensable
  - Barrier testing offline – only tested 2 wells on critical path
  - Reconfiguring subsea control systems
  - Tree coupler shroud removals post tree cap recovery– most wells
  - Tree cleaning
- Digital slickline
- Plan for success on bullheading – unlikely to block 3,000ft screens
- Metrol gauges very effective for monitoring and diagnostics
- Consider alternatives to OEM nipple plugs
- Listen to the Cerberus modelling
- The Interwell BVS is an excellent tool

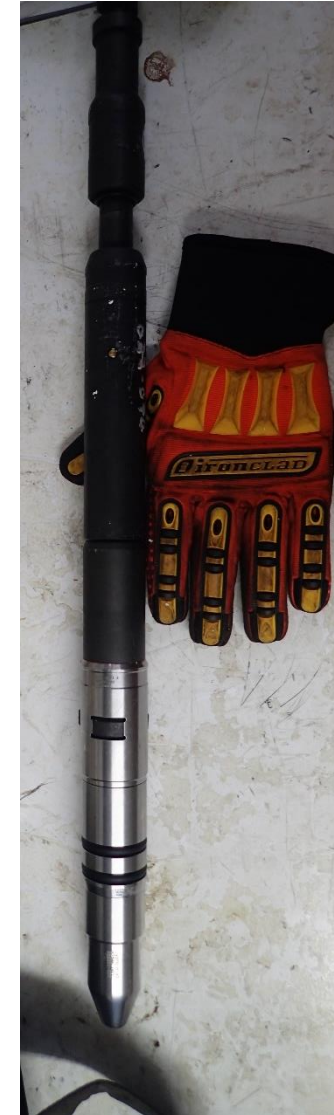
- Oilenco Hybrid Annulus Plugs
  - One run plug with integral prong
  - Worked perfectly 9 times
  - Geometry makes it easier to run
  - A third of the cost of OEM plug & prong, 3-5 weeks lead

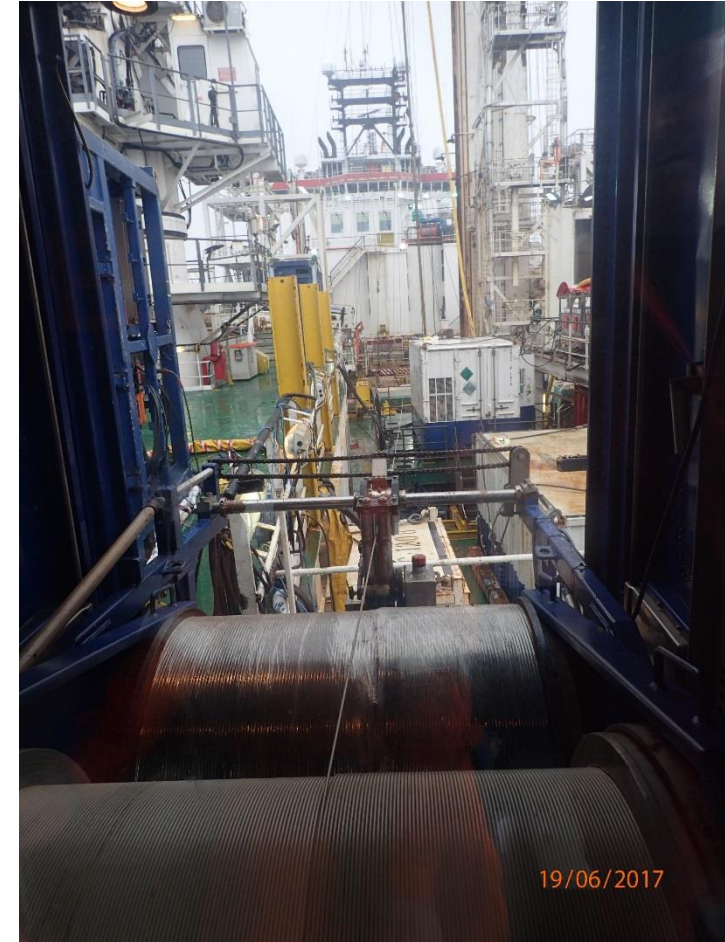
- Digital Slickline – pro's
  - Ability to send signals to setting tools/firing cutters etc
  - Immediately recovered from stuck toolstring via disconnect
  - Same strength as normal Slickline
  - CCL data leads to more accurate setting etc
- Con's
  - Unable to transmit logging data
  - Signal dependent on earth on the tubing – some issues with weak signal in places

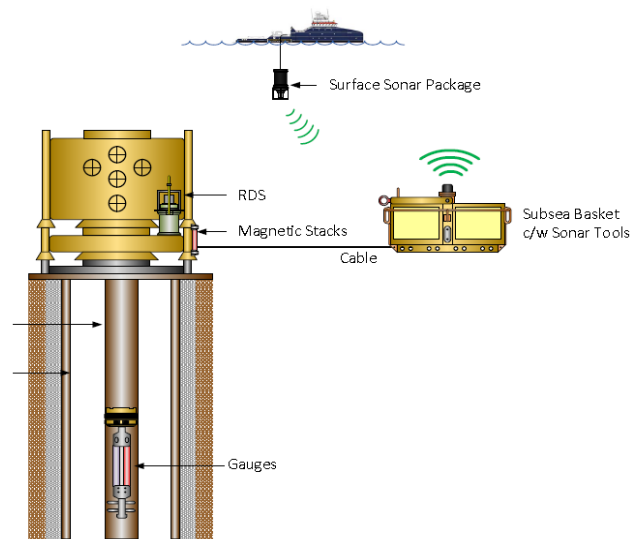
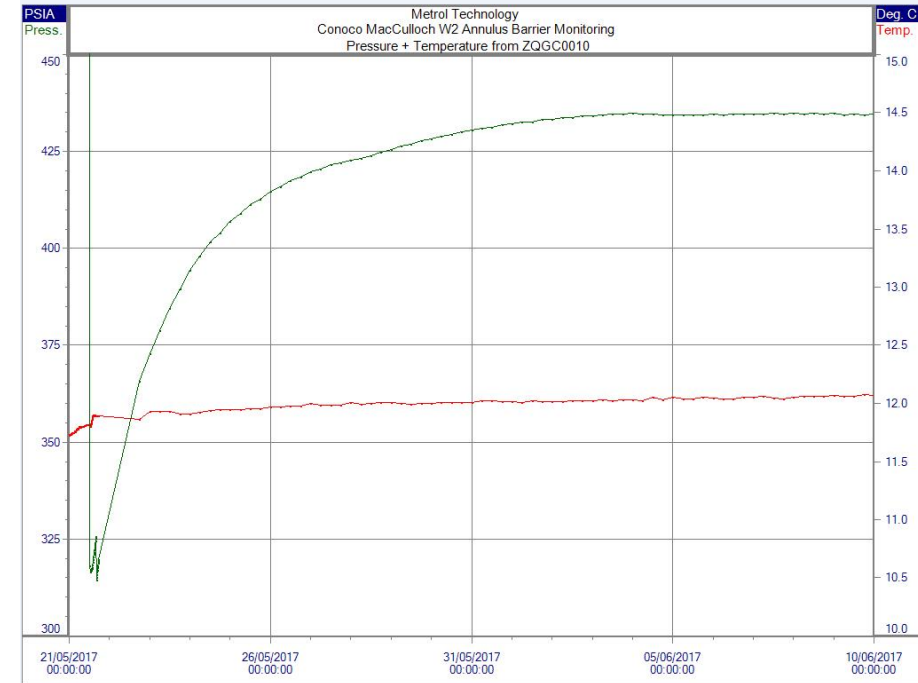
- Metrol Acoustic Wireless Gauges
  - Set 22 gauges – all working
  - 1 failure identified as tool was picked up

Well	E1	W2	W3	W4	W6	W7	W8	W9	W10	W11	W12
SITHP on arrival (psi)	1026	1763	1070	1791	2073	1400	1500	2190	1580	1070	850
Gauge installed?	Yes	Yes	Yes	Yes	Yes	Yes	Yes	Yes	Yes	Yes	Yes
Most recent pressure (psi)	297	438	390	742	390	309	478	295	528	433	370
