### Incident description: Gas leak 2016

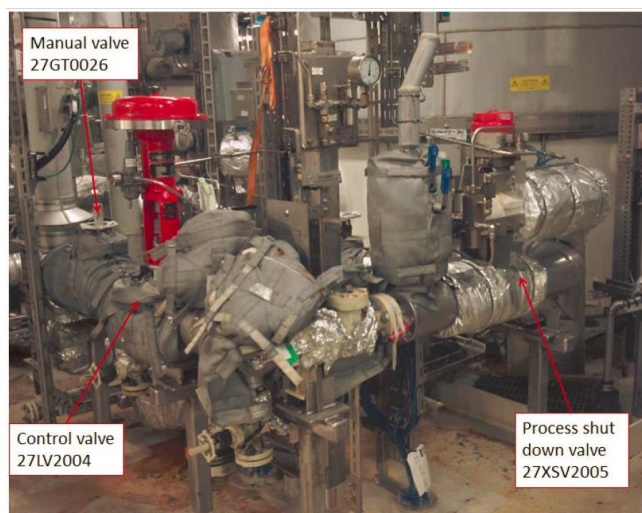
Figure 2 Layout

The leak came from a level control valve (LV) where the cage was taken out for cleaning. This valve controls the liquid out of the 1st stage suction scrubber on a high pressure compressor. The upstream process shutdown valve (XSV) was being used as a barrier against the pressure from the scrubber. However, the air supply to the actuator on the XSV was not blocked. With the air supply not being de-energized, the valve acted on signals from SAS/CCR. The XSV was programmed to open at 50% level in the scrubber, resulting in a gas/condensate/water leak from the level control valve.

When the XSV opened, process fluids (gas, condensate and water) were released through the top of the LV. The leak was calculated to 330 kg in total with an initial leak rate of 8.7 kg/s. It lasted for 38 seconds.

- The air supply on the actuator on the XSV was not blocked.

- It is recommended to implement work instructions for typical/routine operations on all systems.
- Revise procedure: need to specify that for valves to be isolated – the actuator supply; hydraulic, pneumatic and electric shall be isolated in order to approve the valve as a barrier.
- Make a list of typical valves how to de-energize and prevent unwanted action.
- It is recommended to do the following immediate implementation of a checklist for hazardous systems based on the figure on the next page.
