Investigation report

Report	
Report title Investigation report after the fire on Statfjord A of 16 October 2016	Activity number 001037031

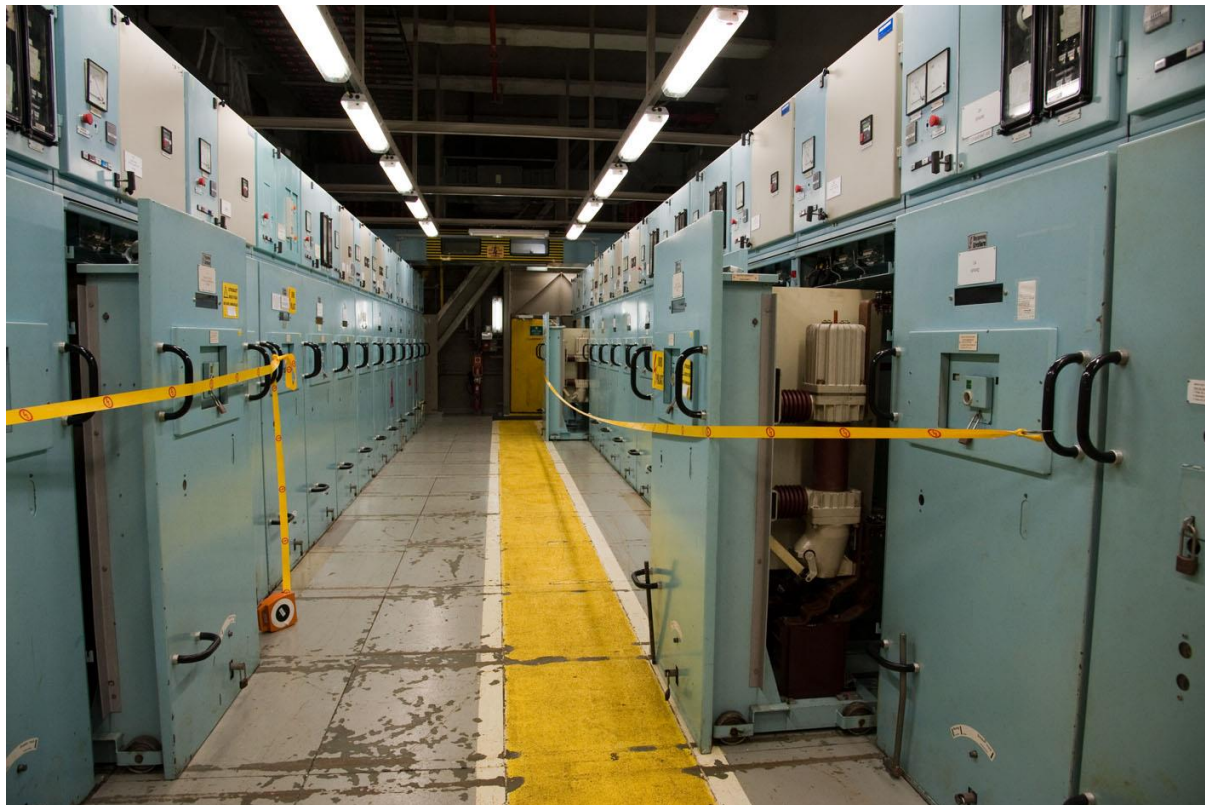
Investigation of the circuit breaker for loading pump D revealed a fracture in the shaft which operates connection/disconnection of the three current phases to the pump. Phase L1 was found to be correctly disconnected, phase L2 was in an intermediate position so that an electric arc occurred in the circuit-breaker cabinet, and phase L3 was still connected.

Photograph 1 - Circuit breakers in switchboard room KC0001.
