Investigation report

Report title Investigation report following a condensate leak on GjØa	Activity number 027153036
--	------------------------------

A condensate leak occurred in the GjØa process module at 20.01 on 21 June 2017. This incident led to gas detection, a general alarm, automatic shutdown of the process plant, pressure blowdown and mustering in accordance with the alarm instructions.

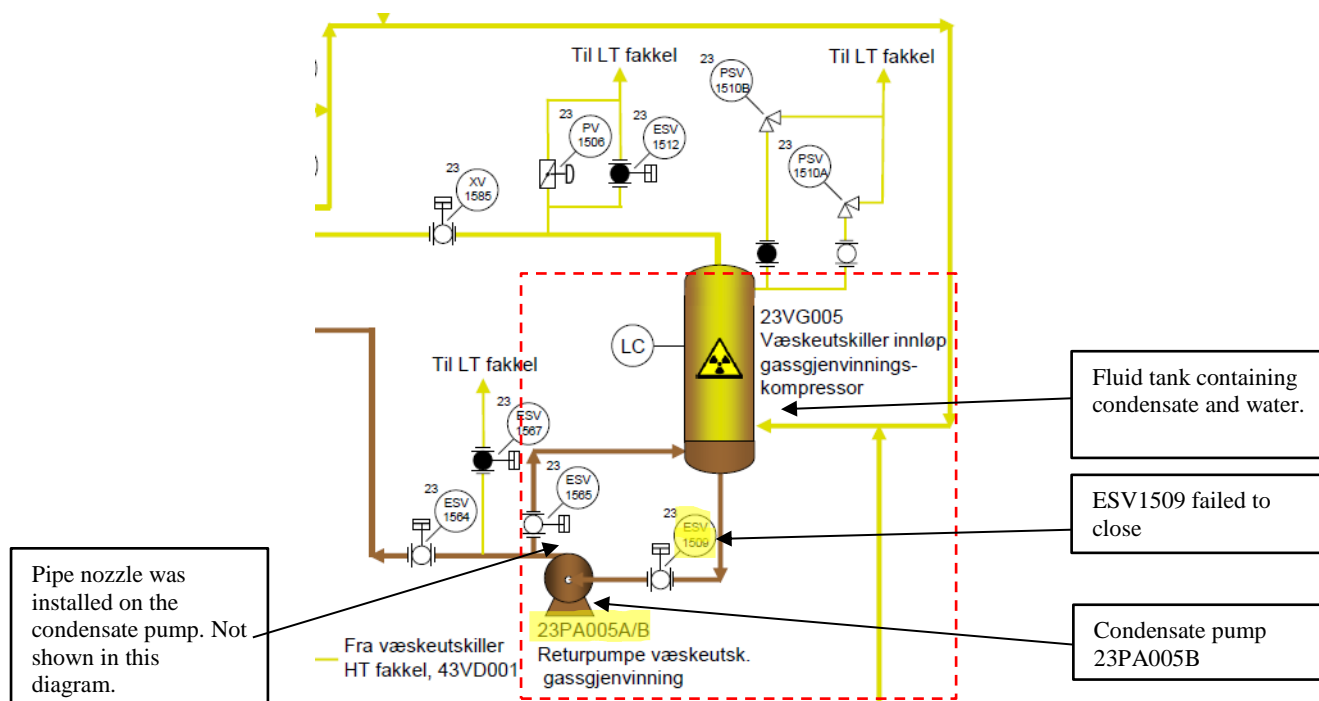
Figure 8 - Extract from the Gjøa main process, system 23 gas recompression.
The diagram belongs to Engie E&P

The leak occurred as the result of a fracture in a pipe connected to system 23 for gas recompression. This pipe nozzle was installed on a condensate pump located downstream from a scrubber tank in order to pump condensate into the second-stage separator while simultaneously recirculating condensate from the scrubber tank. Connected to the gas recompression system, the equipment is intended to collect gas from the various stages in the separation process, cool it down and separate out the fluid. The gas is recompressed, while the fluid – or condensate – is removed in the scrubber and returned to the separators. The relevant scrubber tank also contained inlets from the system for both MEG and TEG regeneration. In addition, input came from units in the produced water system. As a result, the condensate contained a good deal of water.

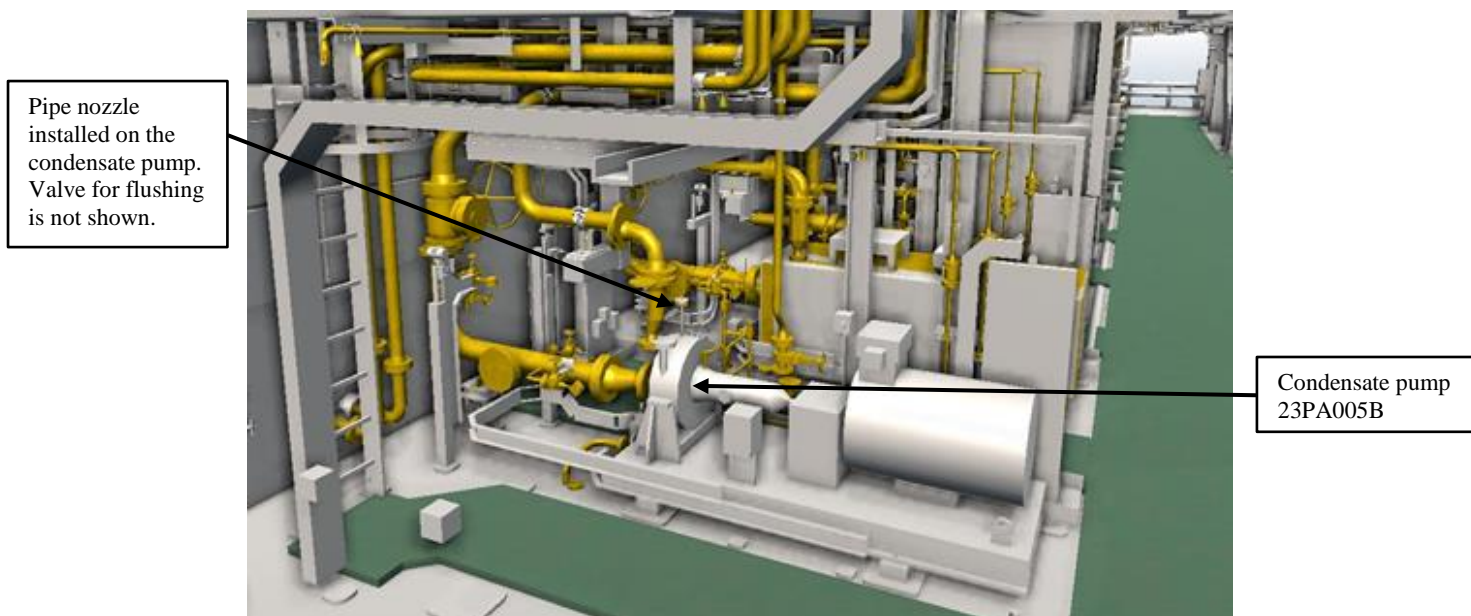
*Figure 9 - Process area and condensate pump in a 3D illustration.
The illustration belongs to Engie E&P.*

A pipe nozzle with a manual valve is installed on the condensate pump for maintenance flushing of the pump. The relevant nozzle with pipe, flanges and valve weighs altogether about 5.3kg. The length from pump housing to the valve centre is 18.5cm. No support is provided for this valve arrangement. The actual pipe is specified in the drawing with a 3/4-inch dimension, but a 1/2-inch dimension in duplex steel and schedule 160, which gives 4.78mm of nominal wall thickness, are found to have been used on both pumps. According to the DNV GL report (2) and X-ray images, the internal diameter of the pipe is virtually identical on both sides of the weld. The external diameter of the pipes varies somewhat because of differing material thickness in welded piping. Pipe nozzles and pipes welds do not have a full V joint or full penetration. That creates an internal crack point for possible fatigue.
