## **Offshore Platform Well Control Incident**

## **After Action Review Summary**

During pulling of old 9 5/8 x 10 3/4 " tie-back string from a oil producer with gas lift a well control incident occurred involving release of gas to rig floor and mustering of personnel.

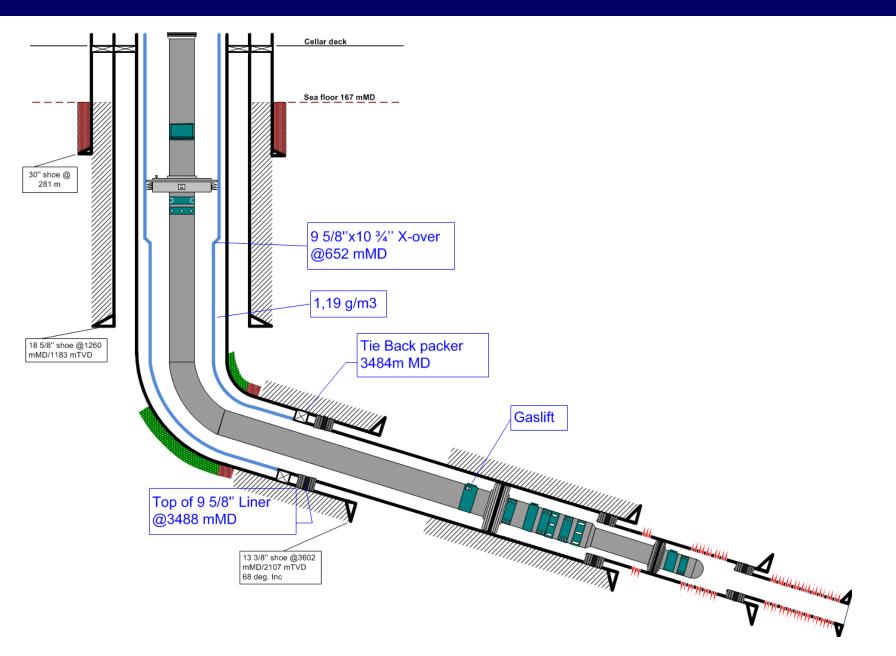
## Well in production

Hand over of well from operations to drilling:

Pressure on B-annulus approximately 40 bar.

Worked a few days to bleed off gas from B-annulus.

Filled up B-annulus with base oil.

Rigged up BOP.

Pulled completion and established cement barriers against reservoir.
