Norsk olje&gass

# "Sharing To Be Better"

Influx through failed cement in shoetrack during completion operations

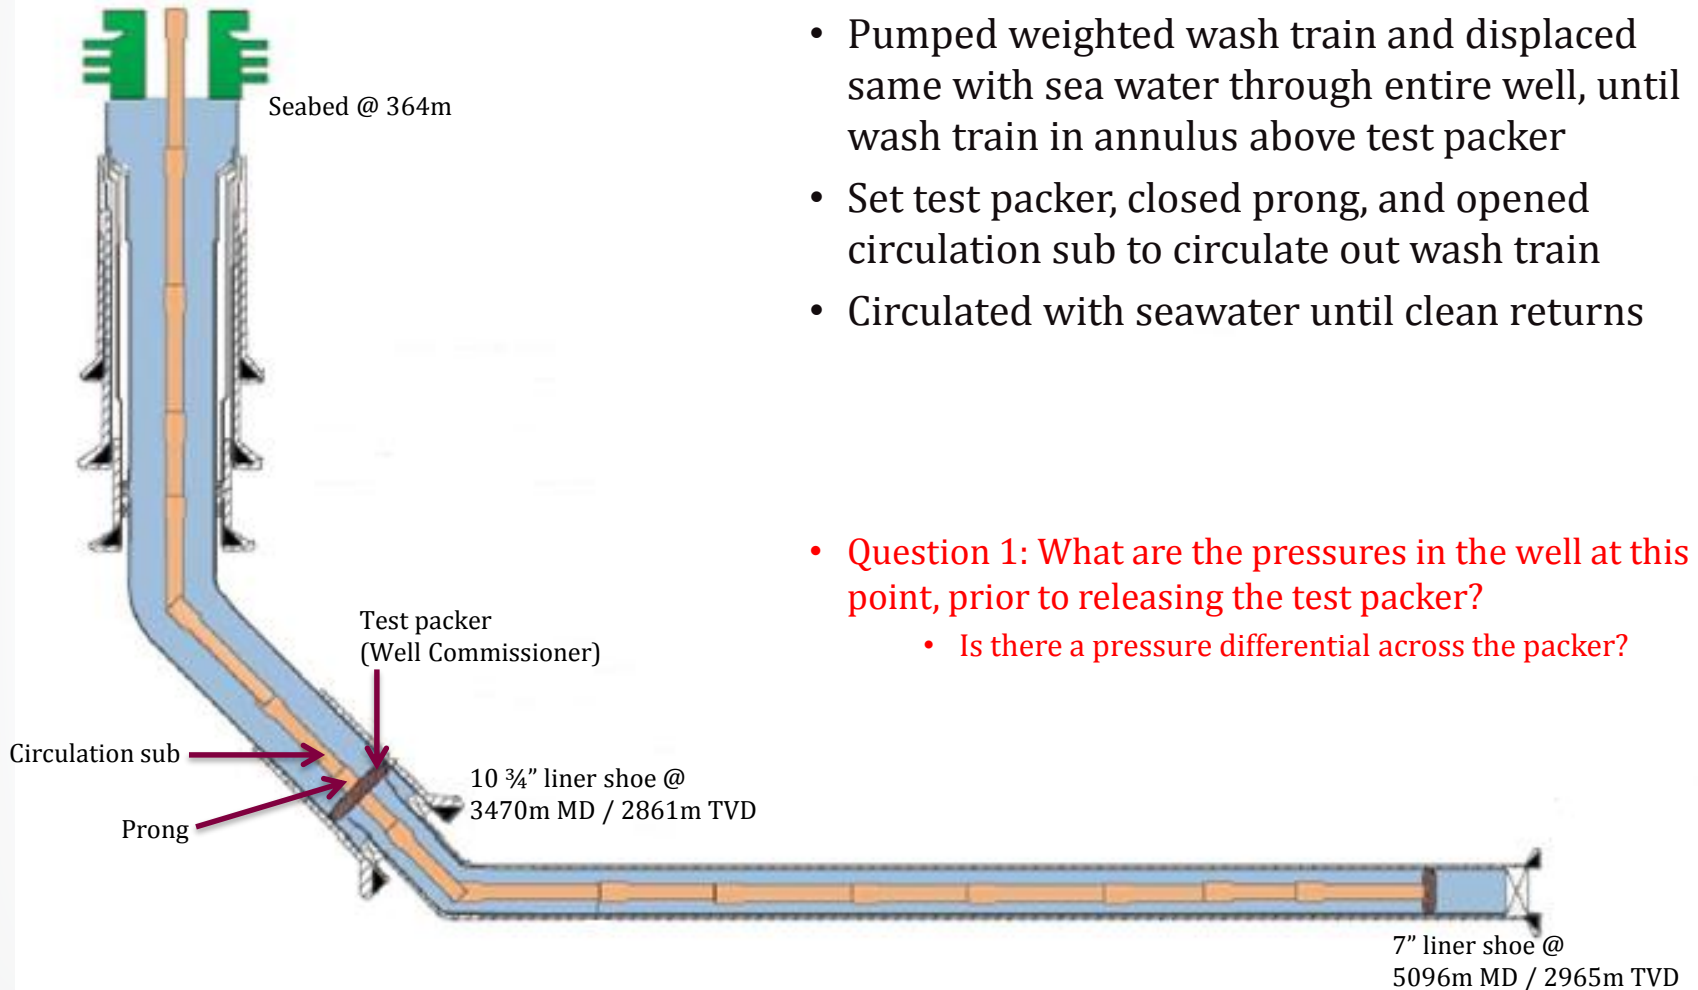
# Washing and displacement to sea water

- 7" liner cemented across reservoir
- Well filled with 1.54 SG OBM
- 7" liner inflow tested with base oil inside string
  - 147 bar u-tube pressure on string after pumping base oil. Set test packer.
  - Bled off to 10 bar on string side to give pressure decrease below test packer.
- Pumped up pressure back to 147 bar and released test packer with 20 ton overpull
- **Not known at this point: The base oil volume pumped was too low so the inflow test pressure was insufficient; seawater gradient would result in 30 bar lower pressure at 7" shoe**

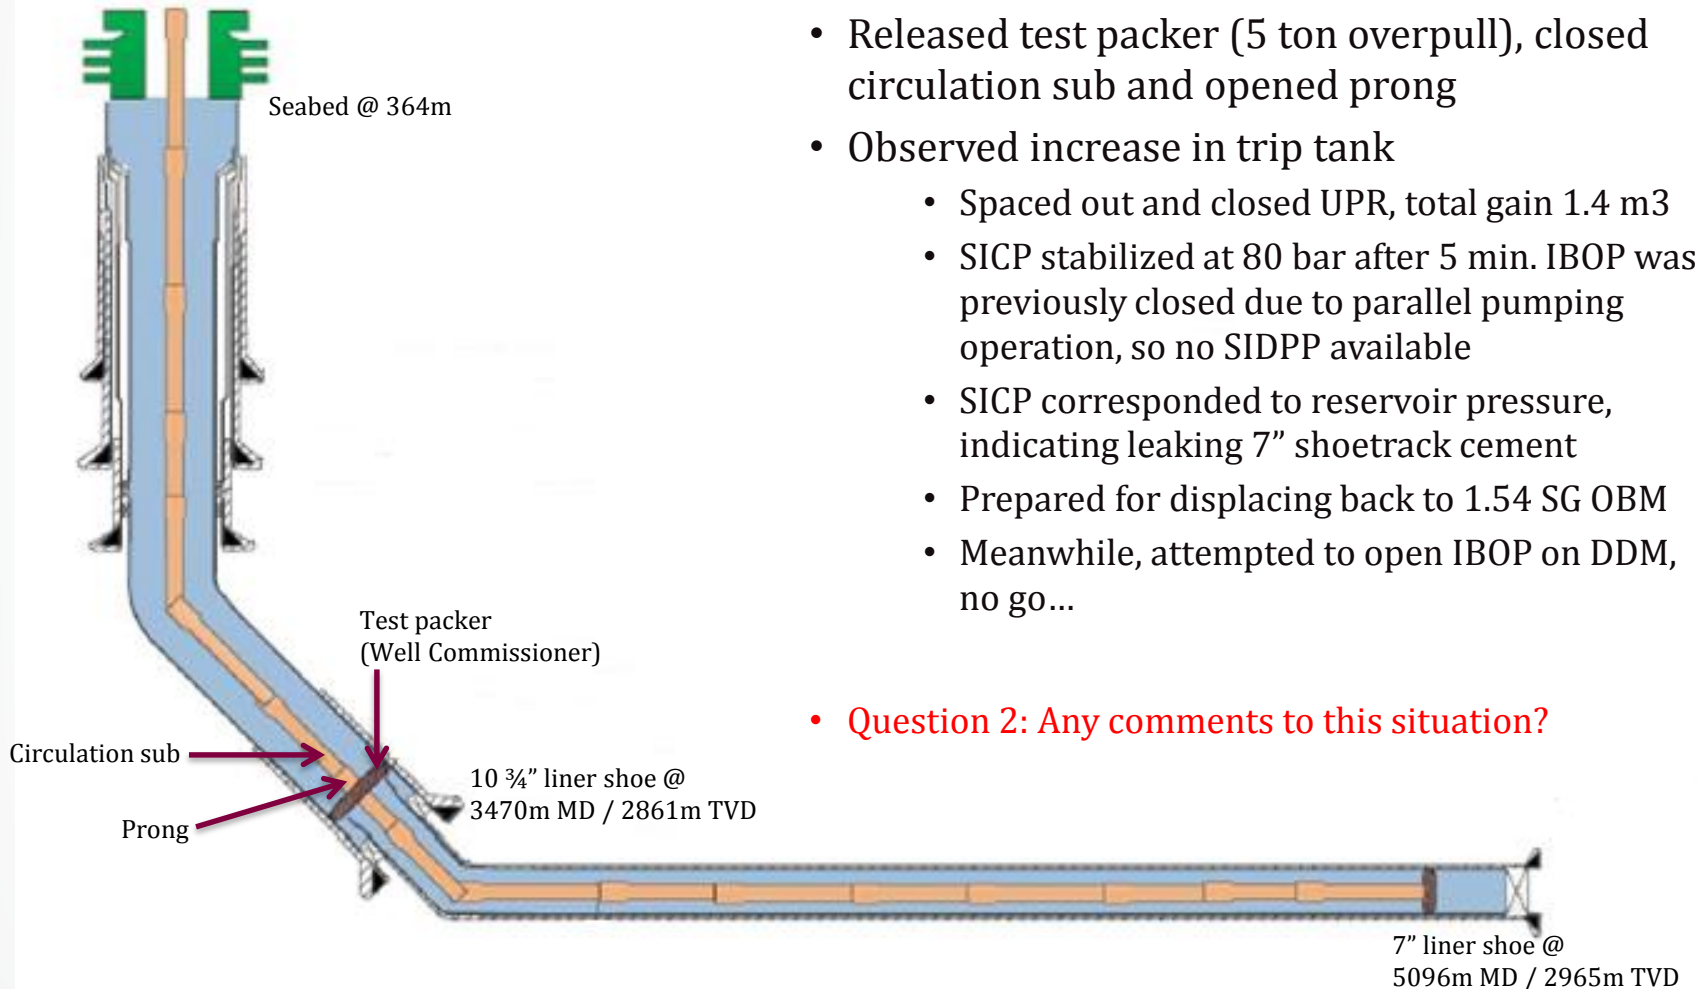
# Prepare for displacement to heavy brine

- Released test packer (5 ton overpull), closed circulation sub and opened prong
- Observed increase in trip tank
  - Spaced out and closed UPR, total gain 1.4 m<sup>3</sup>
  - SICP stabilized at 80 bar after 5 min. IBOP was previously closed due to parallel pumping operation, so no SIDPP available
  - SICP corresponded to reservoir pressure, indicating leaking 7" shoetrack cement
  - Prepared for displacing back to 1.54 SG OBM
  - Meanwhile, attempted to open IBOP on DDM, no go...
- **Question 2: Any comments to this situation?**

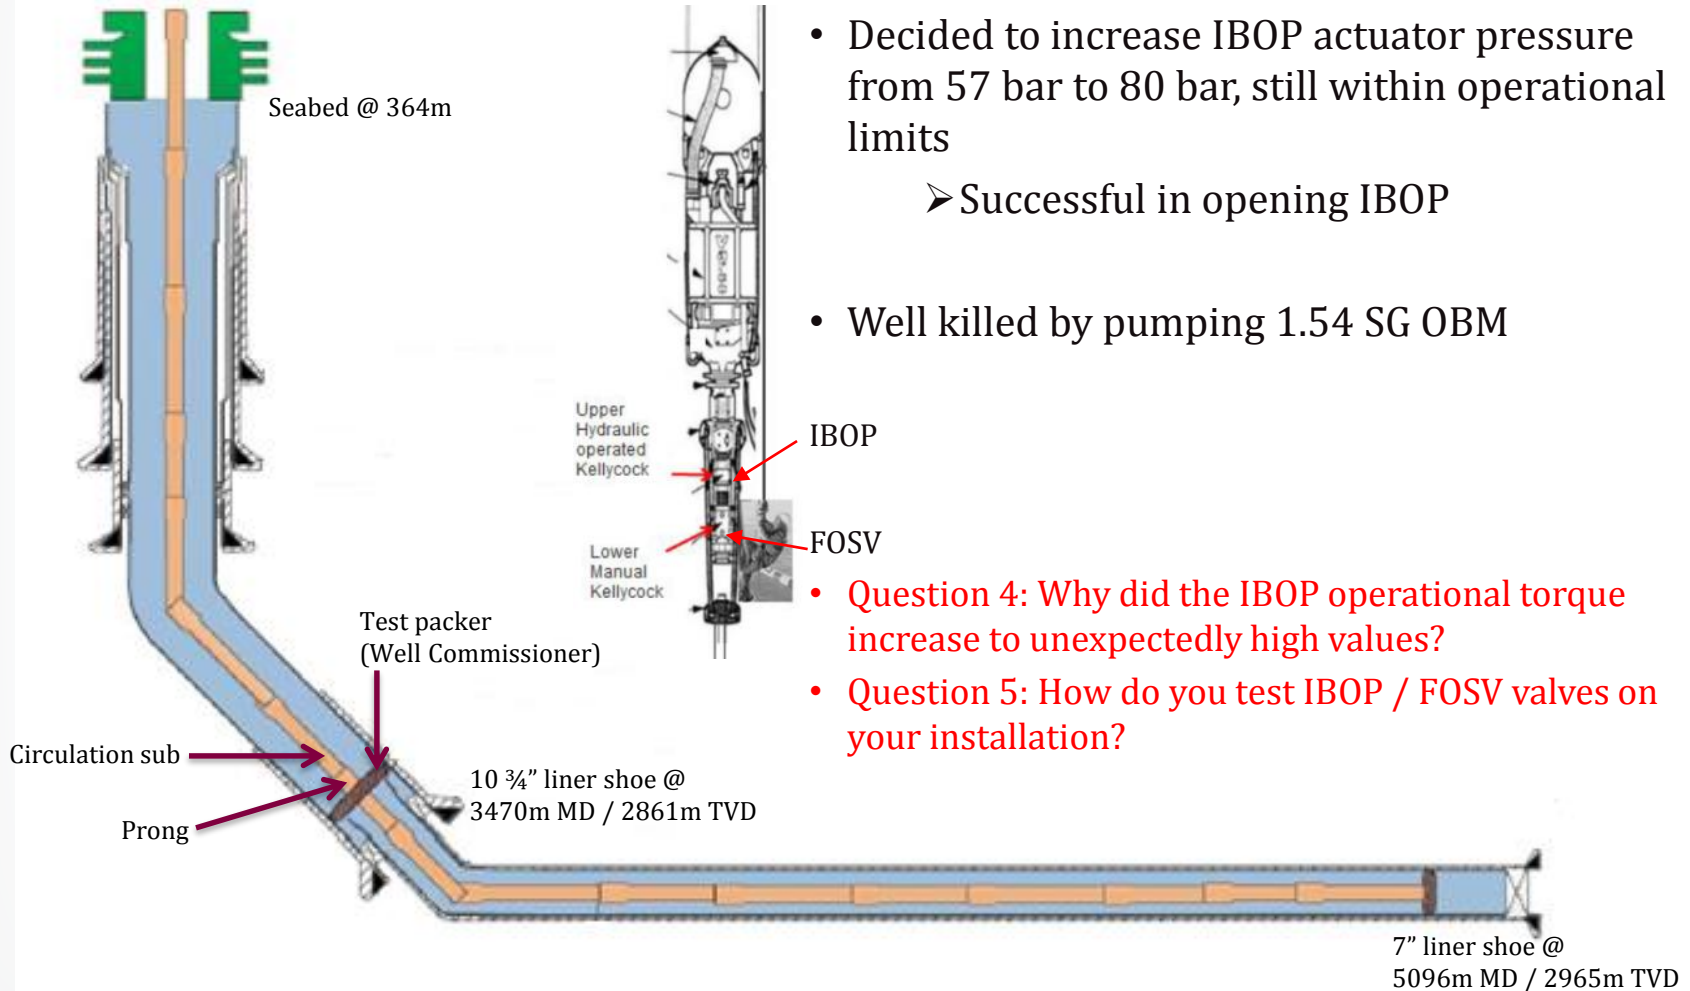
# Handling the situation

- Decided to increase IBOP actuator pressure from 57 bar to 80 bar, still within operational limits
  - Successful in opening IBOP
- Well killed by pumping 1.54 SG OBM
- Question 4: Why did the IBOP operational torque increase to unexpectedly high values?
- Question 5: How do you test IBOP / FOSV valves on your installation?

- Inflow test pressure was insufficient, due to insufficient detail in operational procedure
  - Include both volume and expected pressure in operational procedure
  - After inflow test, the well shall still be monitored
- No tracking system for valve maintenance
  - Notify contractors of expectation
- Valves had significant wear while still passing pressure tests
  - Suggest review of existing FOSV's and stab-in kelly-cocks
  - Recommend to use improved valve designs, available on the market
  - Establish routines for change-out based on operational history
- Weakness in valve design was not uncovered during routine testing without pressure on valve when operating it
  - Acquire vendor operational torque values to operate valve. To be available on drill floor.
  - Discuss with vendor about routinely test-operating the valve under pressure.
