Another dimension in downhole barrier assessment

Maxim Volkov – Principal Domain Champion, TGT Oilfield services

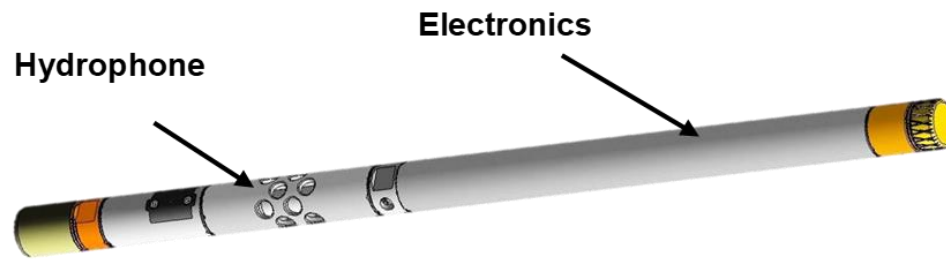
Passive hydrophone

Frequency range	8-60 000 Hz
Dynamic range	100 dB
Tool OD	38/42mm
Length	80cm
Thresholds (SAP)	0.5 Bar/day
Thresholds (ml/min)	9.7 / 22

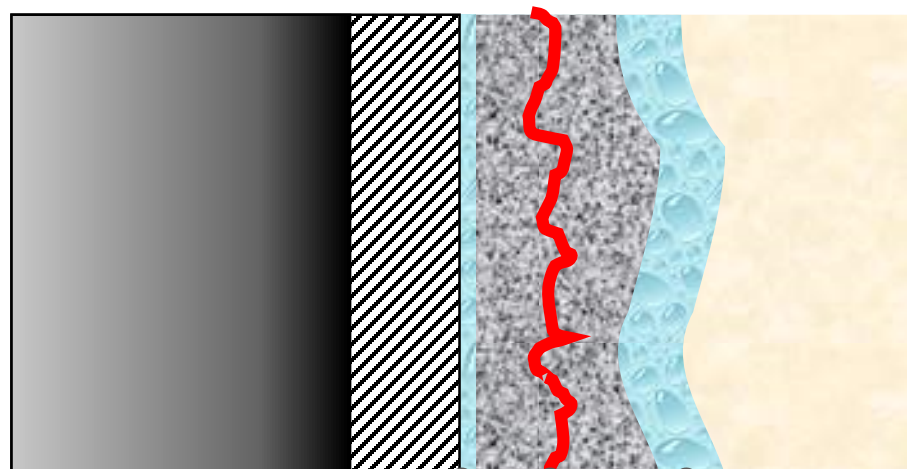
CSG-CMNT microannulus

CMNT
Channel

CMNT-FORMATION microannulus

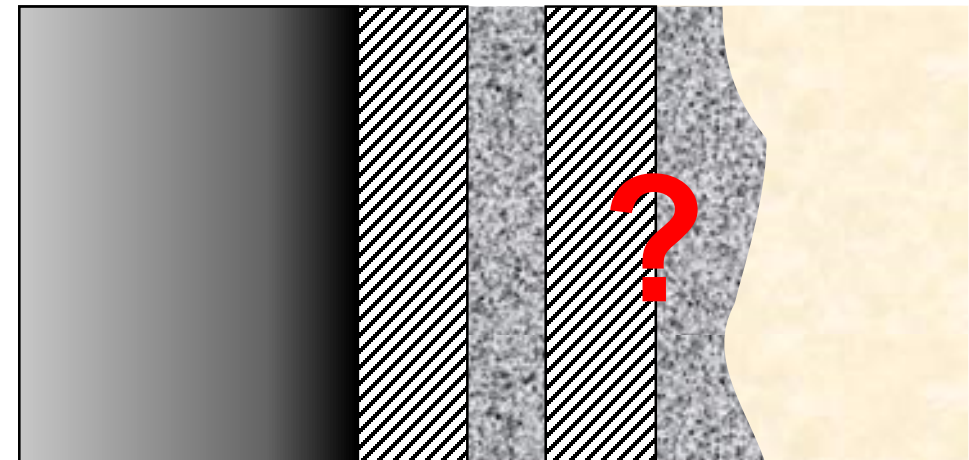
CSG2-CMNT2

CMNT2-FORMATION

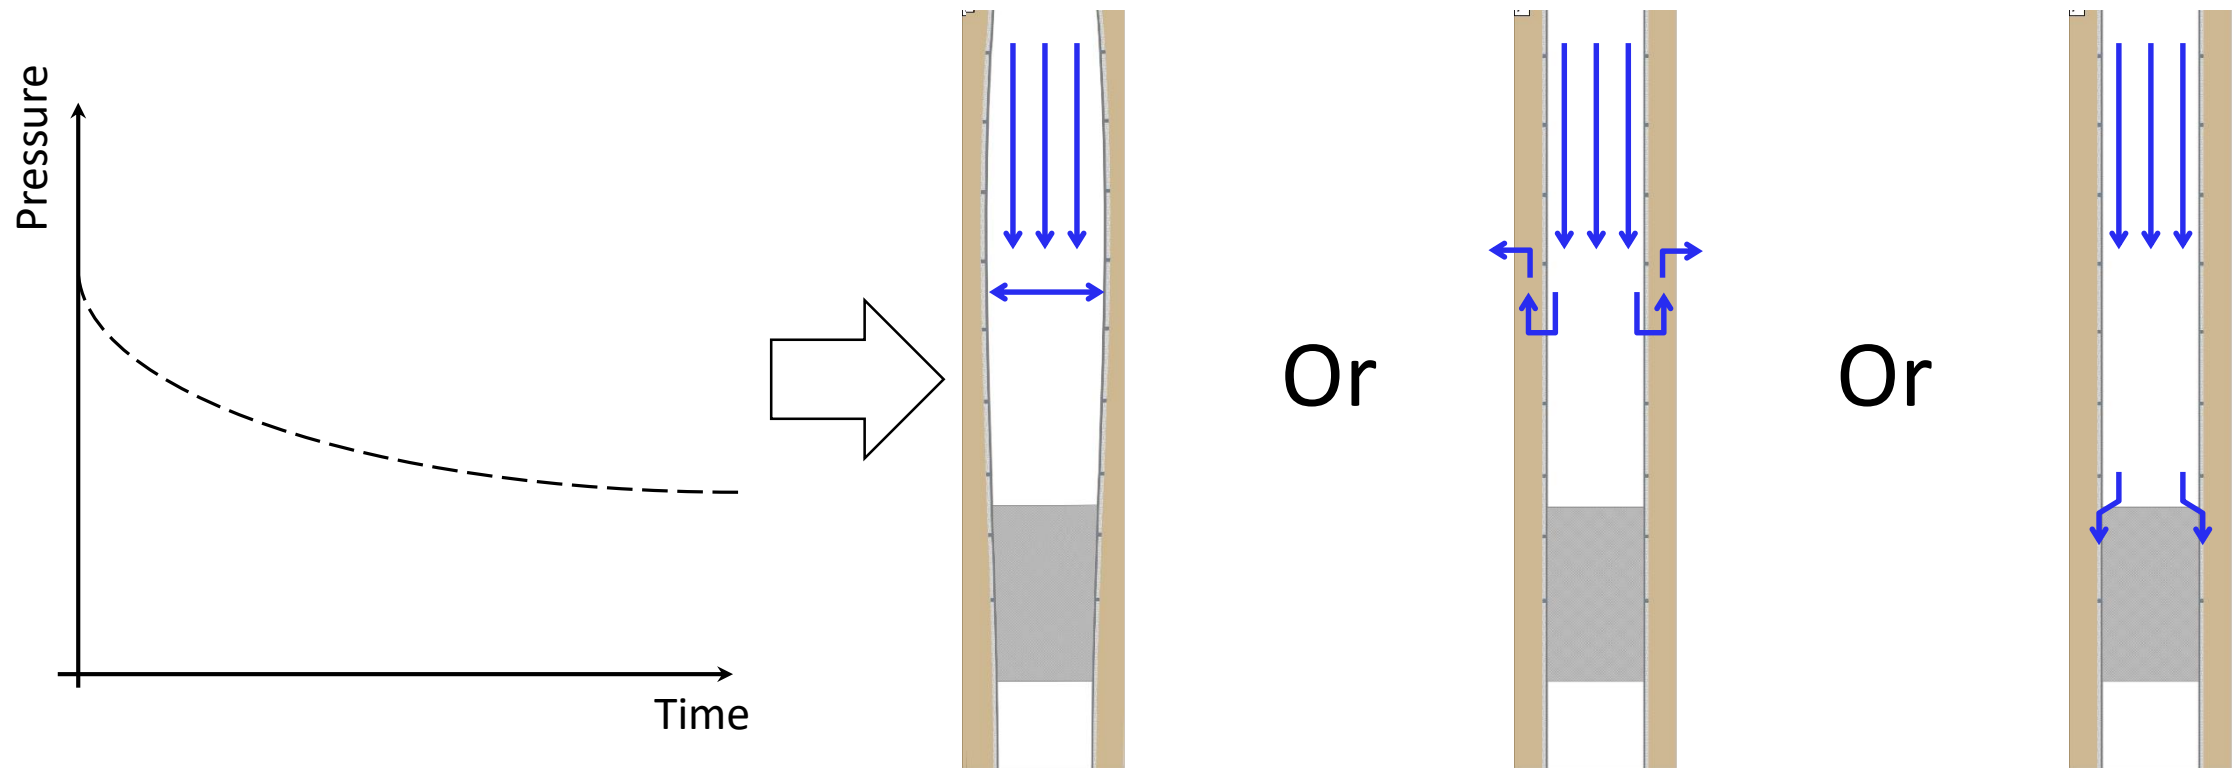
Surface (perf and) pressure test interpretation challenges

- Impact of casing ballooning
- Completion leaks in non-targeted zones
- Missed minor leakage

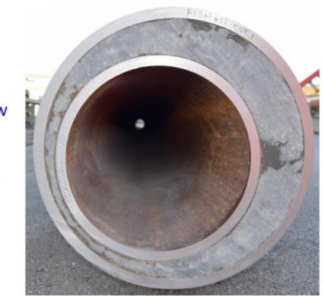
Norce test 2019

Main observations:

1. Annular space 100% cemented
2. Visual signs of debonding? – inner and outer casing
3. Apparent debonding visually appears worst on narrow side
4. Minor defects in cement bulk – few mm in depth
5. Debonding material and defects filled with material - might be mud solids
6. 9 5/8 casing collar present

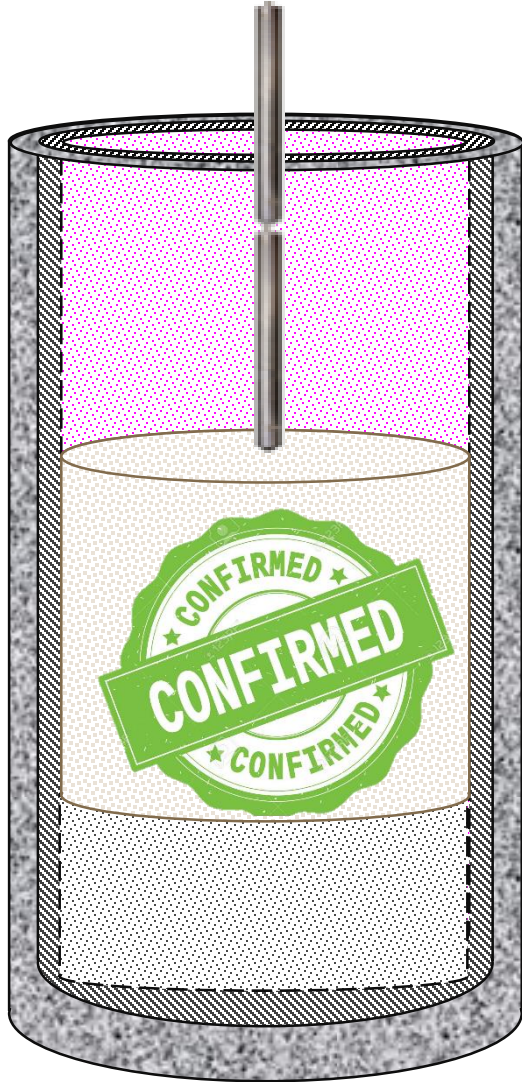
Cement plug pressure Test (success)

Shut-in Station (5 minutes)

Pressure Test Station (30 minutes)

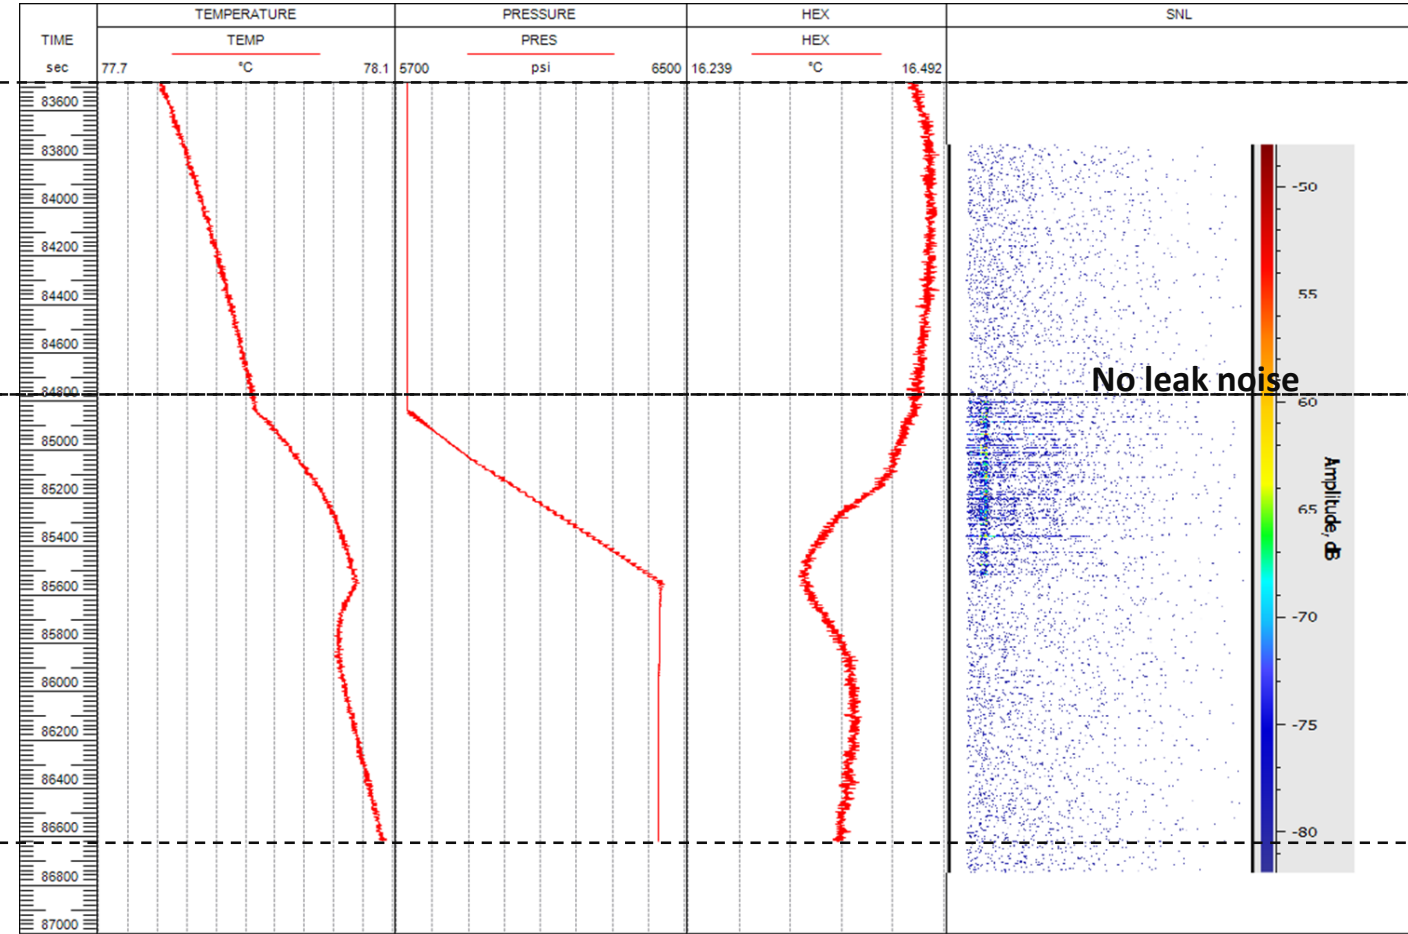
Perf and pressure test

Cement isolation failure
