OLF hydrocarbon leak reduction project

Analysis of causes of hydrocarbon leaks in 2008 – 2011

Final report, 08.06.2012

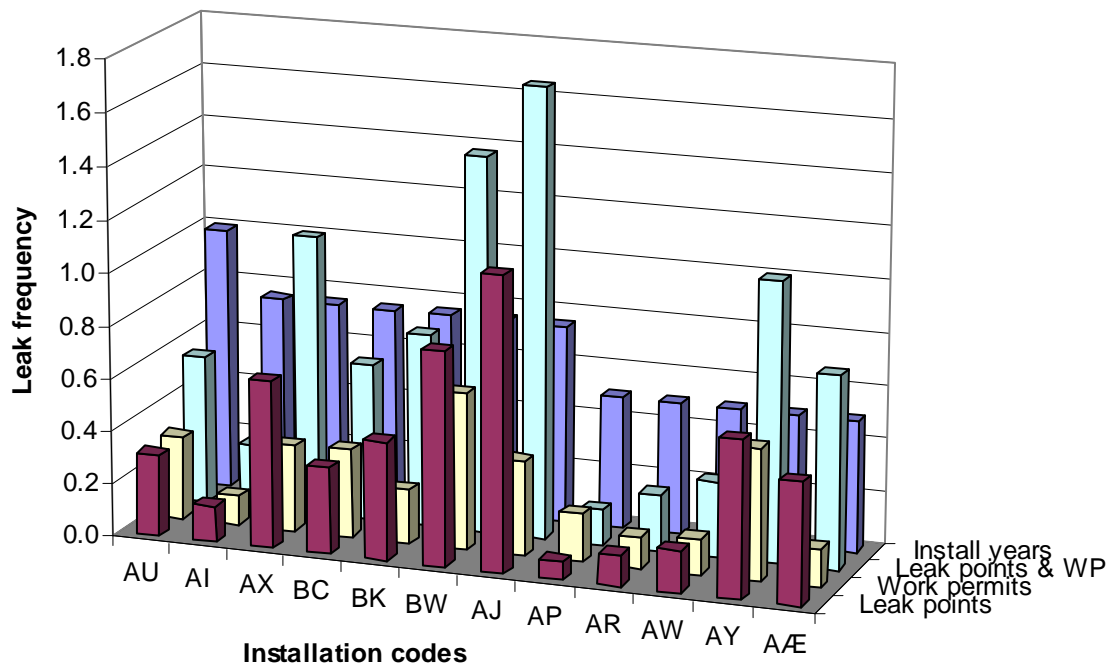
Figure 7 presents a summary of the different normalizations. It is clearly demonstrated that normalization according to installation years only gives an incomplete picture.

Please note that the diagram is somewhat special to read. The installations with the highest leak frequencies are the ones with highest bars, according to Table 4–Table 7. The values plotted in Figure 7 are the same values as in Table 4, Table 5, Table 6 and Table 7, with the exception that the values in Table 6 have been divided by 10, in order to fit to a common scale.

The different series in Figure 7 correspond to the data in Table 4, Table 5, Table 6 and Table 7. If the rankings were completely consistent independently of which parameter that is used, the rankings would have been similar for all installations in the diagram.

Figure 7 Comparison of ranks according to the different normalizations

The four installations which altogether have the highest leak frequencies for all parameters combined are BW; AJ, AX, and AY. Interestingly, these installations represent one old (>25 years in operation), two medium aged (10–20 years in operation) and one new (< 5 years in operation) installation. Hence, age does not appear to explain the observed differences.

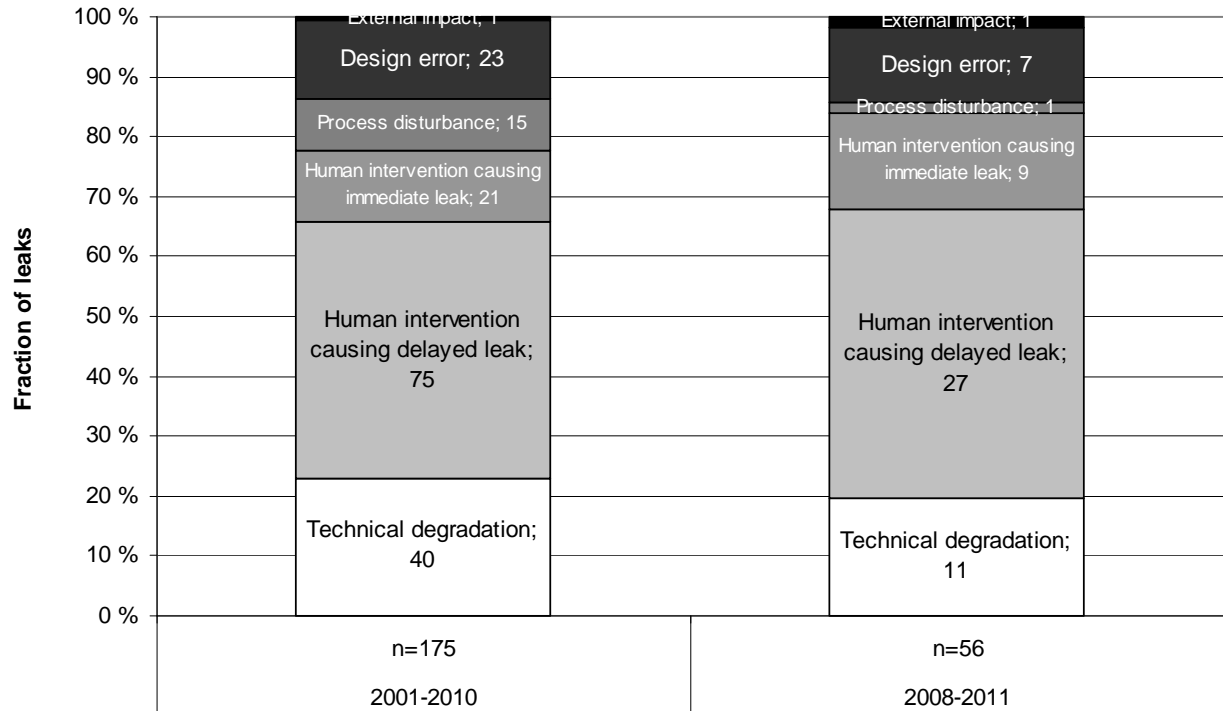
The first presentation is an overview of the failures relating to work flow phases. The data in the period 2008–11 is compared to the entire period 2001–10, for the entire Norwegian sector, where the data for the period 2001–2010 is presented in Vinnem (2012a).

Figure 8 Hydrocarbon leaks distributed on operational circumstances, Norwegian Continental Shelf, average 2008–11 (n =56) and average 2001–10 (n =175) (partly based on Vinnem, 2012a)

The fraction of leaks due to technical degradation are slightly lower in the period 2008–11 period when compared to the previous ten year period, but is surprisingly close. The contribution from manual intervention is even higher in the 2008–11 compared to the ten year period, especially for immediate leaks due to errors made during the intervention. The contribution from process distributions is the most significant change (reduction) for the period 2008–11 compared to the previous 10 year period.

The distribution on the main categories is presented in Figure 8. Please consider the subcategories for categories B&C, i.e. the failures during manual intervention.

Figure 8 shows that the number of leaks in the period 2008–2011 can be categorized as follows for design and degradation:

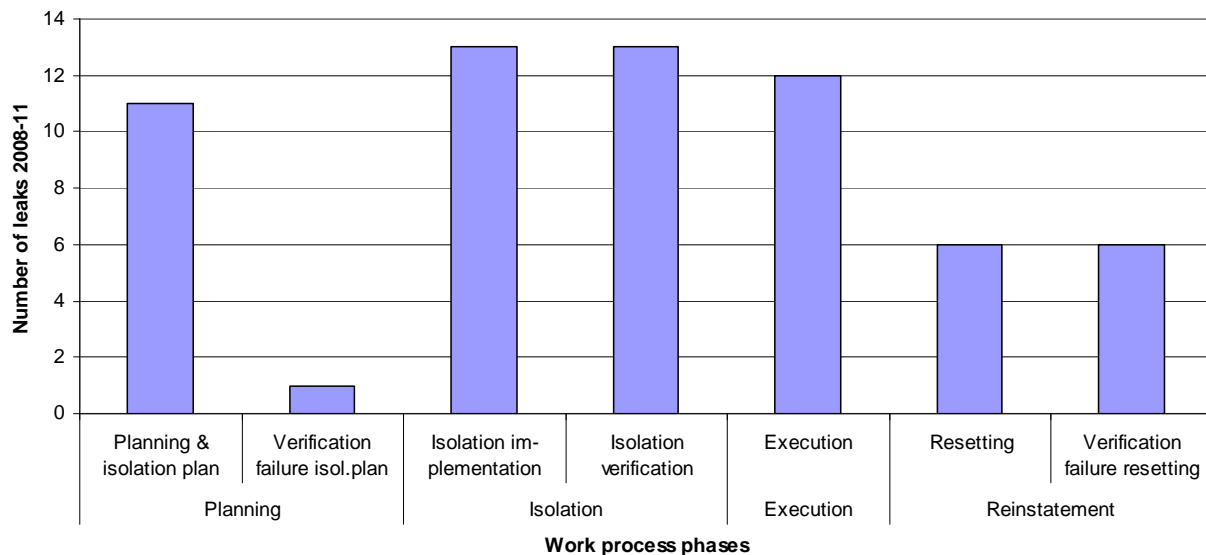
Figure 11 presents an overview of the errors made during the various work flow phases, for leaks due to manual interventions (B & C categories; see Section 2.1). The data set is limited to 32 B & C leaks in the period 2008–11, where the information was sufficient to be able to determine which work flow phase that the error had been made in.

Figure 11 Distribution of errors during leaks due to manual intervention (B & C categories), NCS, 2008–11, for each work process phase separately (n=32)

It should be noted that there are several errors made during planning, but only one of these could have been picked up during verification of the isolation plan, see further discussion in Section 6.3.

Figure 13 presents the distribution of when (i.e. in which work flow phase) the leaks occurred. Figure 13 may be compared against Figure 11, which shows in which phase the errors were made.

Figure 11 shows that some errors have been made in the planning phase, these have caused leaks in subsequent phases. Planning errors are often made together with other errors, and the times at which the leaks occur will then be influenced by what other errors that are made. The type of error will also influence when leaks occur, some errors cause immediate leaks, other errors lead to delayed leaks, either during reinstatement or after start-up.

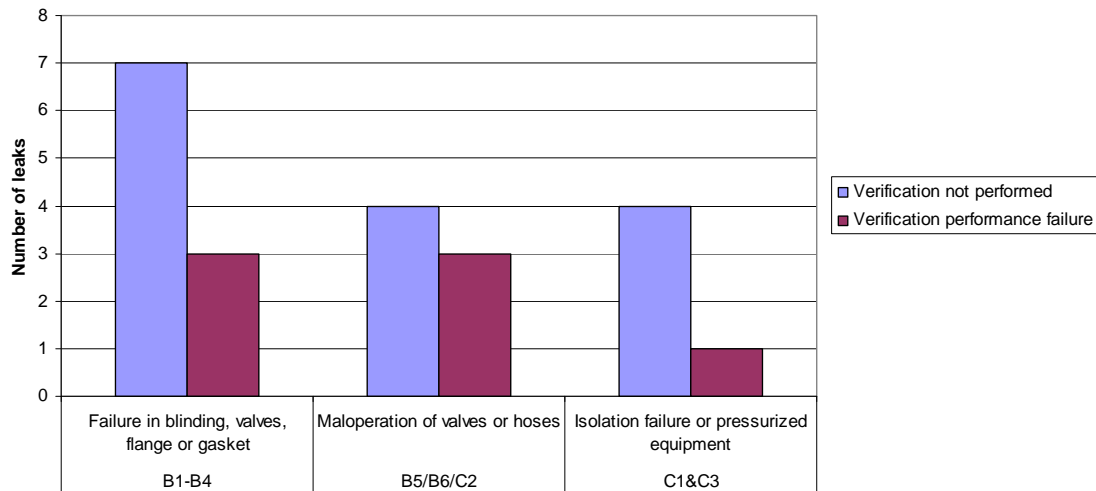
There are two categories of failure of verification that are represented in the data basis, either the verification is not carried out, or it is carried out but failed to reveal the error that has been made, Figure 12.

Figure 12 Verification failure split in verification not performed and verification performed but failed

Verification failures were discussed in relation to work phases in Section 6.4, see Figure 12 in particular. In the present discussion we aim to go deeper into the circumstances of verification failures.

First of all, please note that for the 20 leaks where verification had failed, shown in Figure 12, 68% failures were related to deficient performance of the verification, whereas 32% were failure of the verification itself. It is to be expected, although not identified clearly, that many of the failures to conduct specified verification activities are associated with 'silent deviations' from steering documentation. Unacceptable practices have been developed over time on some installations, implying that it is considered acceptable not to follow steering documentation, and that instead so-called 'qualified evaluations' conclude that simplifications are just as good. Often such simplifications imply that verification activities either are not carried out at all, or made in a simplistic manner.

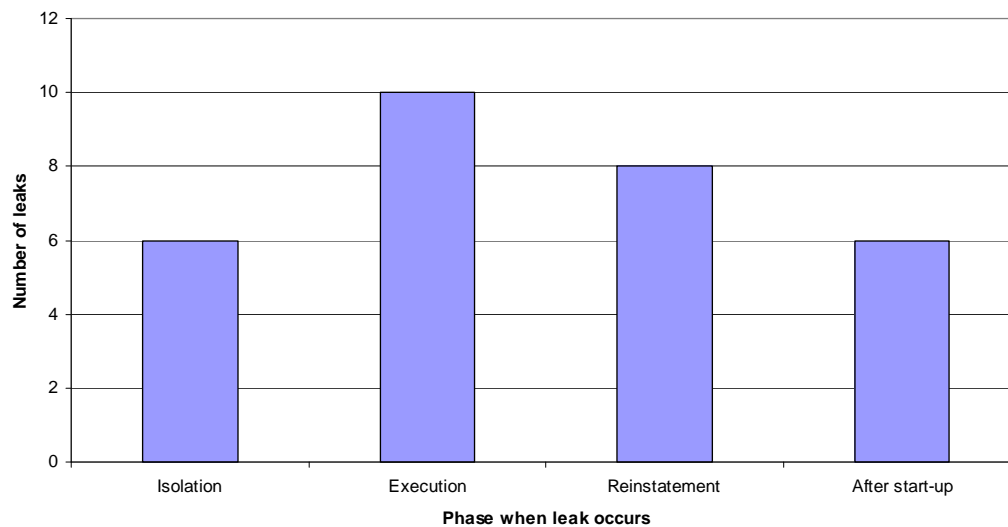
Figure 13 Phase in which leaks occur, NCS 2008–2011 (n=30)

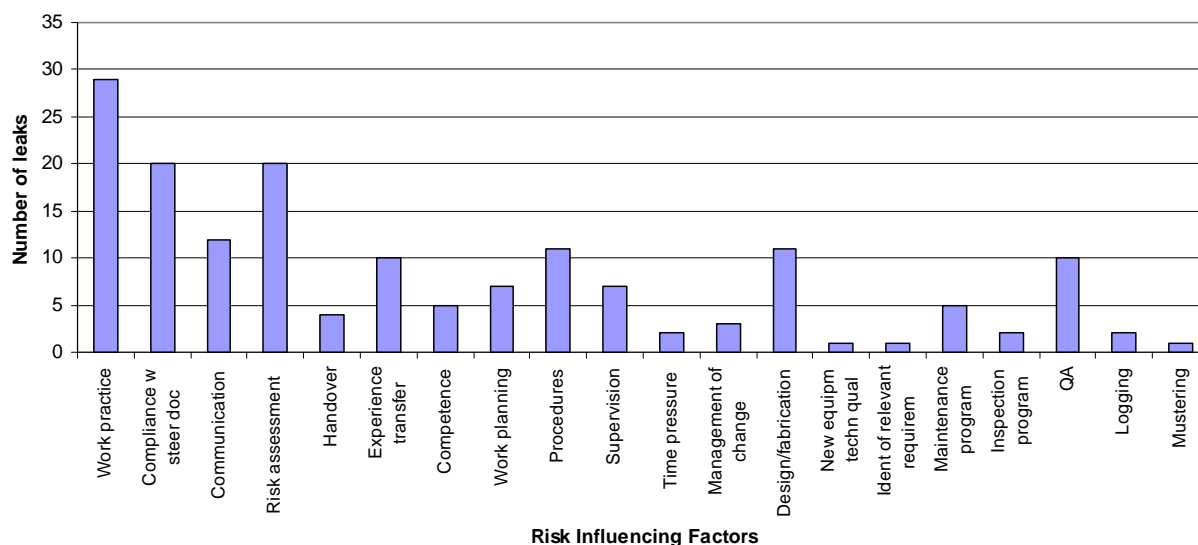
Work practice is the RIF that is cited in most of the investigations, 29 out of 47 leaks. Failure to comply with steering documentation (such as procedures) is the second most frequently used, with 20 out of 47 leaks. If we take failure of work practice **or** failure to comply with procedures, this applies to 35 or out of 47 leaks (74%). On the other hand, if we take failure of work practice **and** failure to comply with procedures, this applies to 14 or out of 47 leaks (30%). Work practice errors and failure to comply with controlling documentation are therefore the most critical RIFs associated with hydrocarbon leaks.

'Risk assessment', which should be interpreted as 'failure to perform relevant risk assessments' as well as 'lack of apprehension of risk', is almost as frequent as failure to comply with steering documentation, 20 out of 47 leaks.

Figure 14 Overview of RIFs from investigations and 'in depth' studies, NCS, 2008–2011 (n=47)

If we focus on RIFs that are identified in at least ten cases, the following RIFs come in addition; failure of experience transfer, lack of/inadequate procedures and error during design/fabrication.

The next diagram, see Figure 15, compares the RIFs for all leaks (as in Figure 14) with only those leaks that are associated with manual interventions (B and C type leaks, see Section 2.1). The same Risk Influencing Factors are used in Figure 15 and Figure 14, the majority of these are most relevant for the leaks that are associated with manual intervention, i.e. the B and C type leaks.

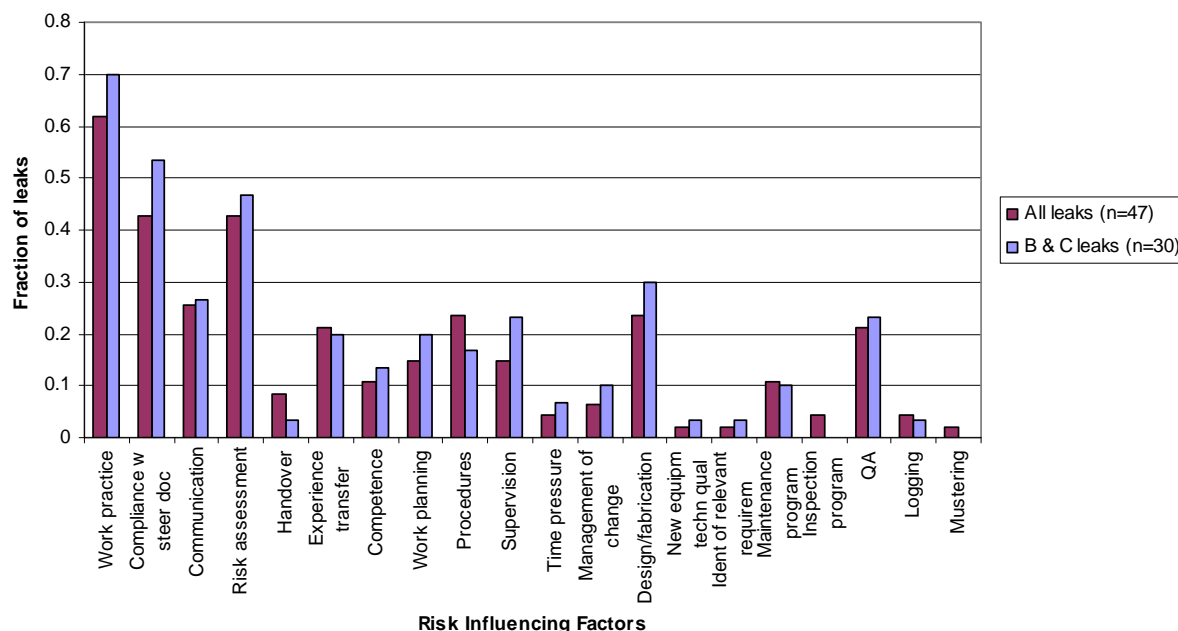
Figure 15 Overview of RIFs from investigations and 'in depth' studies, NCS, all leaks and leaks due to manual intervention, 2008–2011 (n=47&30)

Errors related to work practice and inadequate compliance with steering documentation become important if only leaks associated with manual intervention are considered. If we look at failure of
